TECHNICAL SERVICE BULLETIN

DTC P161D STORED IN BCM

APPLIED VEHICLES: 2020-2021 Sentra (B18)

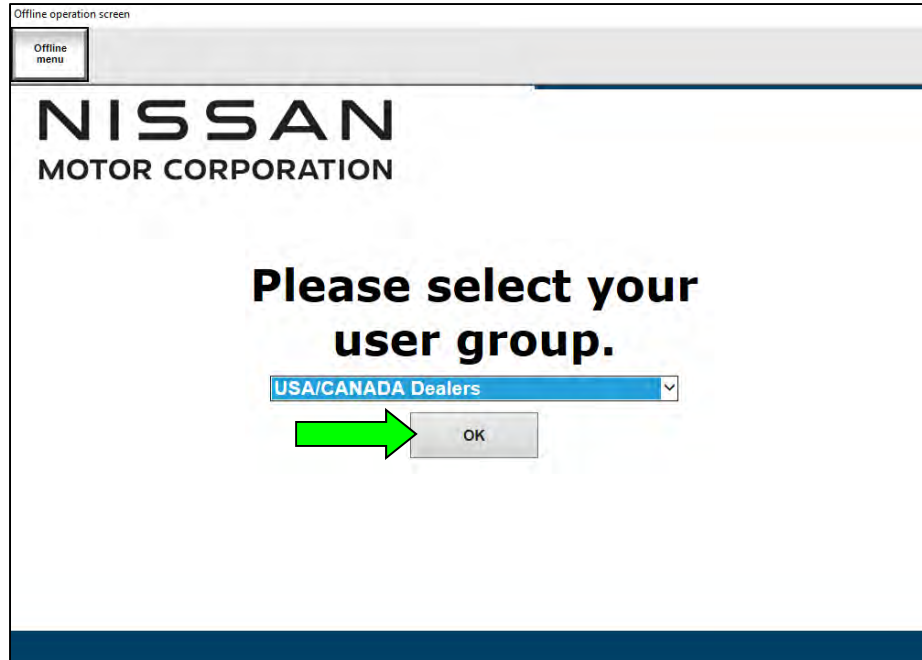
Figure 1

4. Select **USA/CANADA Dealers** from the drop down menu, and then select **OK**.

IMPORTANT: While the VI is being recognized by C-III plus, C-III plus will require a user credential sign in (Figure 1 and Figure 2 on page 3).

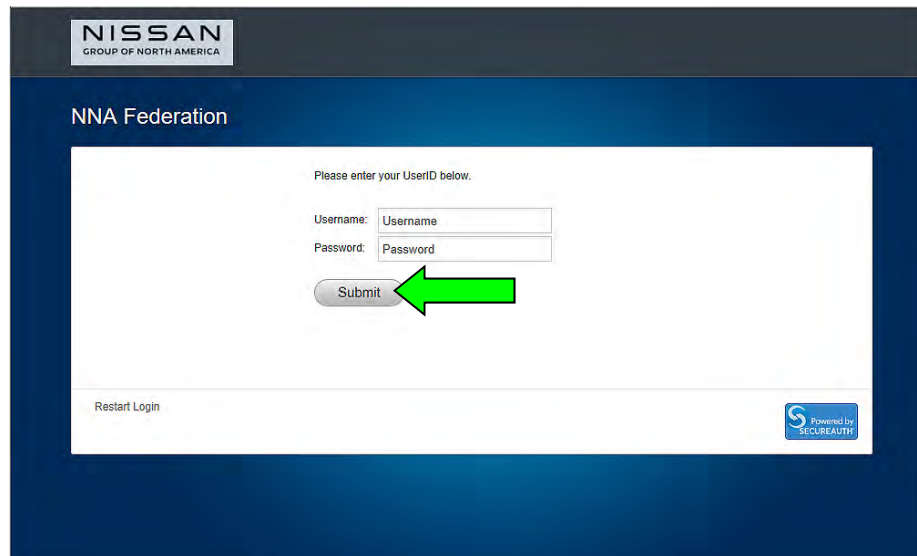
Figure 2

5. Login using your NNAnet credentials.

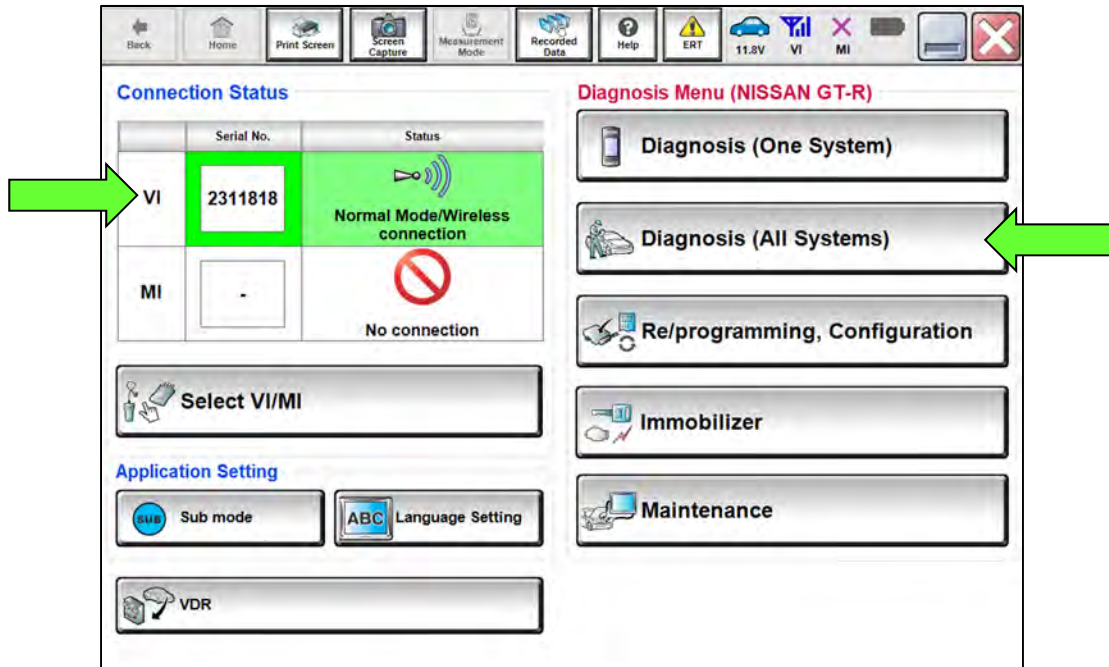
Figure 3

6. Wait for the VI to be recognized.
 - The serial number will display when the VI is recognized.
7. Select **Diagnosis (All Systems)**.

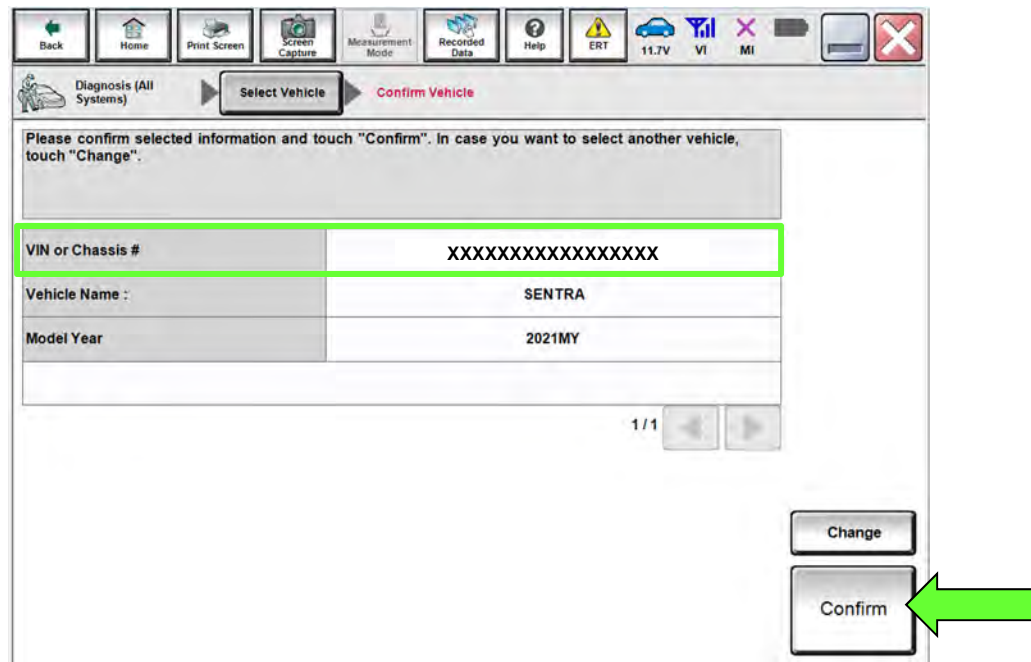
Figure 4

8. Confirm the **VIN or Chassis #** is correct, and then select **Confirm**.

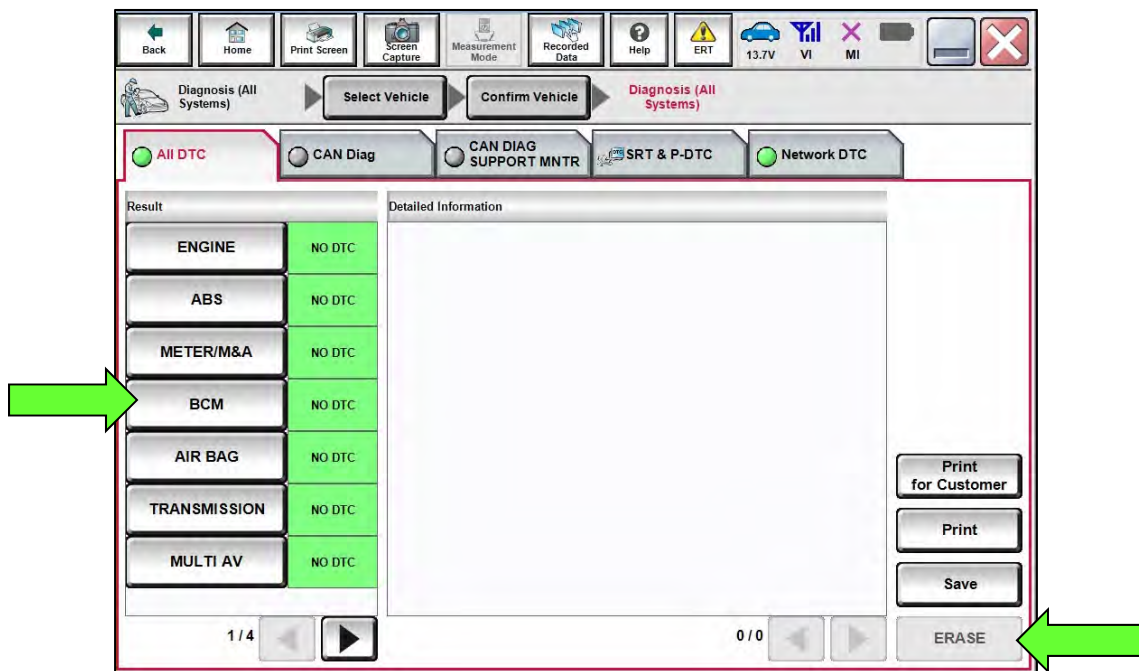
Figure 5

9. Confirm that only DTC P161D is stored.
 - If there are DTCs other than P161D, troubleshoot and resolve those DTCs first.
 - DTCs other than P161D are not covered under this bulletin. Refer to the ESM for further diagnostic information.
10. Select **ERASE** to erase all DTCs.
11. Select **BCM**.

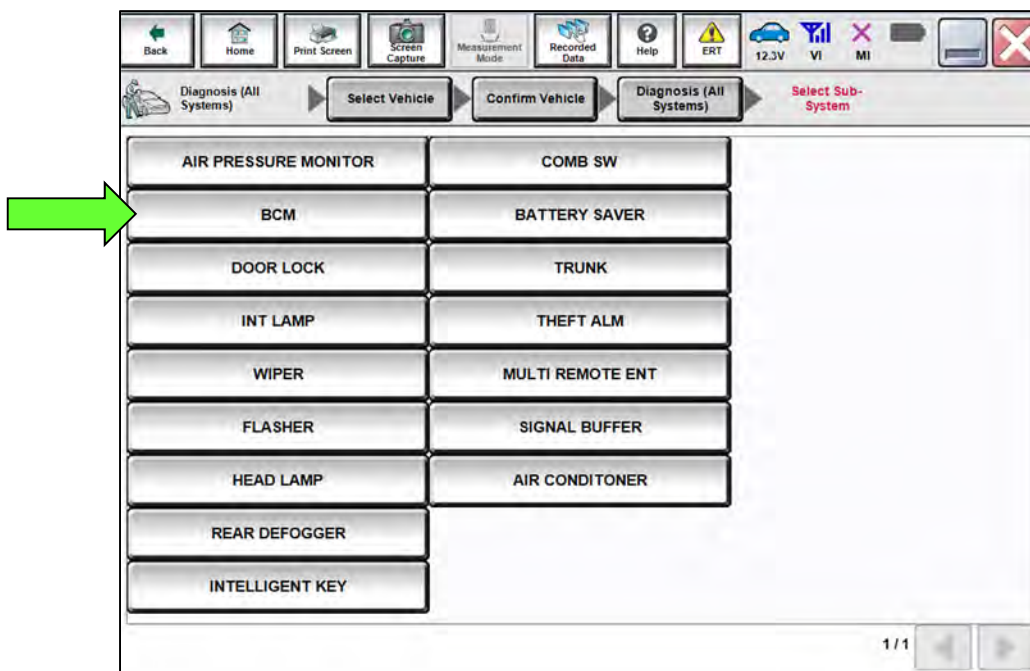
Figure 6

12. Select **BCM** again.

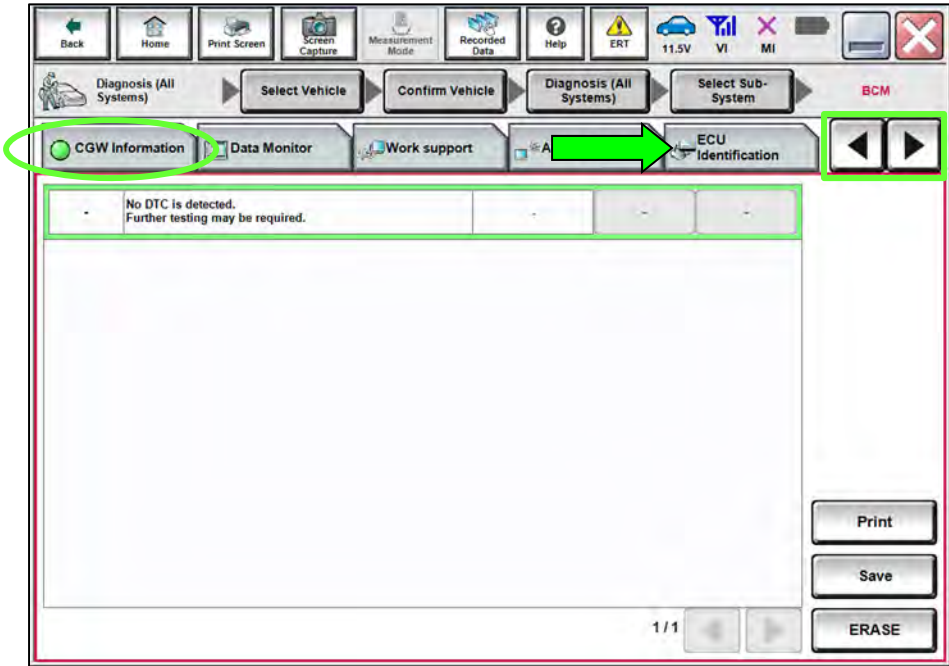
Figure 7

- 13. Confirm the **CGW Information** icon is "green" (Figure 7).
 - If not "green", start the **SERVICE PROCEDURE** over from step 1 on page 2.
- 14. Use the arrows to scroll tabs until **ECU Identification** is found, and then select it.

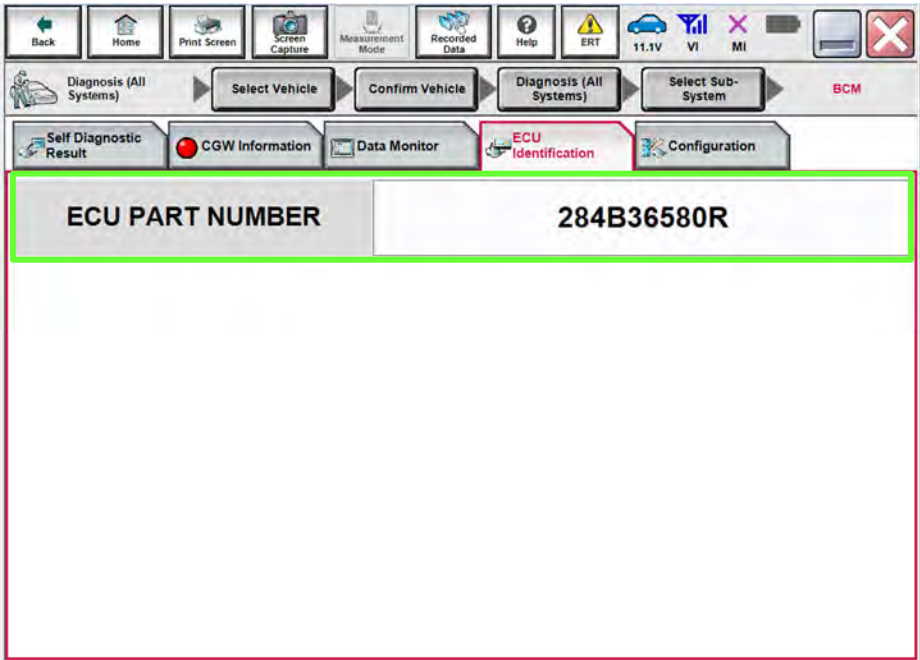
Figure 8

- 15. Confirm that **ECU PART NUMBER** is "284B33613R" (20MY) or "284B36580R" (21MY).
 - If **ECU PART NUMBER** is "284B33370R", this bulletin does not apply.

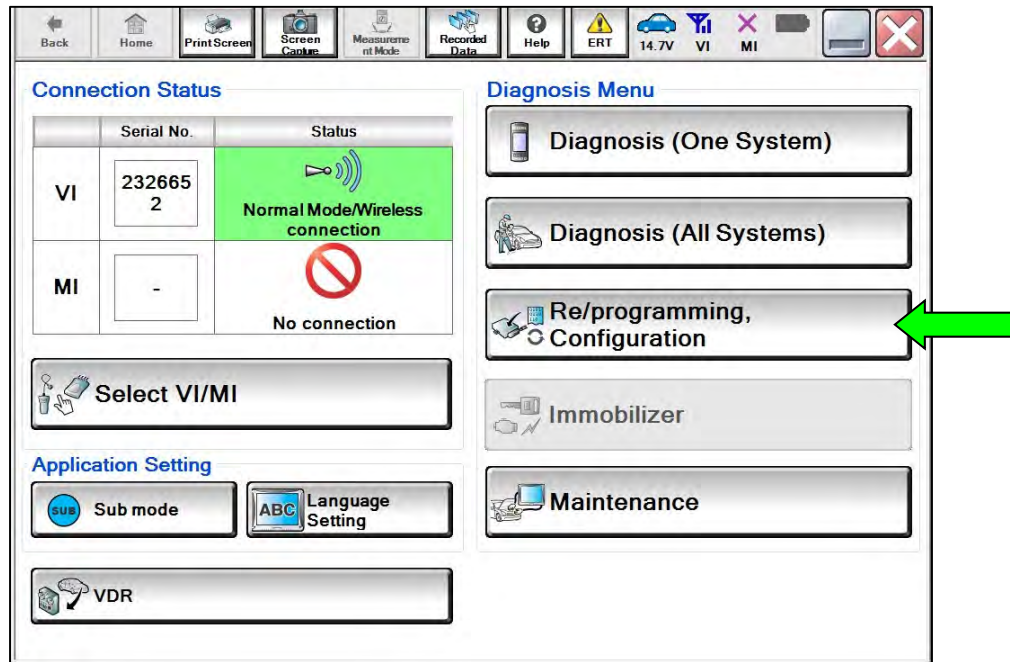
Figure 9

16. Select **Home**.
17. Select **Re/programming, Configuration**.

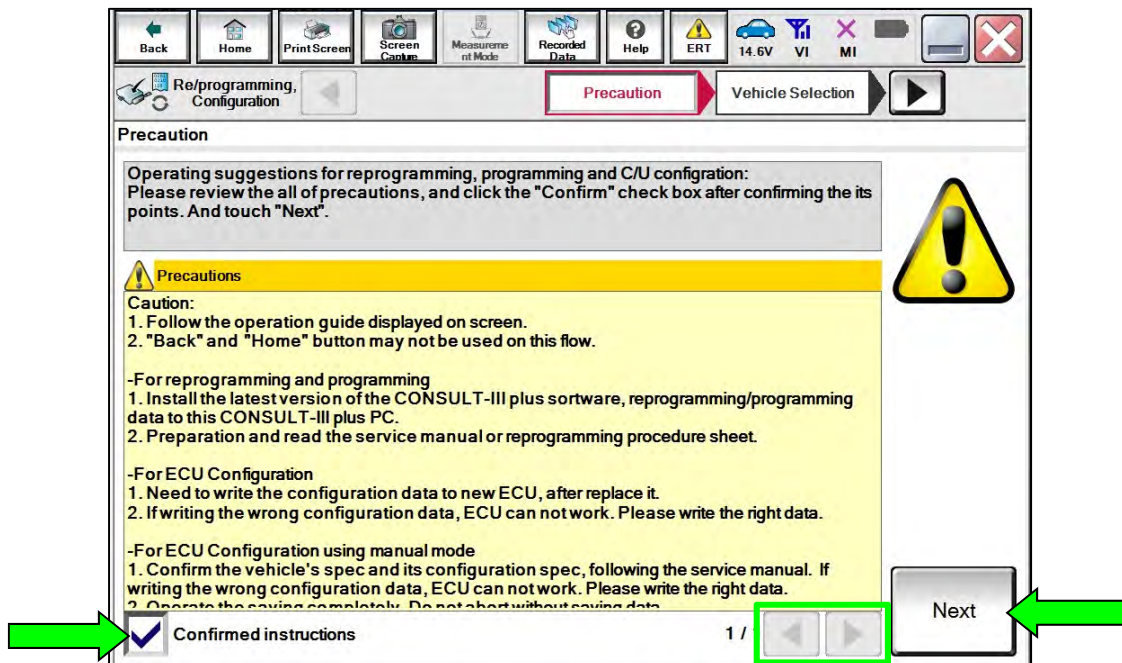
Figure 10

18. Check the box to confirm the precaution instructions have been read, and then select **Next**.

HINT: Use the arrows (if needed) to view and read all the precautions.

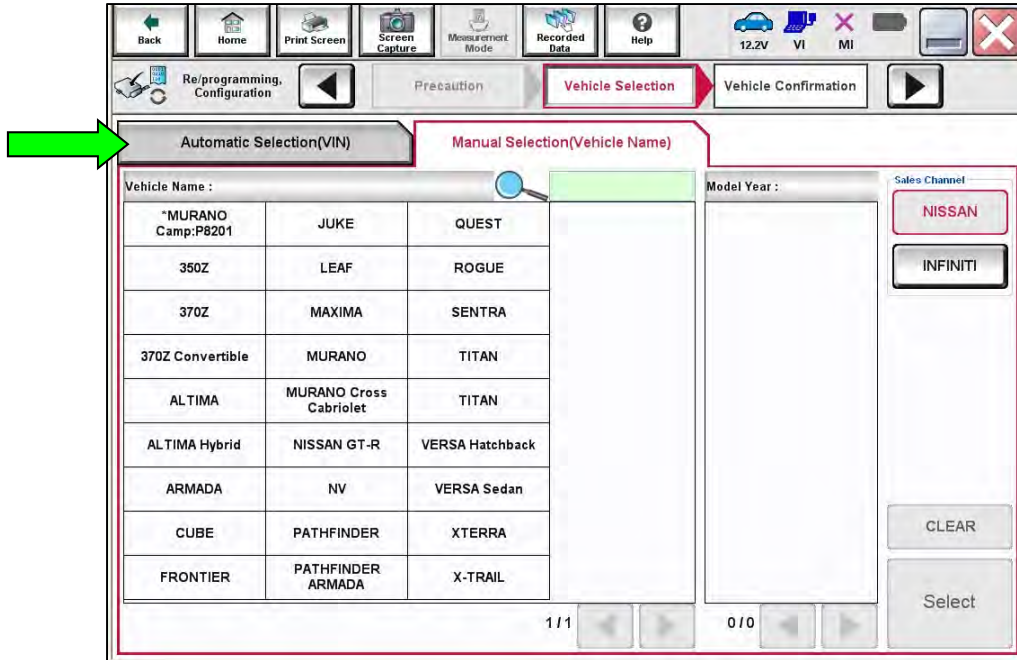
Figure 11

19. Select Automatic Selection(VIN).

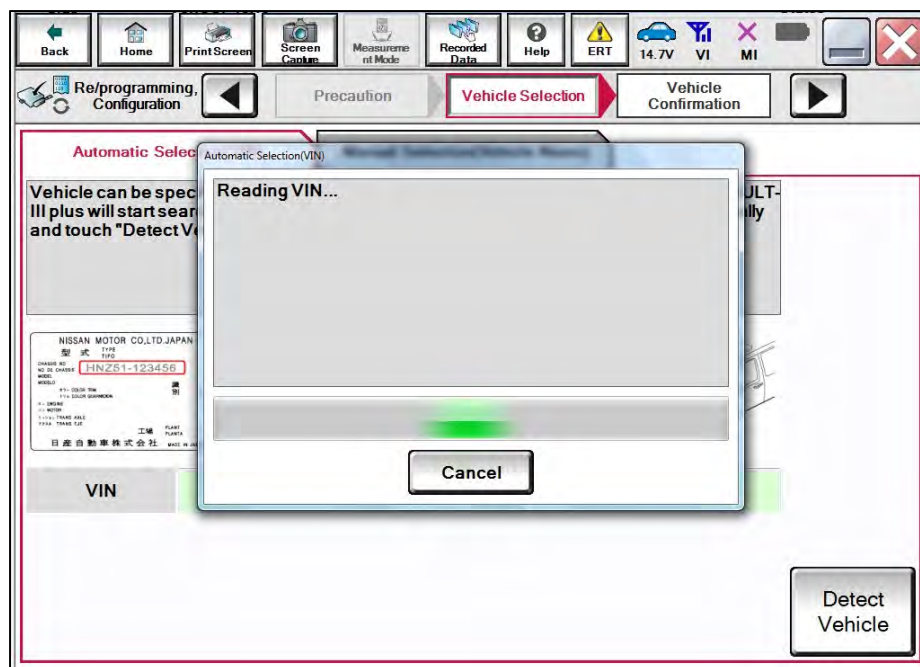
Figure 12

20. Allow the CONSULT to perform automatic VIN selection.

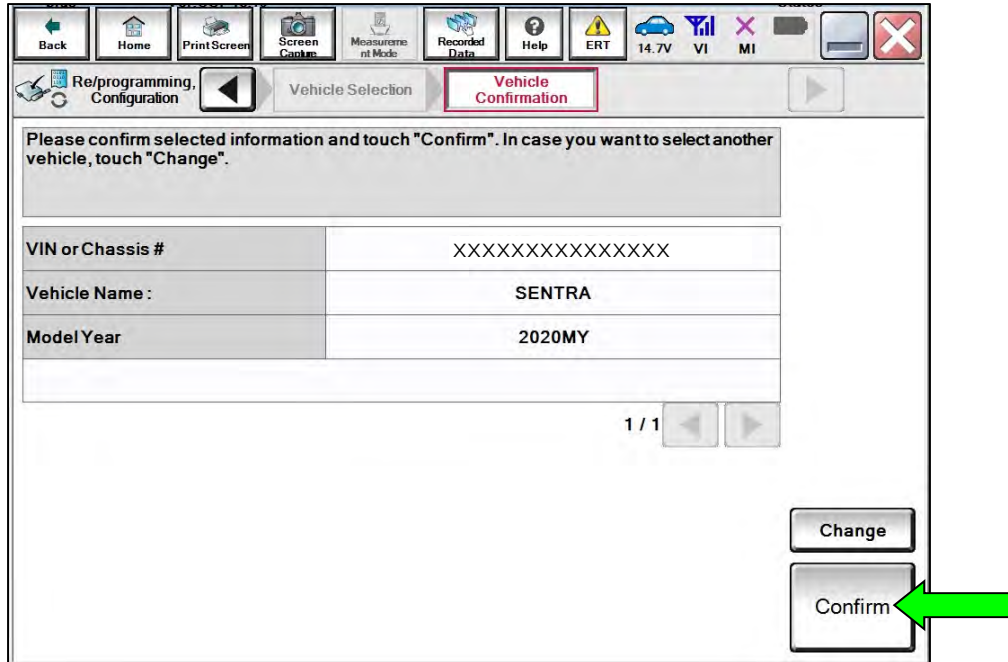
Figure 13

21. Confirm the **VIN or Chassis #** is correct, and then select **Confirm**.

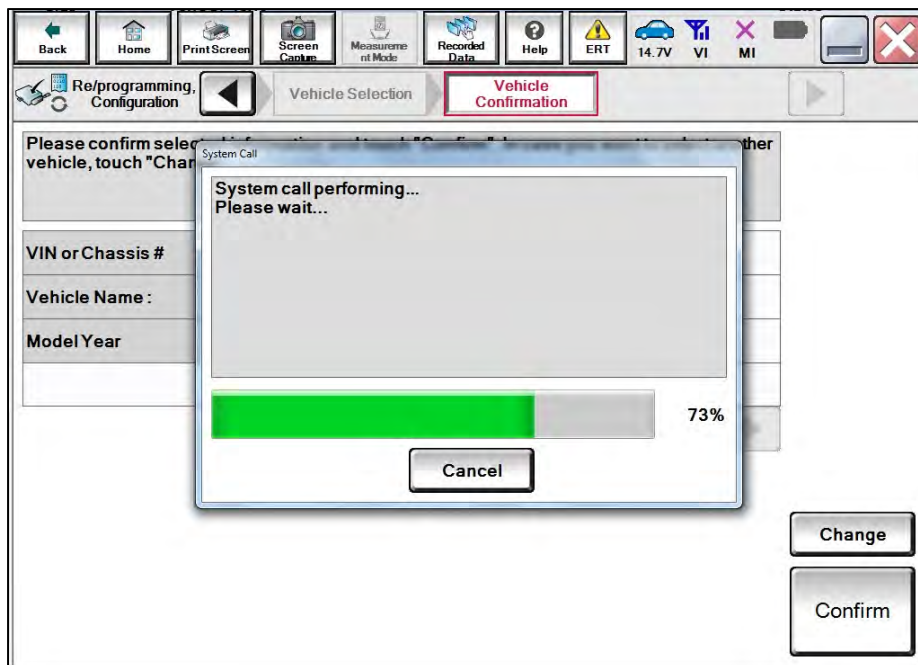
Figure 14

22. Allow the System call to be performed.

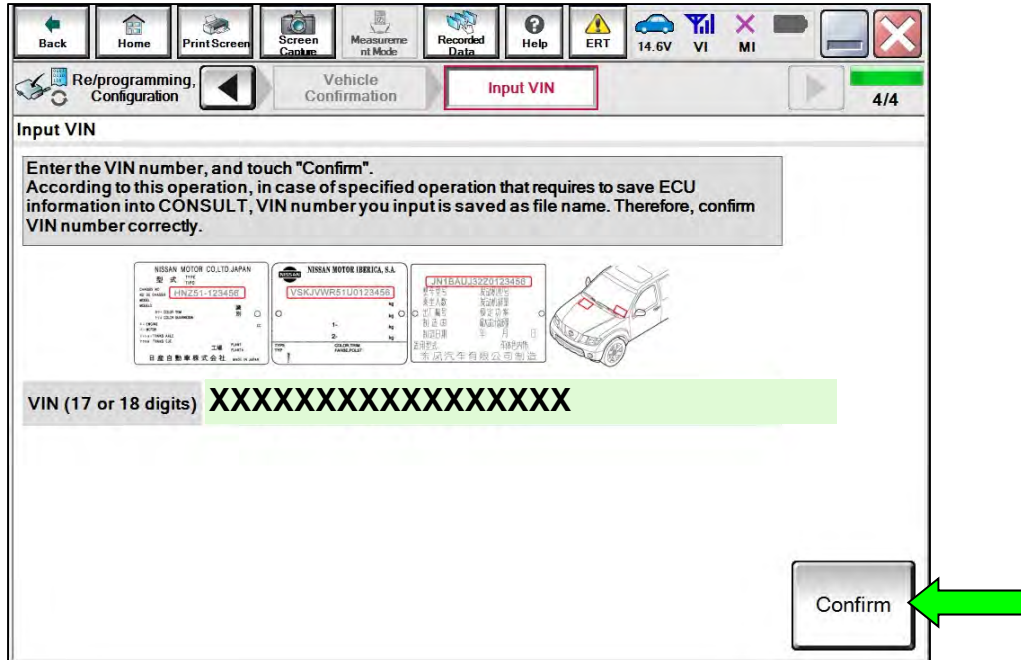
Figure 15

23. Confirm the VIN is correct for the vehicle, and then select **Confirm**.

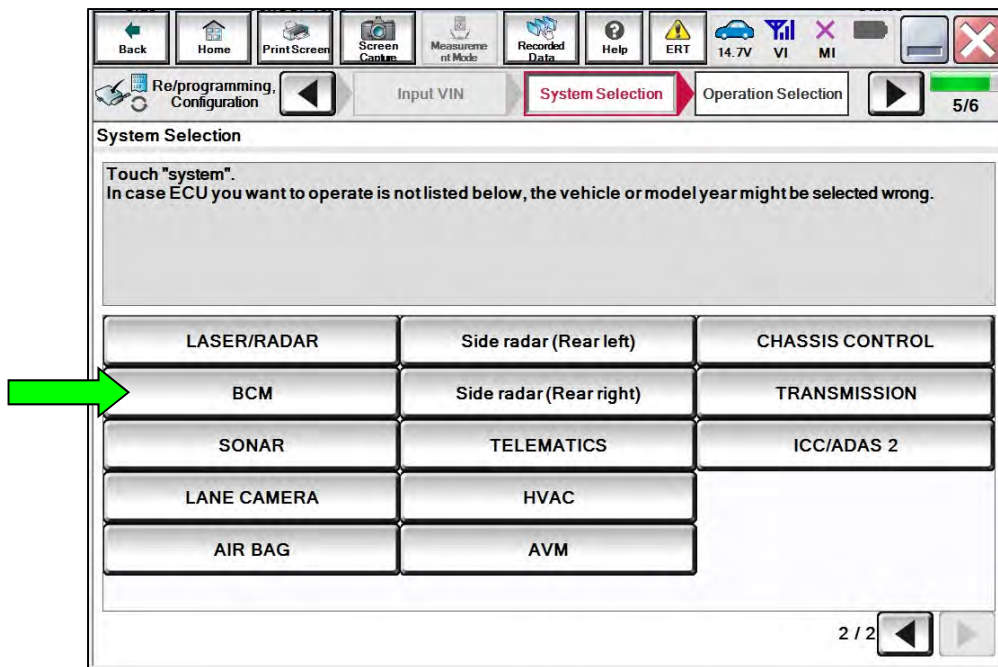
Figure 16

24. Select **BCM**.

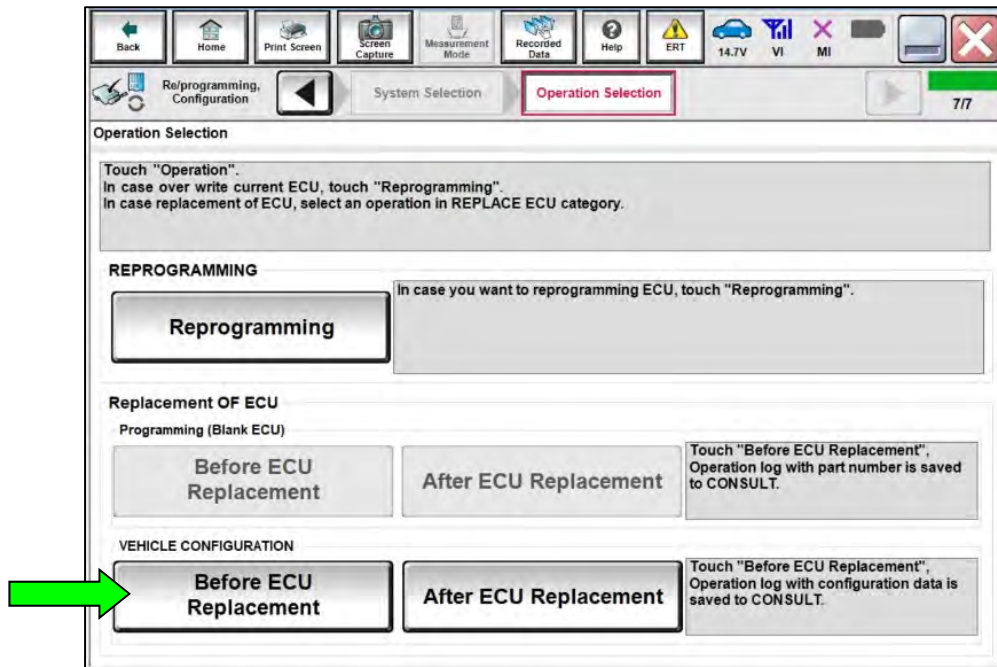
Figure 17

25. Select **Before ECU Replacement** under **VEHICLE CONFIGURATION**.

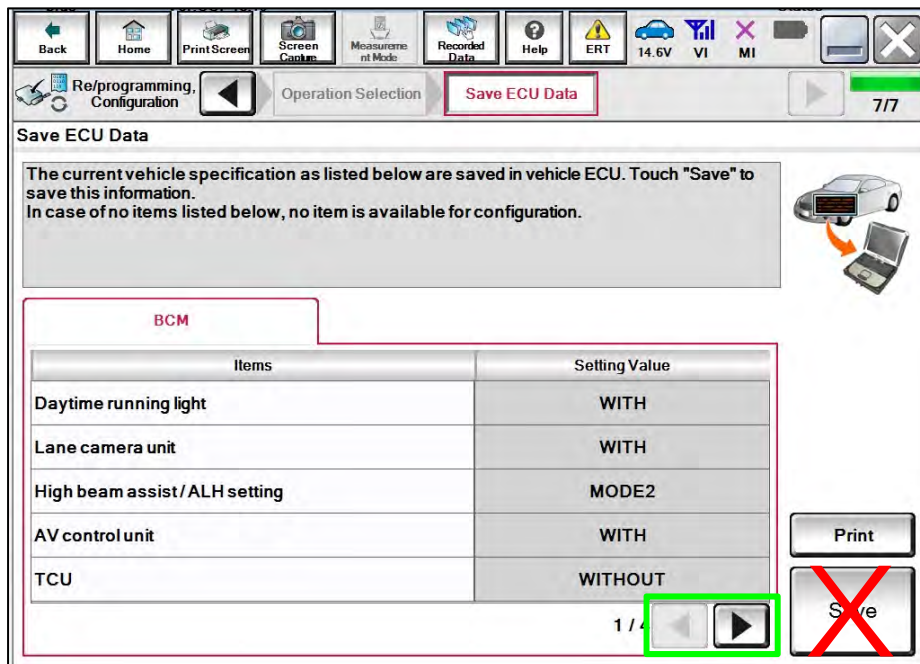
Figure 18

26. Scroll through each of the four pages of configuration items and write down each of the **Items** and their **Setting Value**.

- If a printer is connected to the CONSULT PC, you may select **Print**.

IMPORTANT: Document or print all configuration settings as these settings will be used in step 46 on page 22, and the SAVE function for this reprogram will **NOT** work.

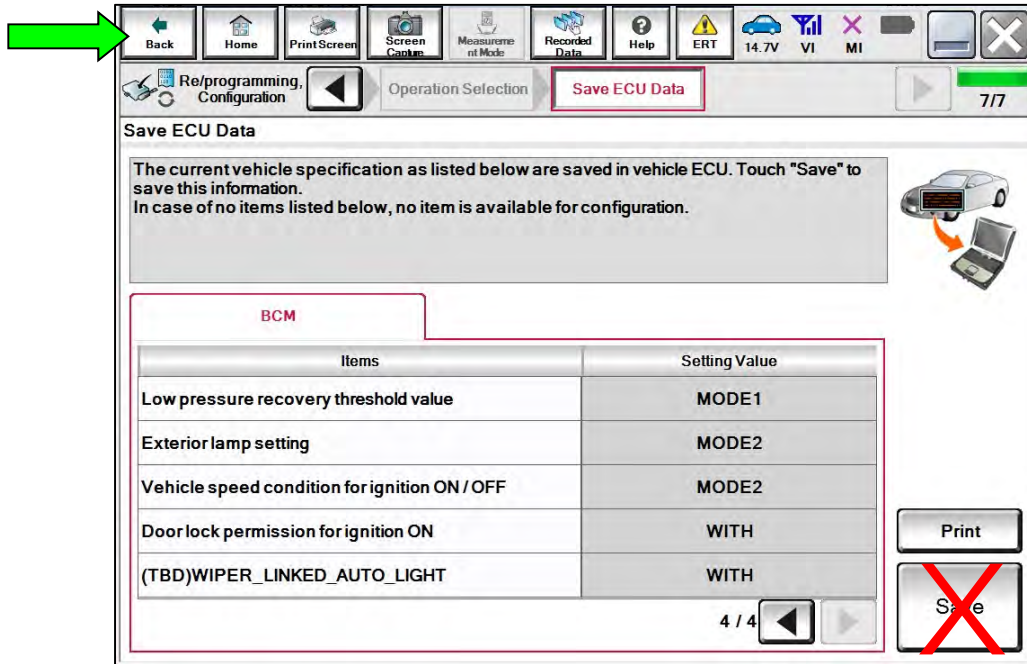
Figure 19

27. Once all the setting values have been documented, select **Back** in the upper left hand portion of the screen.

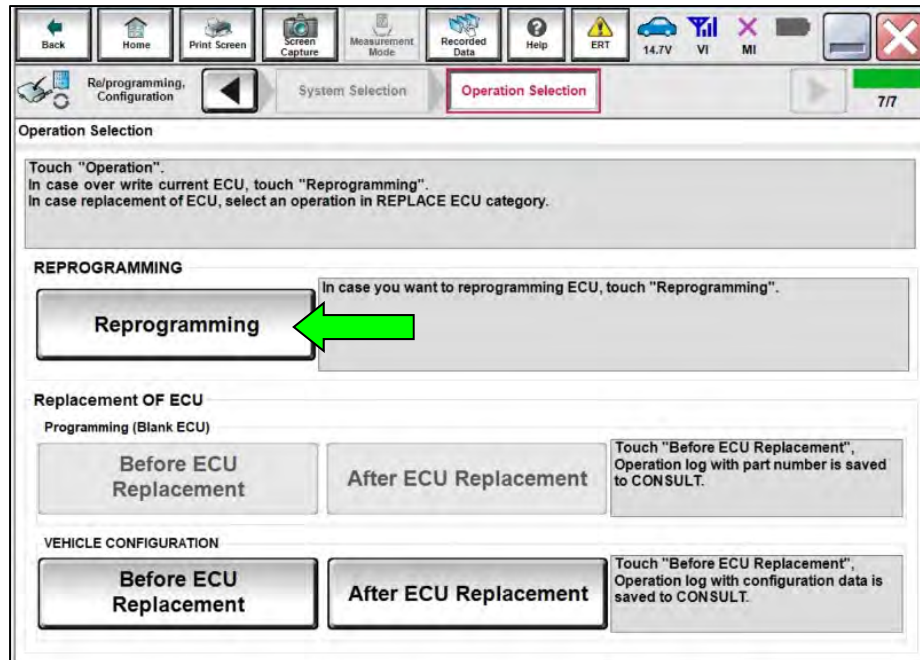
Figure 20

28. Select **Reprogramming**.

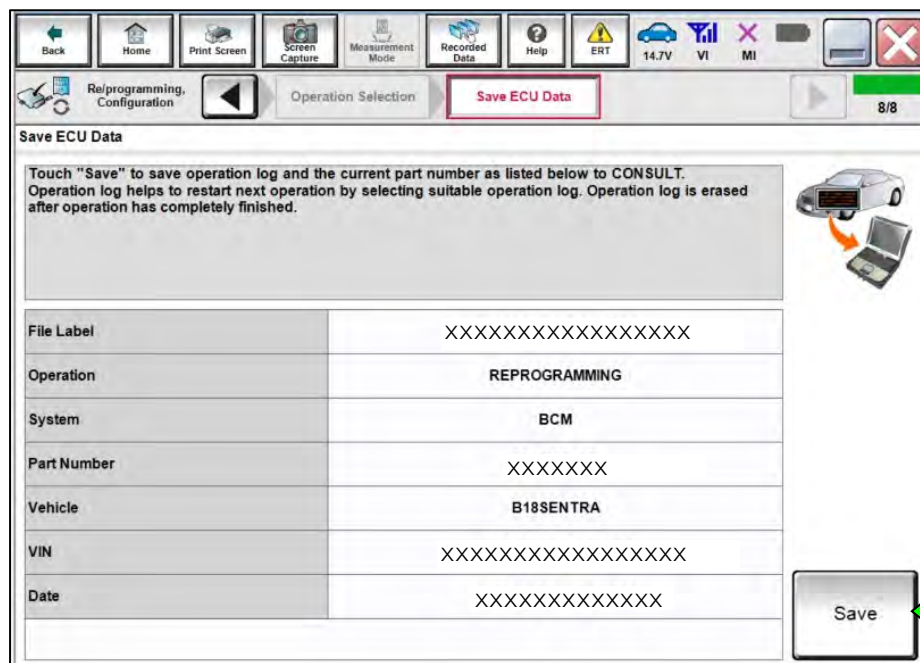
Figure 21

29. Select **Save**.

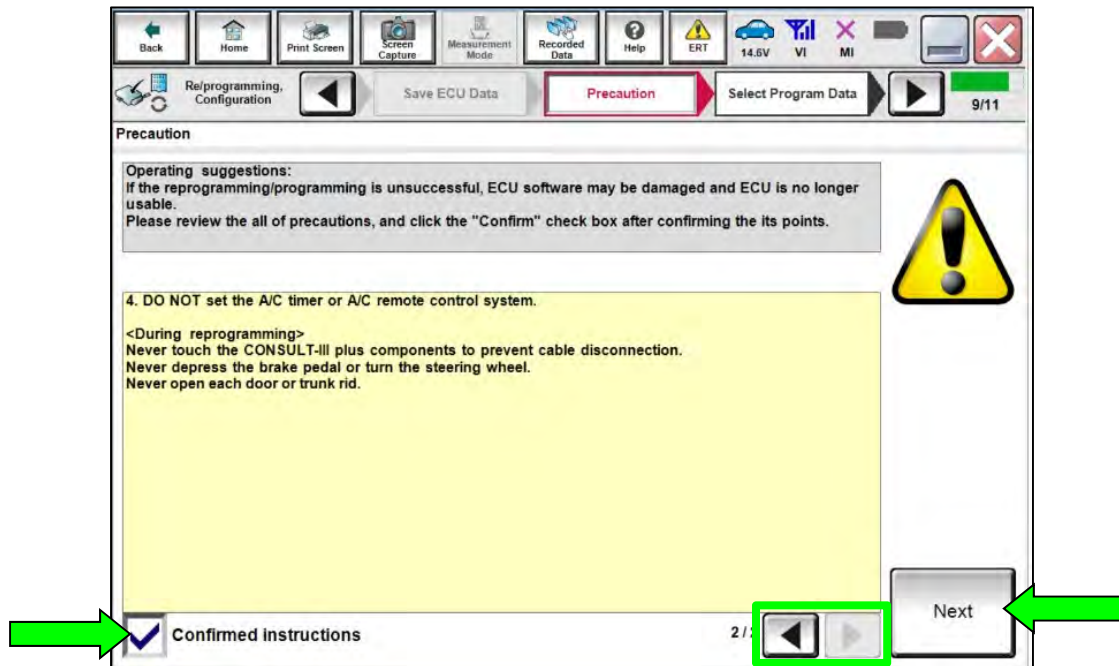
Figure 22

30. Check the box to confirm the precaution instructions have been read, and then select **Next**.

HINT: Use the arrows (if needed) to view and read all the precautions.

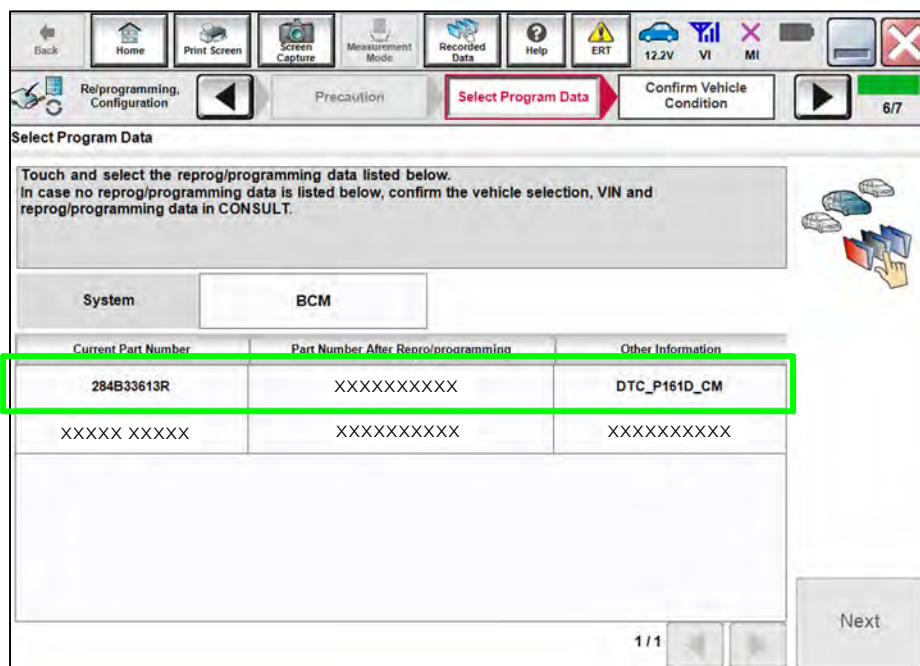
Figure 23

31. Confirm that a reprogram is available.

- If "DTC_P161D_CM" under **Other Information** is listed, select it and then select **Next**.
- If "DTC_P161D_CM" is not listed, this bulletin does not apply. Skip to step 58 on page 28.

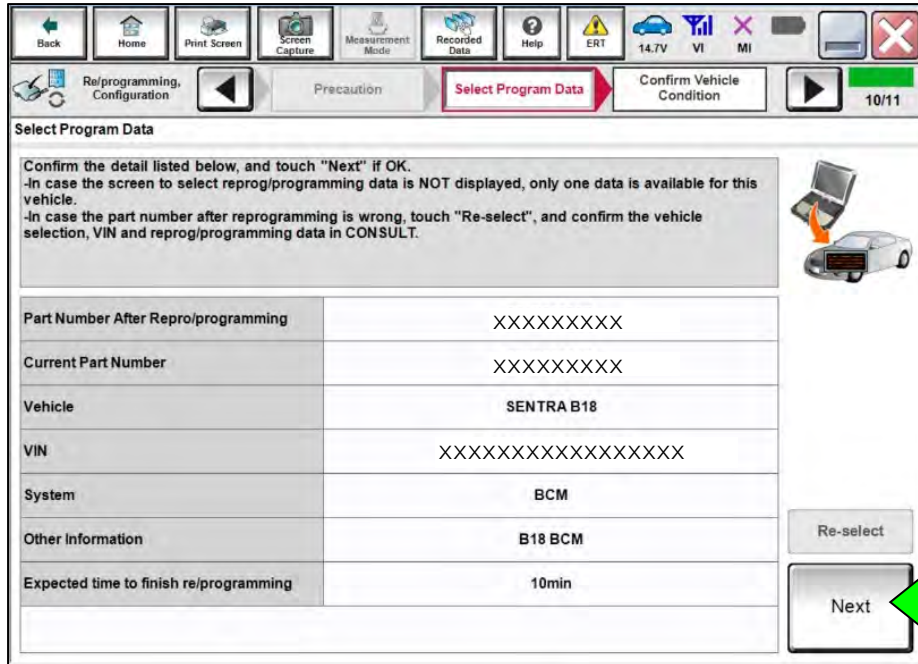
Figure 24

32. Select **Next**.

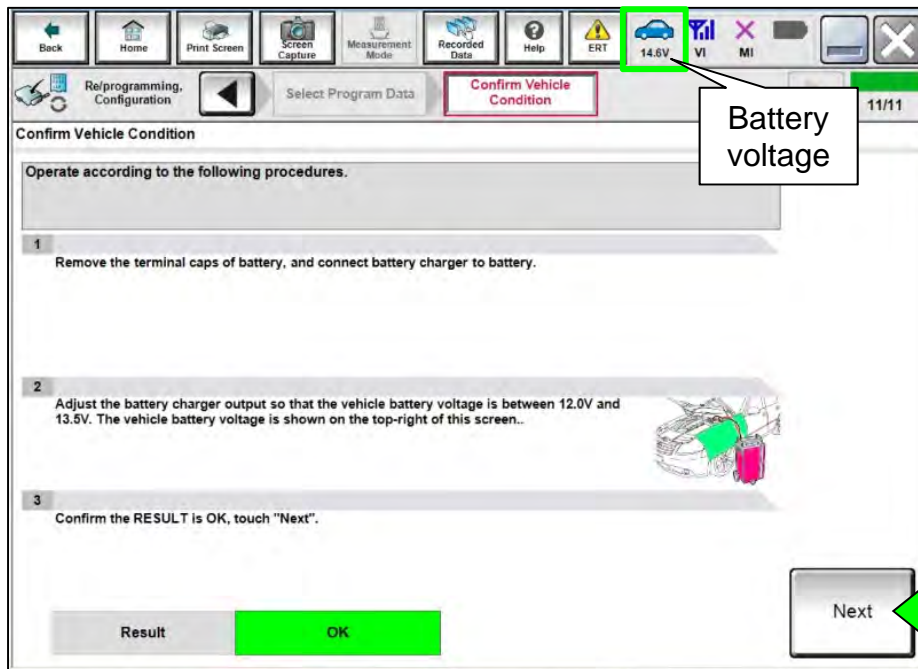
Figure 25

33. Confirm the battery charger is ON and the battery voltage is between 12.0V-15.5V, and then select **Next**.

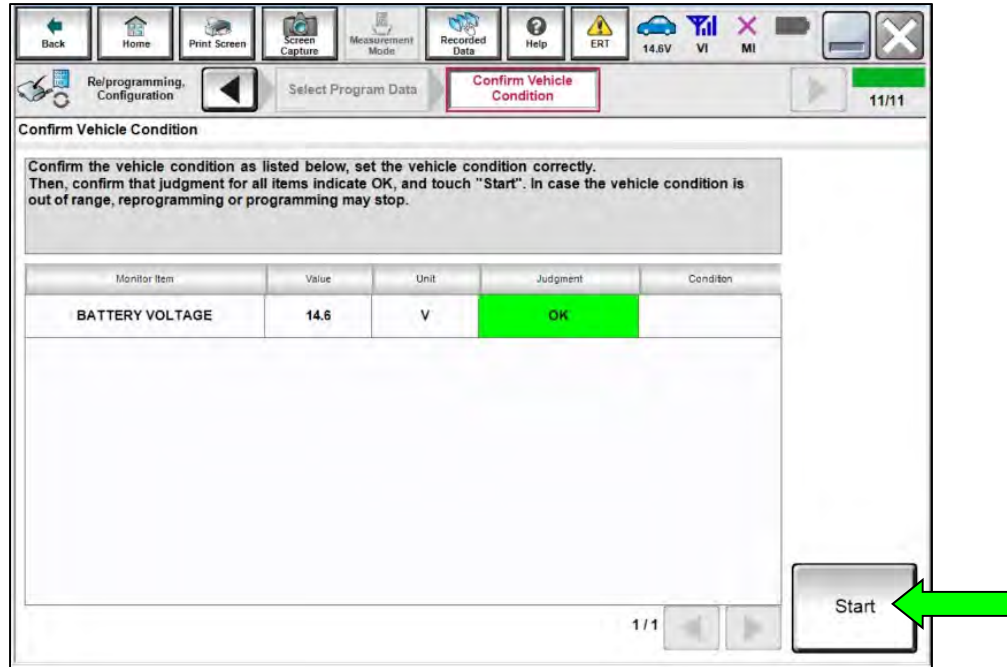
Figure 26

34. Confirm the **BATTERY VOLTAGE** Judgment is "OK", and then select **Start**.

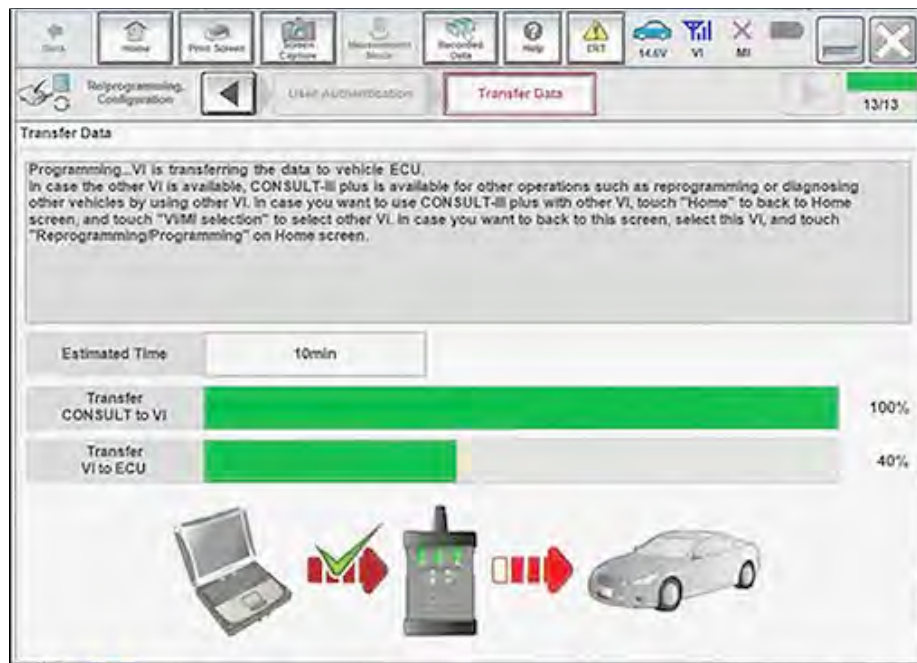
Figure 27

35. Allow CONSULT to reprogram the BCM.

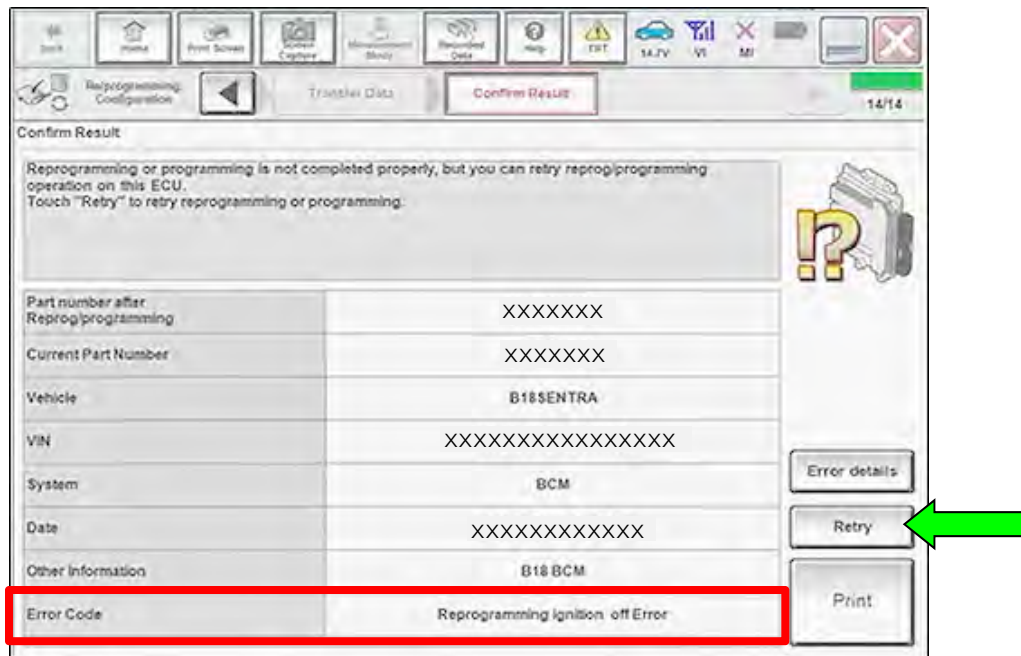
Figure 28

36. Toward the end of the reprogram, the CONSULT will show **Error Code** "Reprogramming Ignition off Error" and the vehicle ignition will turn OFF.
 - a. Turn the ignition ON, engine OFF.
 - b. Select **Retry**.

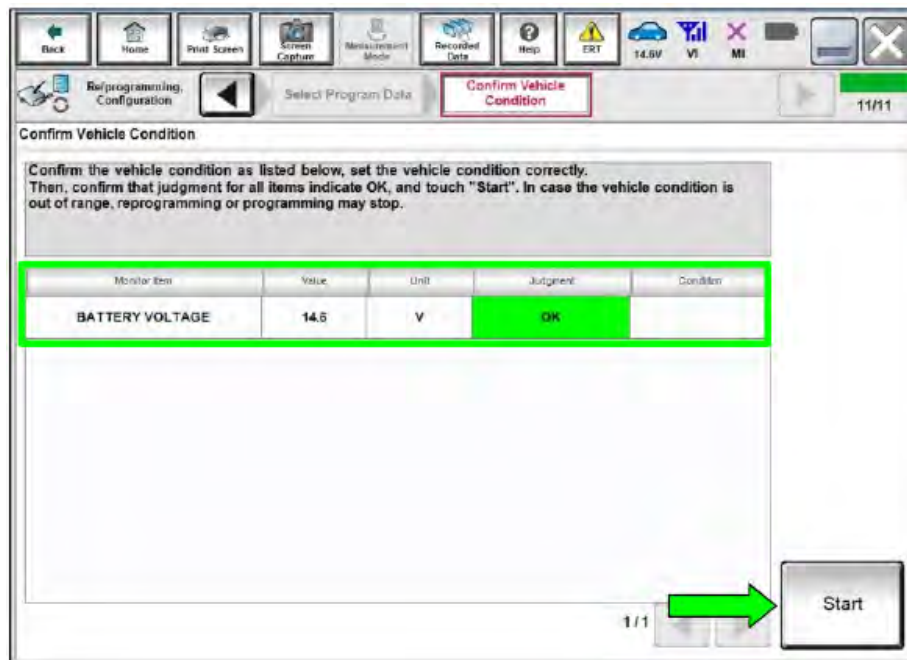
Figure 29

37. Confirm the battery voltage **Judgement** is "OK", and then select **Start**.

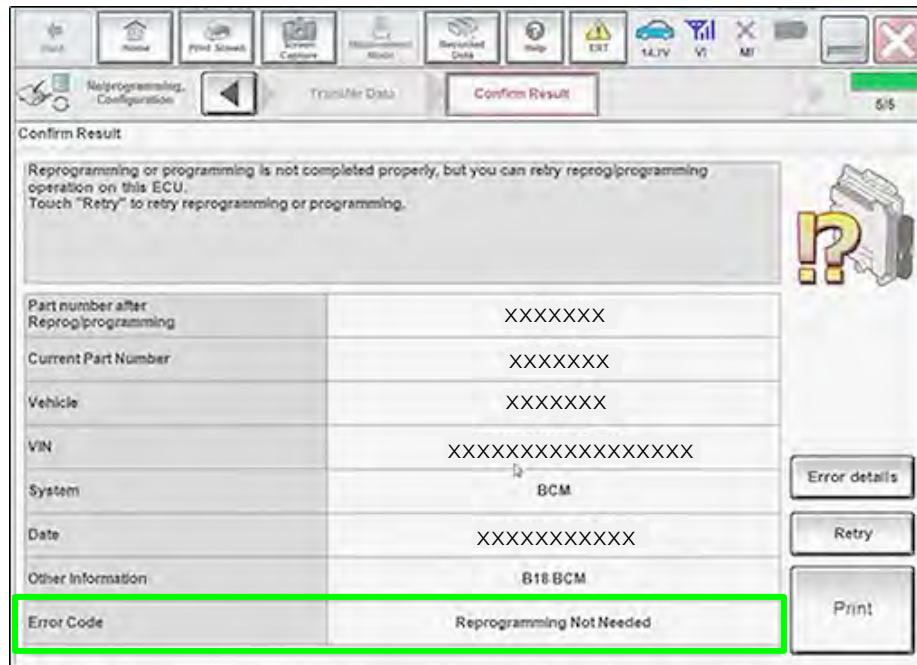
38. If **Error Code** description “Reprogramming Not Needed” is displayed after **Start** is selected, the reprogramming has successfully completed. Proceed to step 39 on page 20.

HINT: If the screen in Figure 30 does not display (indicating that reprogramming did not complete), refer to the information on the next page.

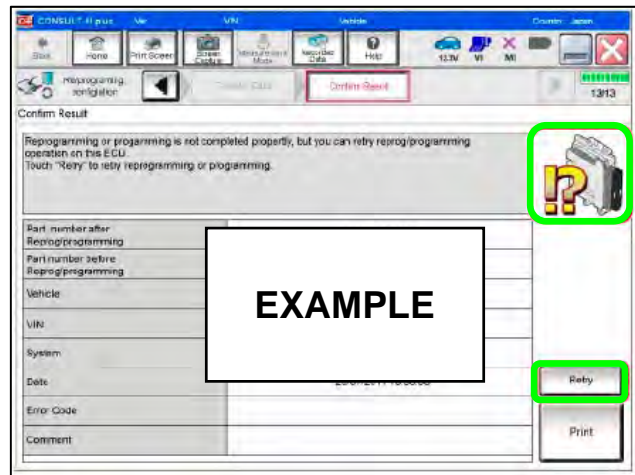
Figure 31

If reprogramming does not complete and the “!” icon displays, as shown in Figure 31:

- Check battery voltage (12.0 - 15.5 V).
- Ignition is ON, engine OFF. Or if EV in Ready Mode.
- External Bluetooth® devices are OFF.
- **All** electrical loads are OFF.
- Select **Retry** and follow the on screen instructions.
- Retry may not go through on first attempt and can be selected more than once.

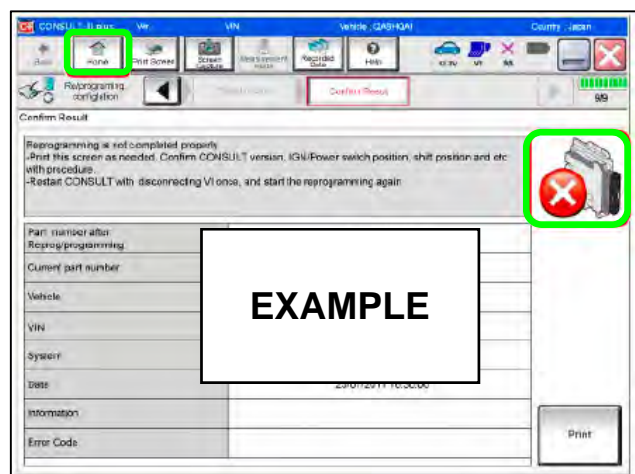
Figure 32

If reprogramming does not complete and the “X” icon displays, as shown in Figure 32:

- Check battery voltage (12.0 - 15.5 V).
- CONSULT A/C adapter is plugged in.
- Ignition is ON, engine OFF. Or if EV in Ready Mode.
- Transmission is in Park.
- All CONSULT VI cables are securely connected.
- All C-III plus updates are installed.
- Select **Home**, and restart the reprogram procedure from the beginning.

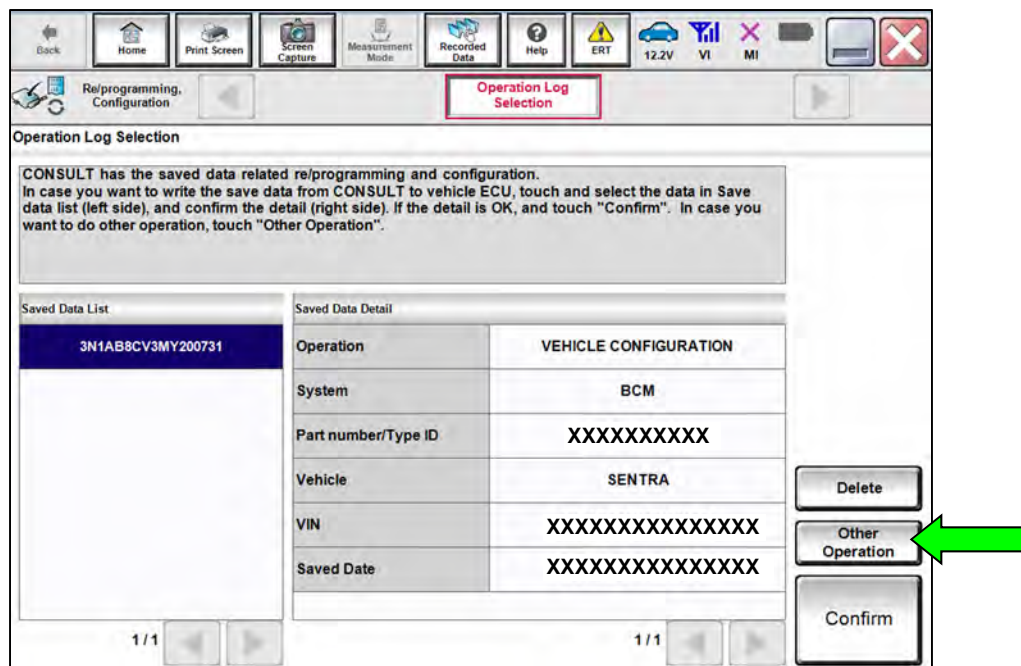
Figure 33

39. Select **Home**, and then select **Re/programming, Configuration**. Figure not shown.
40. Check the box to confirm the precaution instructions have been read, and then select **Next**. Figure Not shown.
41. Confirm the **VIN or Chassis #** is correct, and then select **Confirm**. Figure Not shown.
42. Select **Other Operation** (Figure 33).

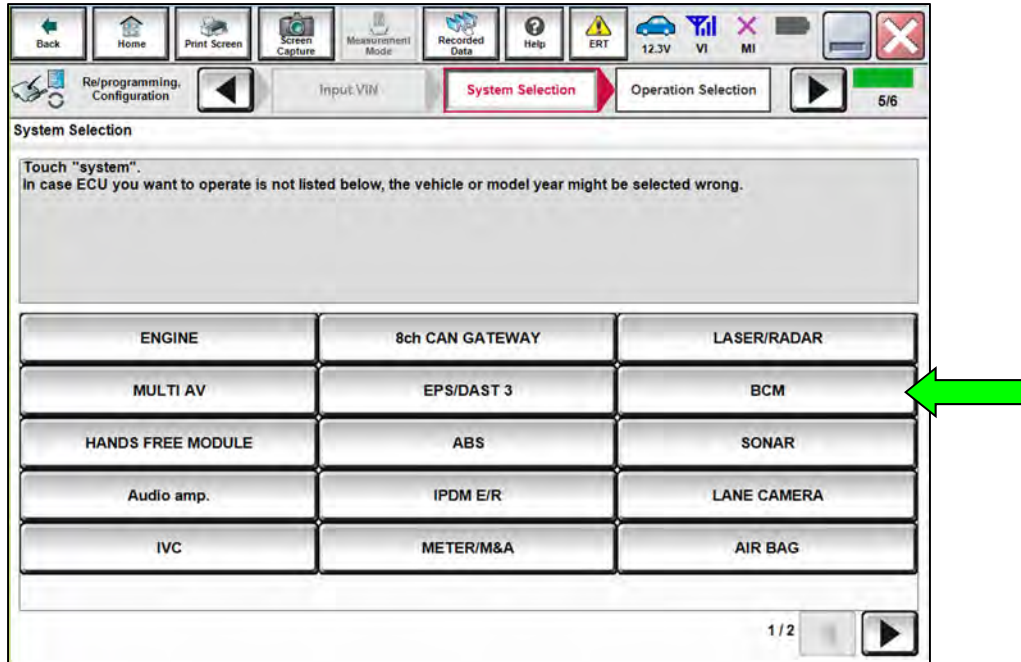
Figure 34

43. Select **BCM**.
