TECHNICAL SERVICE BULLETIN

DTC P161D STORED IN BCM

APPLIED VEHICLES: 2020-2021 Sentra (B18)

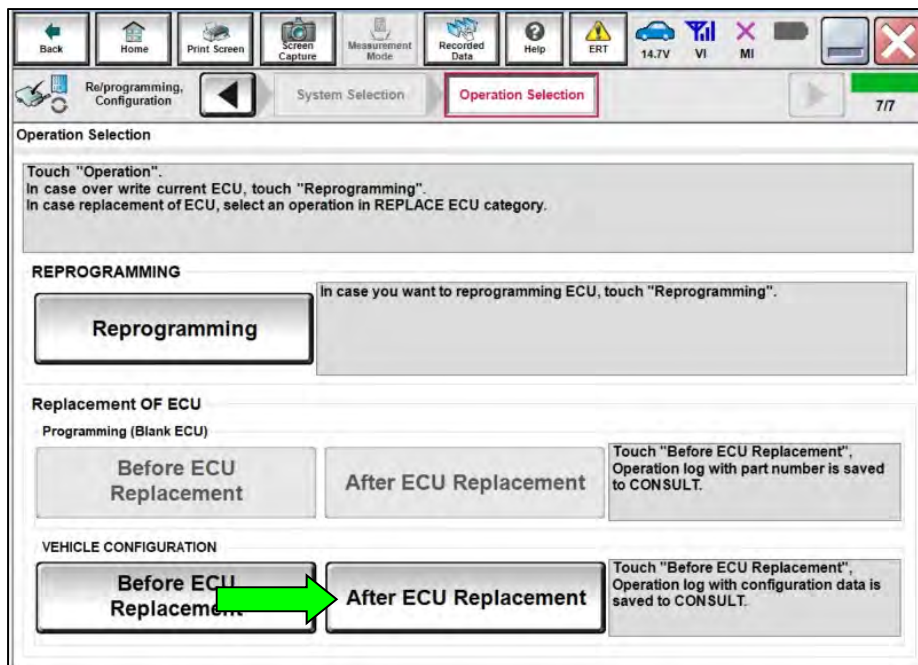
Figure 35

44. Select **After ECU Replacement** under **VEHICLE CONFIGURATION**.

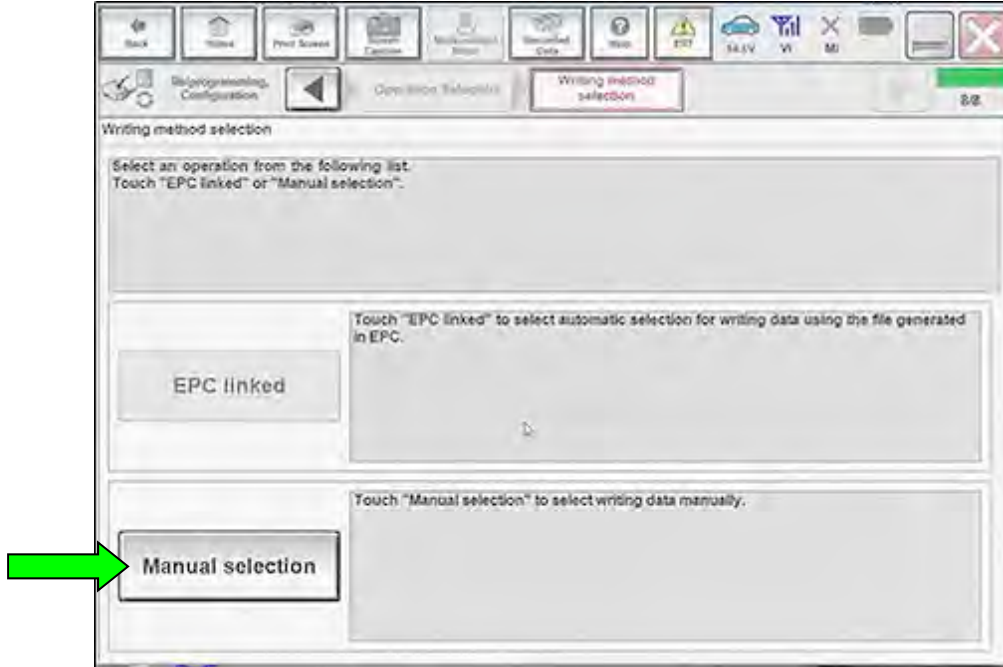
Figure 36

45. Select **Manual selection**.

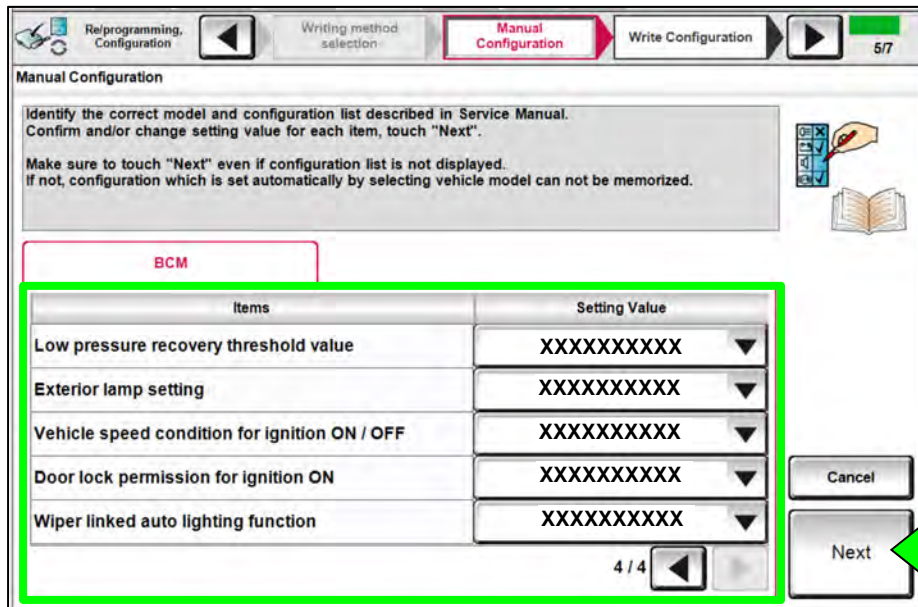
Figure 37

46. Select the **Setting Value** for each of the **Items** that was documented in step 26 on page 11, and then select **Next**.

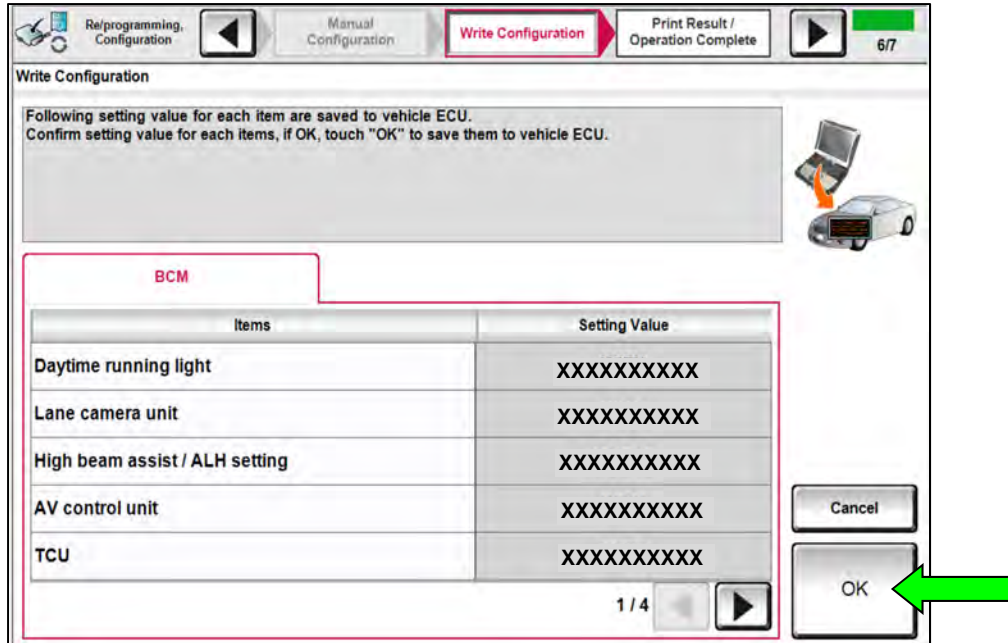
Figure 38

47. Select **OK** to write the configuration.

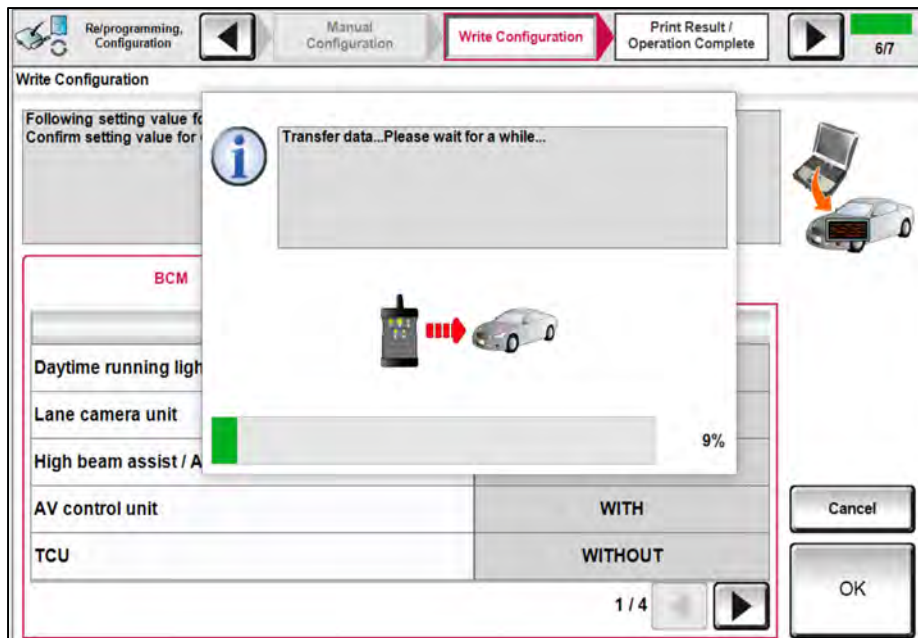
Figure 39

48. Allow the configuration to write to the BCM.

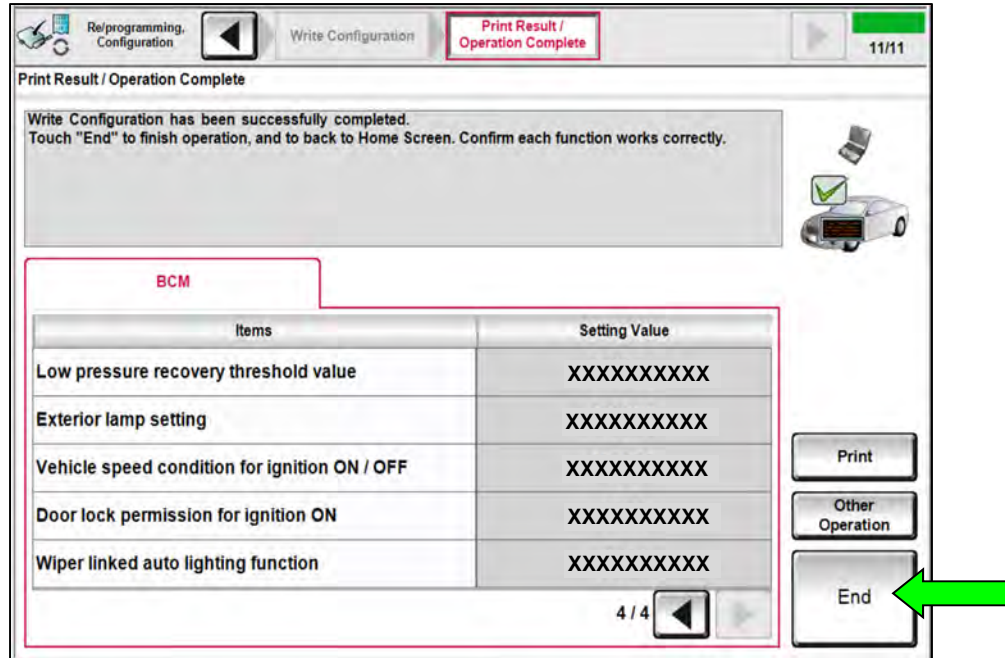
Figure 40

49. Select **End**.

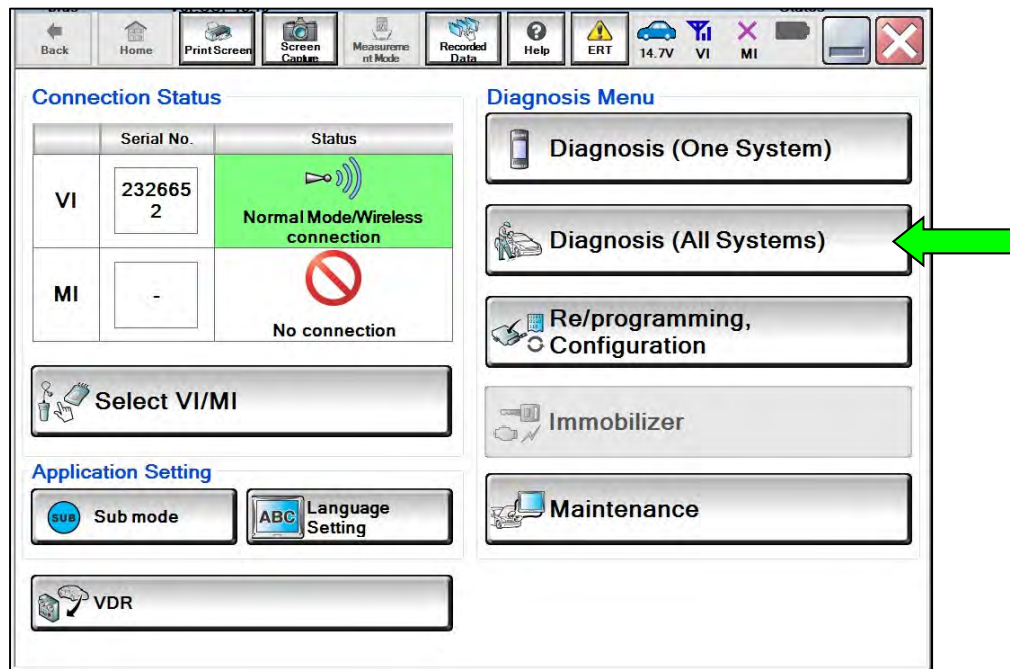
Figure 41

51. Select **Diagnosis (All Systems)**.

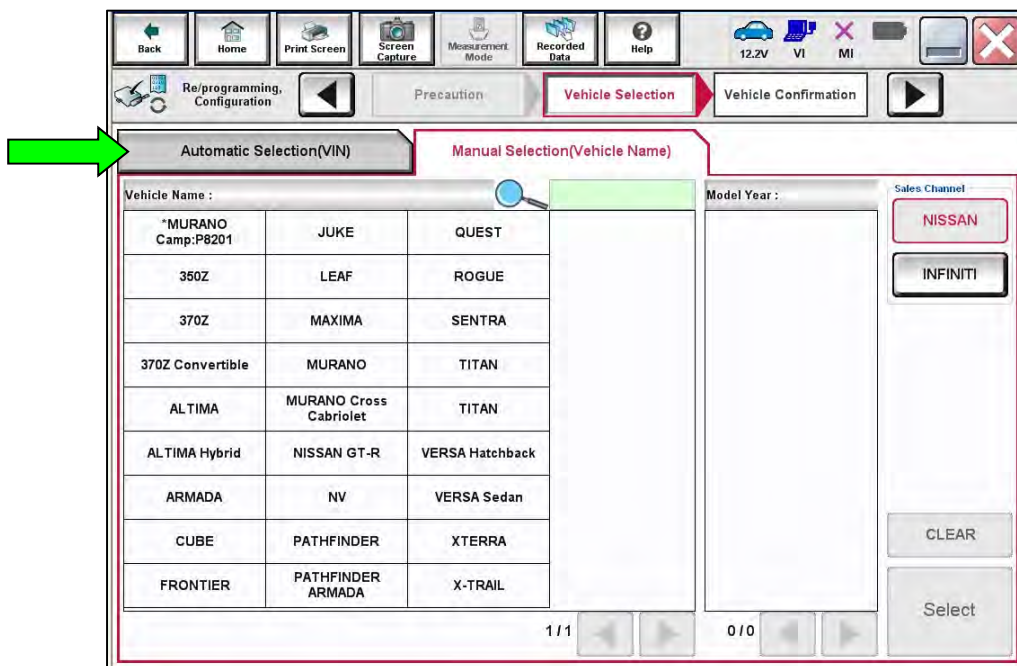
Figure 42

52. Select **Automatic Selection(VIN)**.

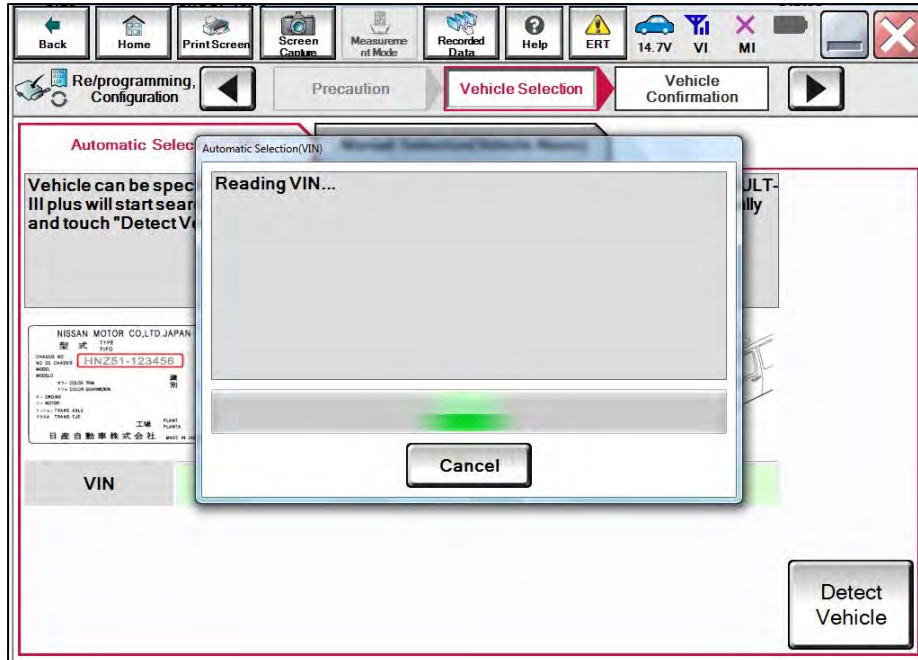
Figure 43

53. Allow the CONSULT to perform automatic VIN selection.

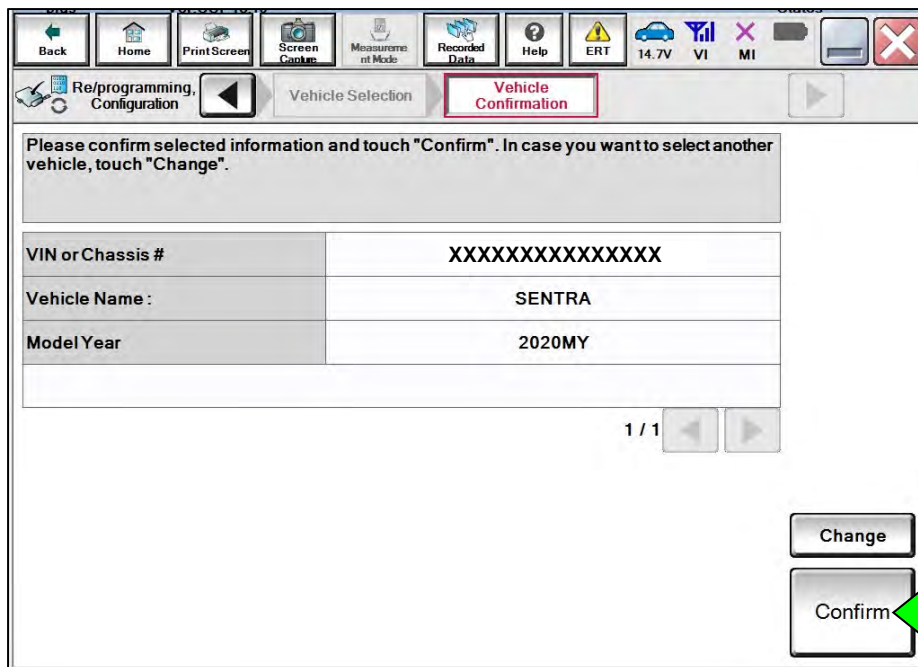
Figure 44

54. Confirm the VIN or Chassis # is correct, and then select Confirm.

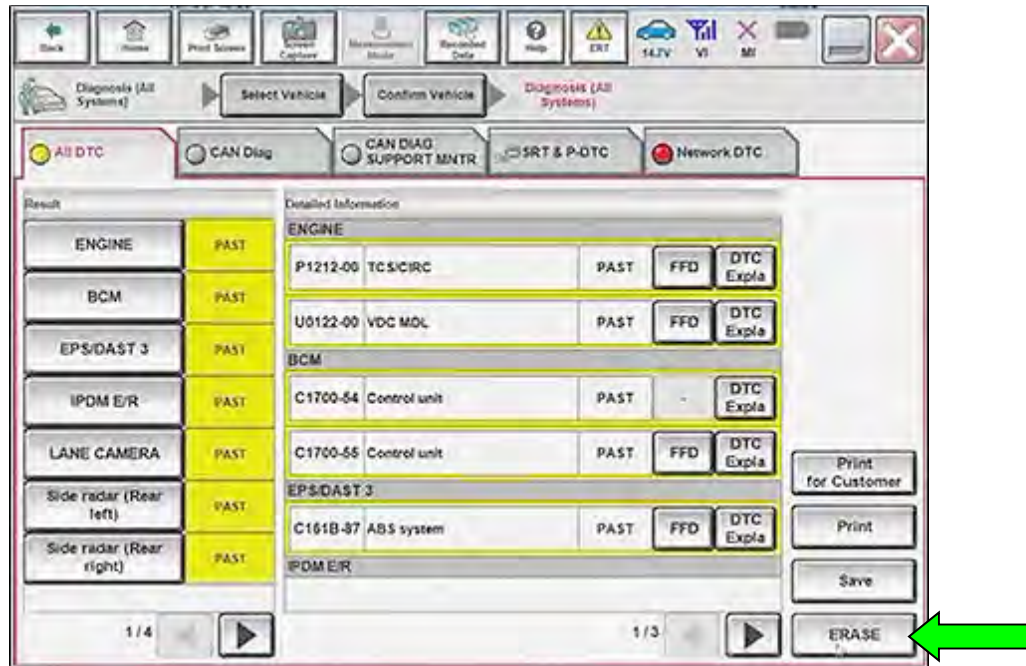
Figure 45

55. Select **ERASE**.

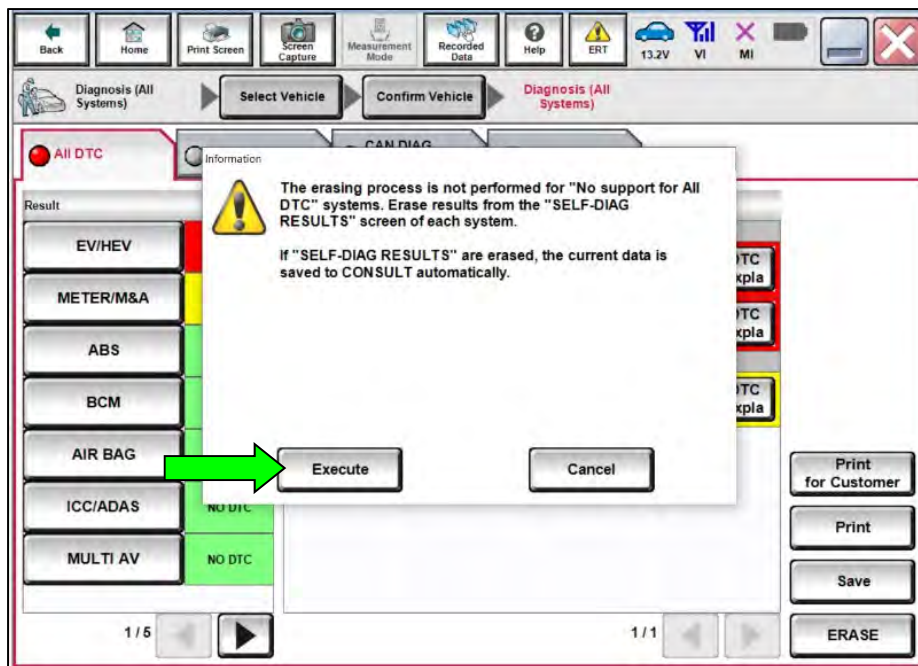
Figure 46

56. Select **Execute**.

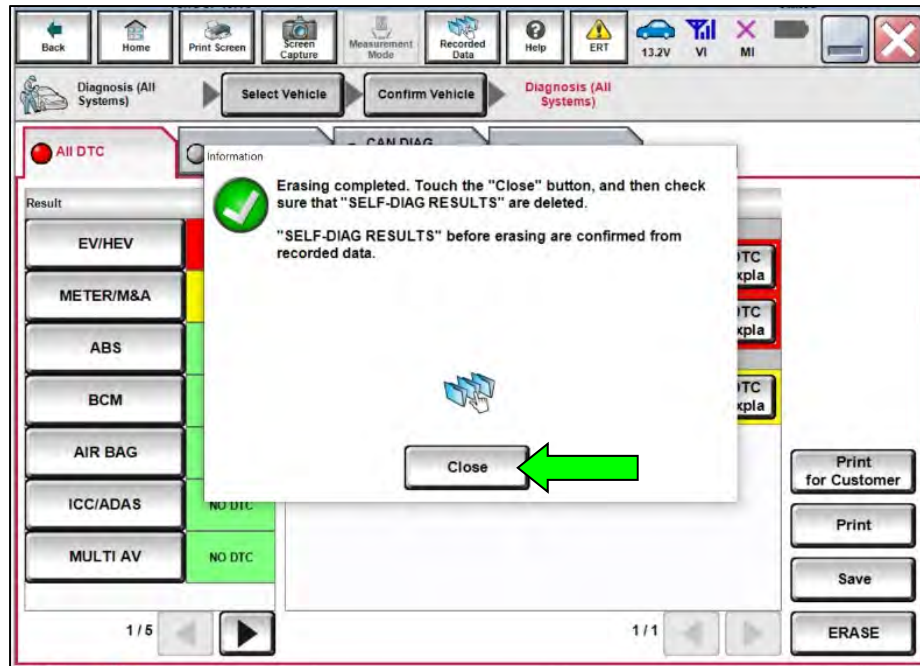
Figure 47

57. Select **Close**.
