Release Date	11/10/2022	<b>Technical Service Bulletin</b>	
<b>24iR UPDATE</b> <b>Software Update – (NVLW)</b>

### Software Update – (NVLW)

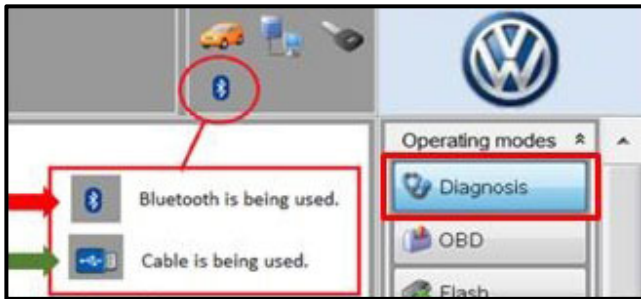
- Confirm that scan tool is communicating with the diagnostic head by USB <Green Arrow>.
  - If the Bluetooth symbol is shown <Red Arrow> then disconnect the diagnostic head from the vehicle and reconnect the USB cable to the diagnostic head and then reattach to the vehicle.
- Upon ODIS startup, verify the “Diagnosis” operating mode is selected <as shown>.
- Once the GFF scan is complete, select “Special functions” <arrow 1>, then “Adapting software” <arrow 2>, then select “Perform test” <arrow 3>.
