GLOBAL SAFETY FIELD INVESTIGATIONS
DCS6348
URGENT - DISTRIBUTE IMMEDIATELY

Subject: N222372591 - Service Update
Charge Air Cooler Icing

Models: 2020 – 2022 Buick Encore GX
2021 – 2022 Chevrolet Trailblazer

N222372591 Charge Air Cooler Icing

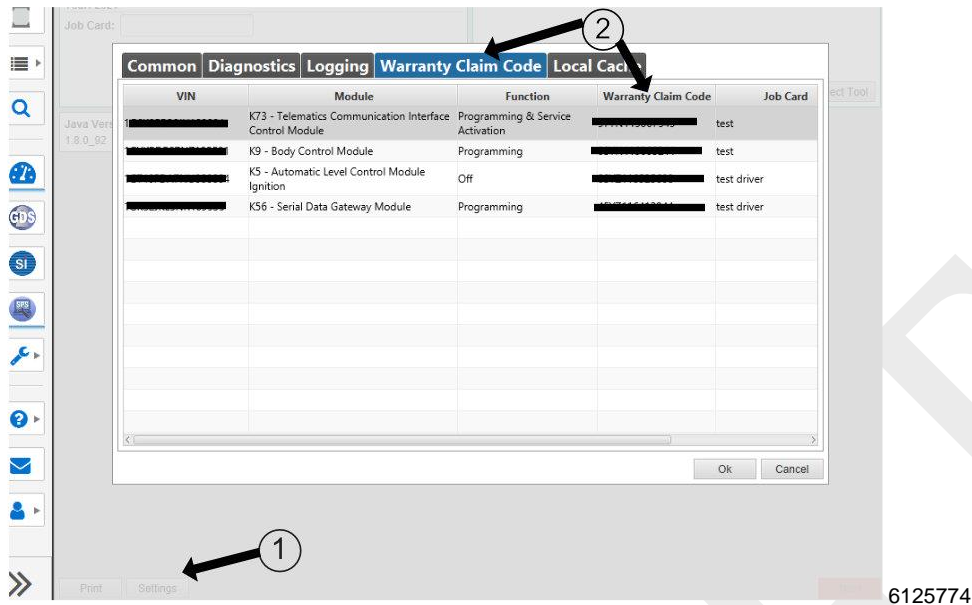
Warranty Claim Code Information Retrieval

If the Warranty Claim Code was not recorded on the Job Card, the code can be retrieved in the SPS2 system as follows:

1. Open TLC on the computer used to program the vehicle.
2. Select and start SPS2.
3. Select Settings (1).
4. Select the Warranty Claim Code tab (2).

The VIN, Warranty Claim Code and Date/Time will be listed on a roster of recent programming events. If the code is retrievable, dealers should resubmit the transaction making sure to include the code in the SPS Warranty Claim Code field.

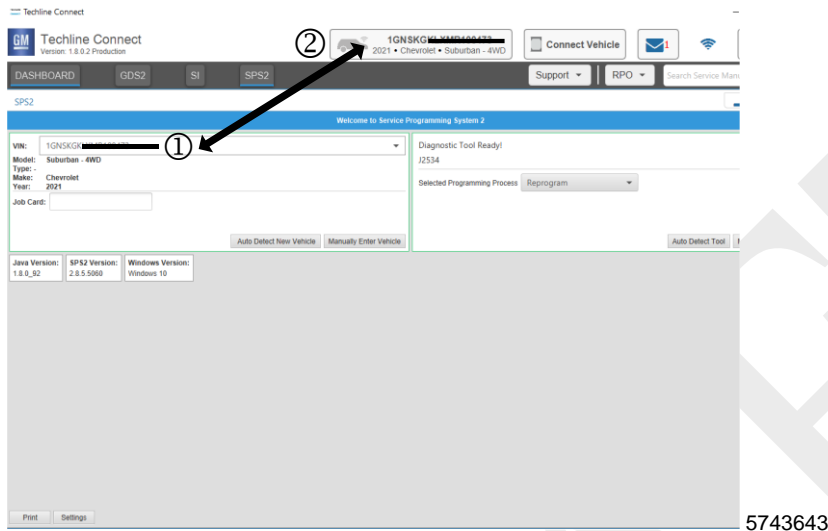
Caution: Be sure the VIN selected in the drop down menu (1) is the same as the vehicle connected (2) before beginning programming.

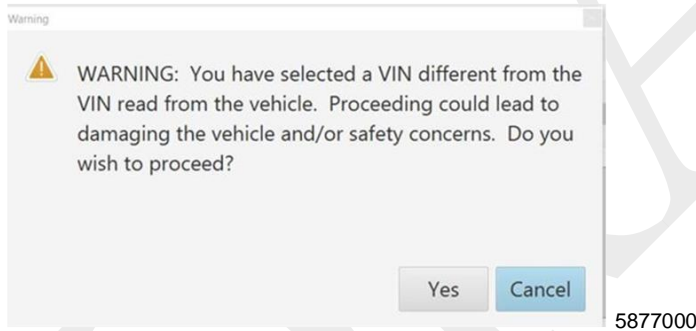
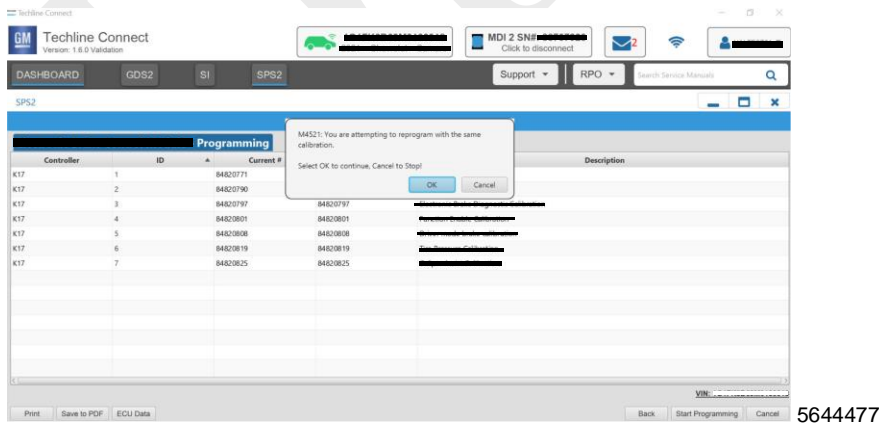
Important: If the vehicle VIN DOES NOT match, the message below will be shown.

Important: Techline Connect screens shown above.
