Stacy L. Balzer  
 Operating Director  
 Service Engineering Operations  
 Ford Customer Service Division

**SUBJECT:** **Customer Satisfaction Program 21M08 - Supplement #2**  
 Certain 2021-2022 Model Year F-150 Vehicles Equipped with a Power Release Tailgate - Unintended Tailgate Opening

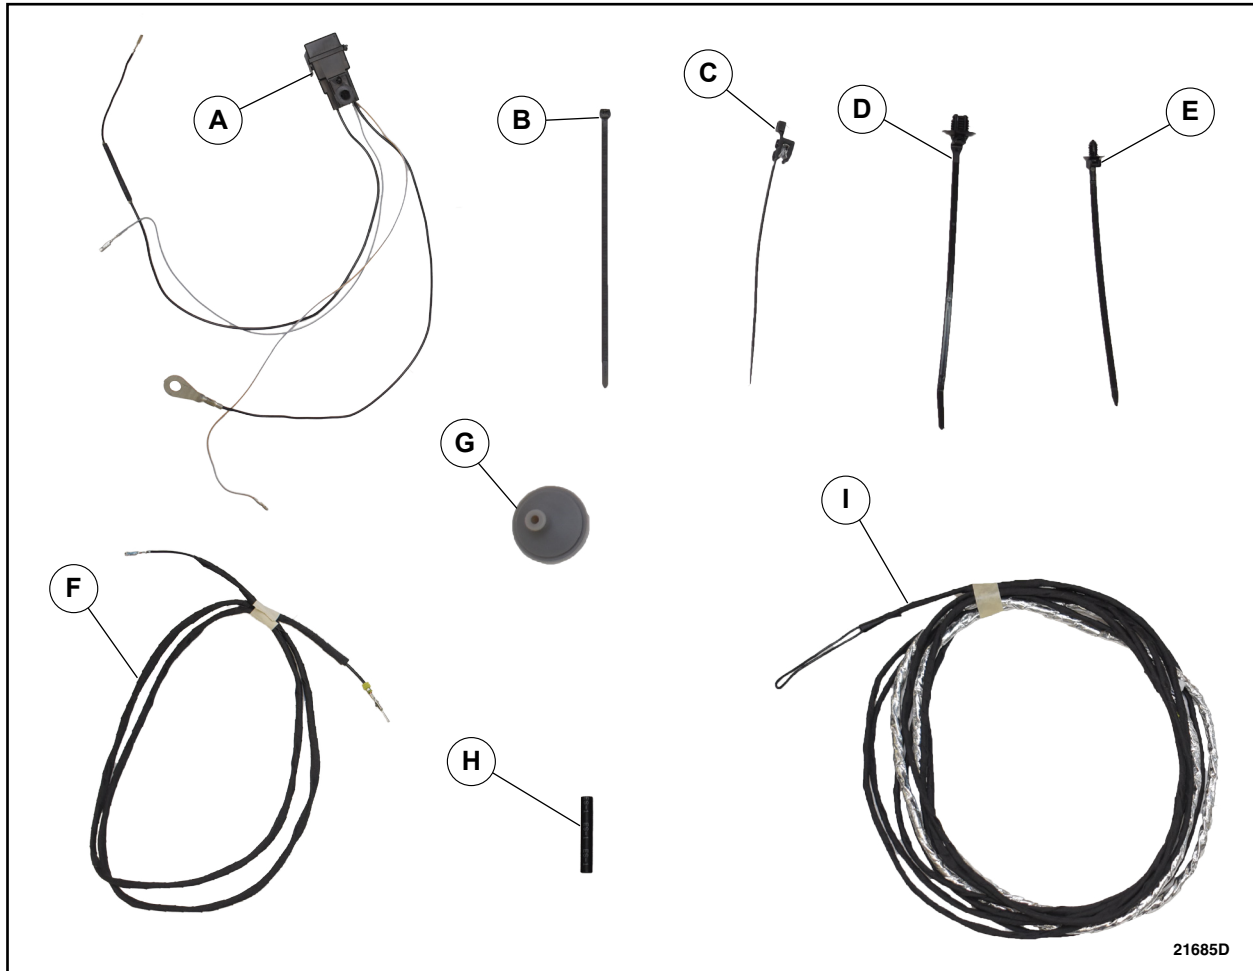
**FIGURE 1**

**Complete Tailgate Actuator Ground Wiring Part Kit**

ITEM	DESCRIPTION	QUANTITY
A	Relay Harness	1
B	Tie Strap	-
C	Edge Biter Style Tie Strap	-
D	Oval Push Pin Style Tie Strap	-
E	Round Push Pin Style Tie Strap	-
F	Tailgate Jumper Harness	1
G	Grommet	1
H	Heat Shrink Tubing	-
I	Body Length Jumper Harness	1

**NOTE:** The parts being installed in this procedure are not labeled. Refer to Figure 1 for component identification.

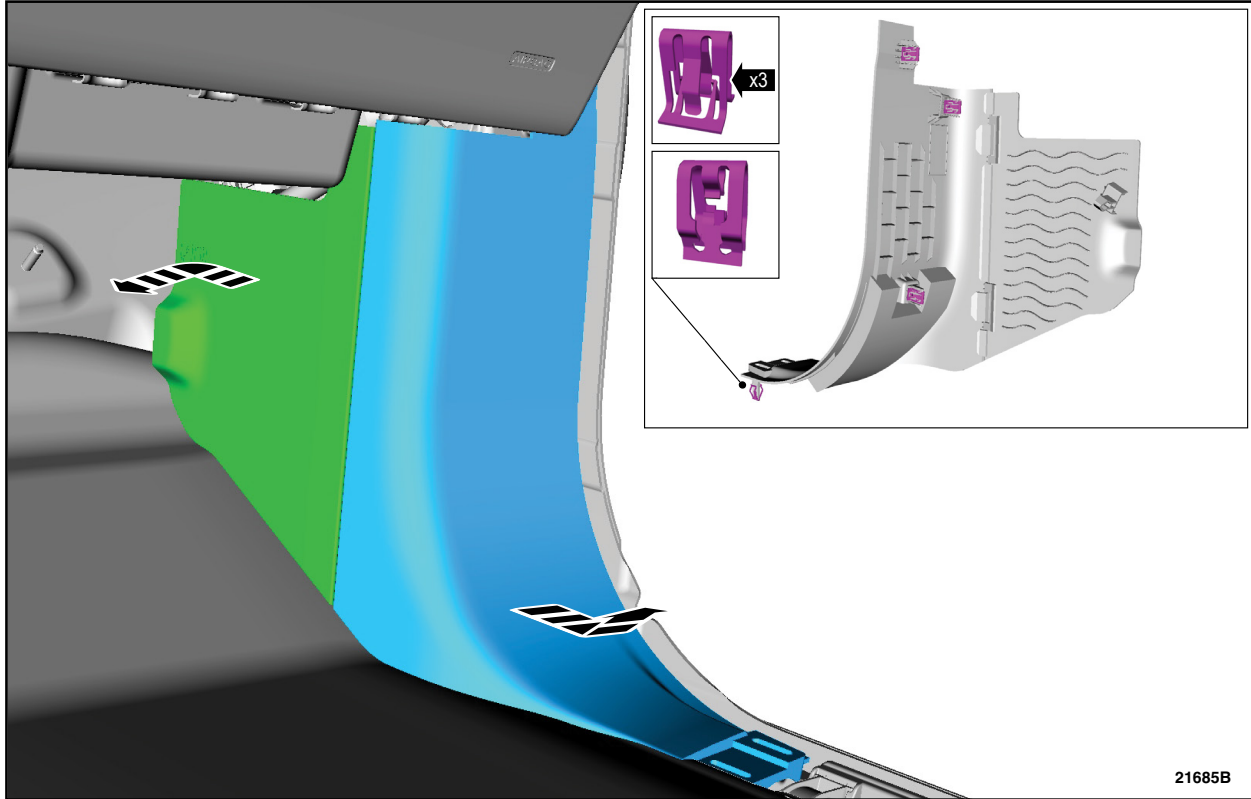
FIGURE 2

6. Release the clips and remove the RH lower cowl trim panel. See Figure 2.

- Release the molded snap in the fuse panel cover then rotate fuse panel inboard and forward to disengage hooks from the cowl trim.

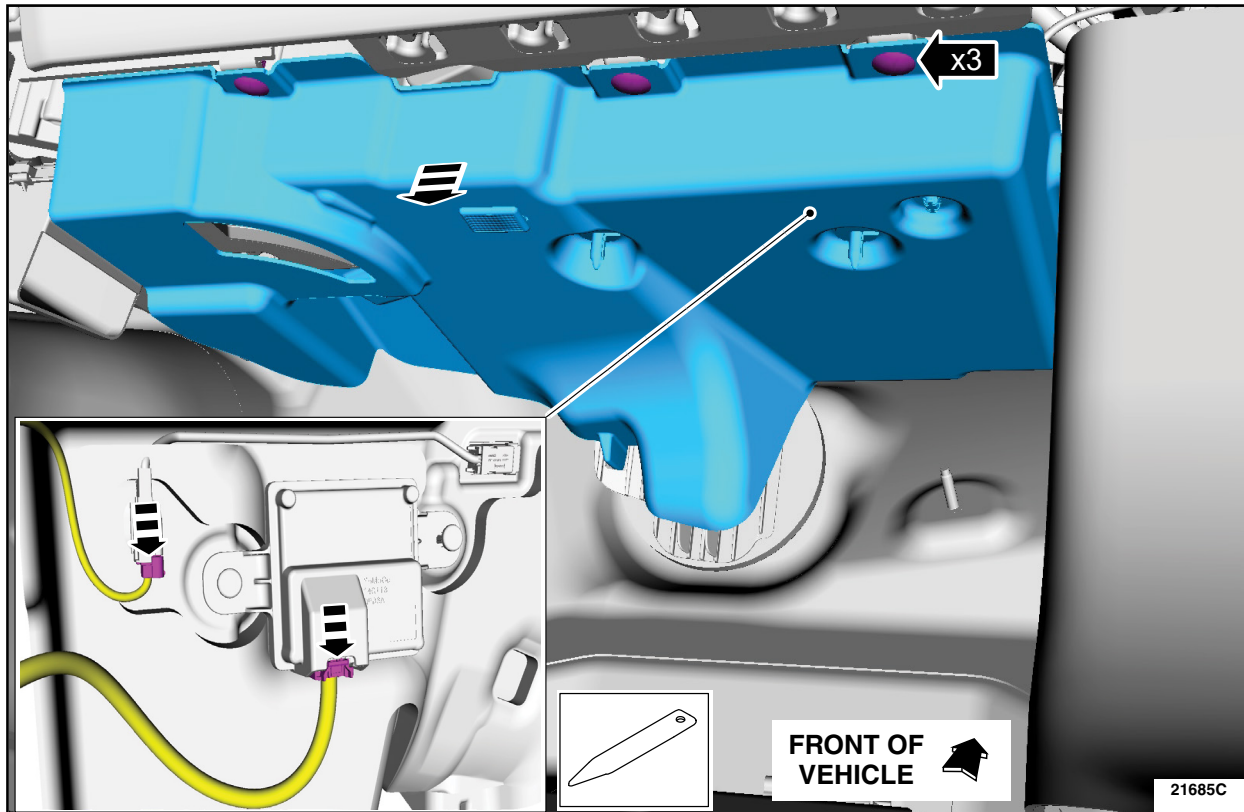
FIGURE 3

7. Using an Interior Trim Remover, remove the push pins and the RH insulation panel. See Figure 3.

- Disconnect the electrical connectors.

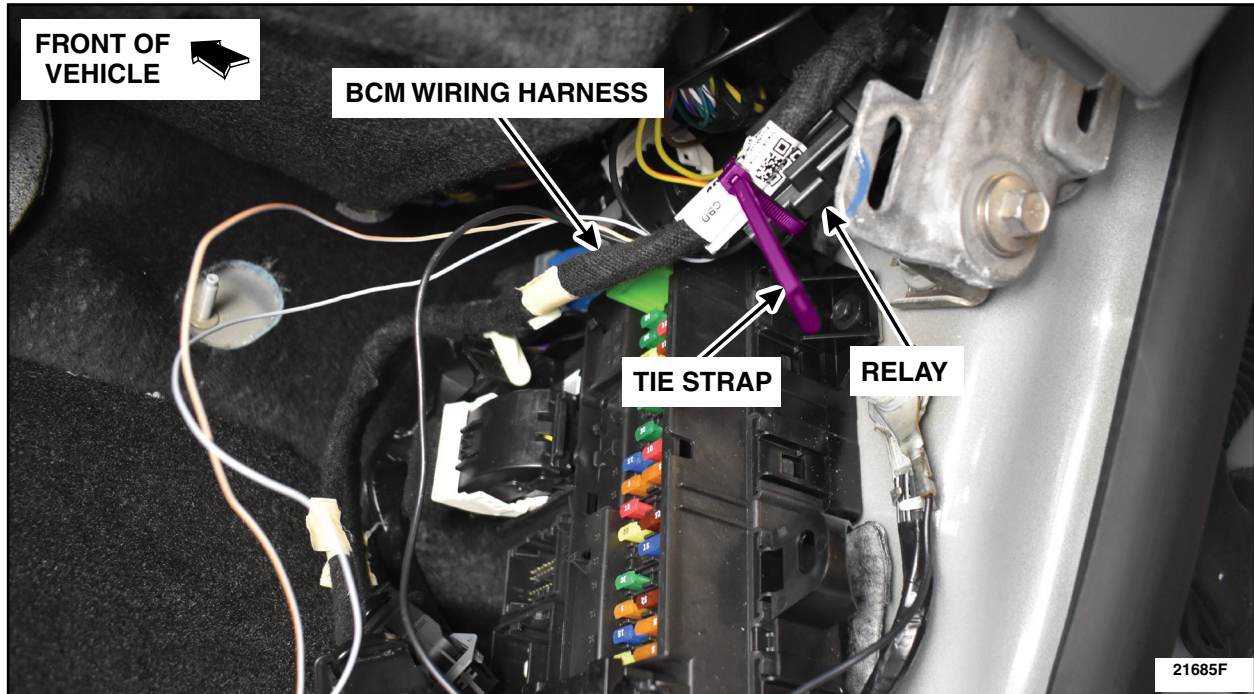
FIGURE 4

8. Place the Relay Harness, included in the kit, onto the Body Control Module (BCM) wiring harness and secure using a tie strap. See Figure 4.

**NOTE:** *Service Procedure Steps on Page 6, Step 8, Figure 4 through Page 11, Step 18, Figure 14, and Page 19, Step 35, Figure 30 through Page 29, Step 50, Figure 47 can be skipped if the wires are in the correct pin locations for ALL 3 of the following inspections. ALL of the Service Procedure Steps listed above will need to be completed if any one of the circuits in Steps 1, 2, or 3 are missing. This may require depinning circuit(s) to install the Relay Harness and Body Length Harness.*

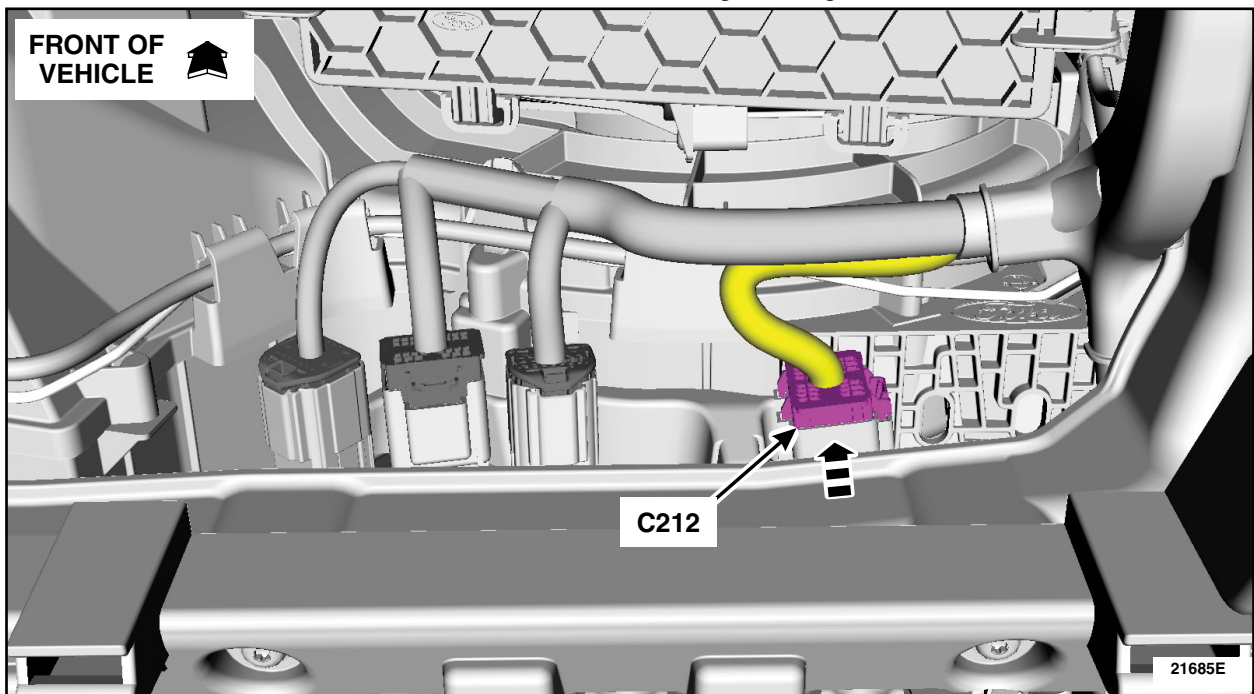
FIGURE 5

9. Locate and disconnect C212 on the climate control housing. See Figure 5.

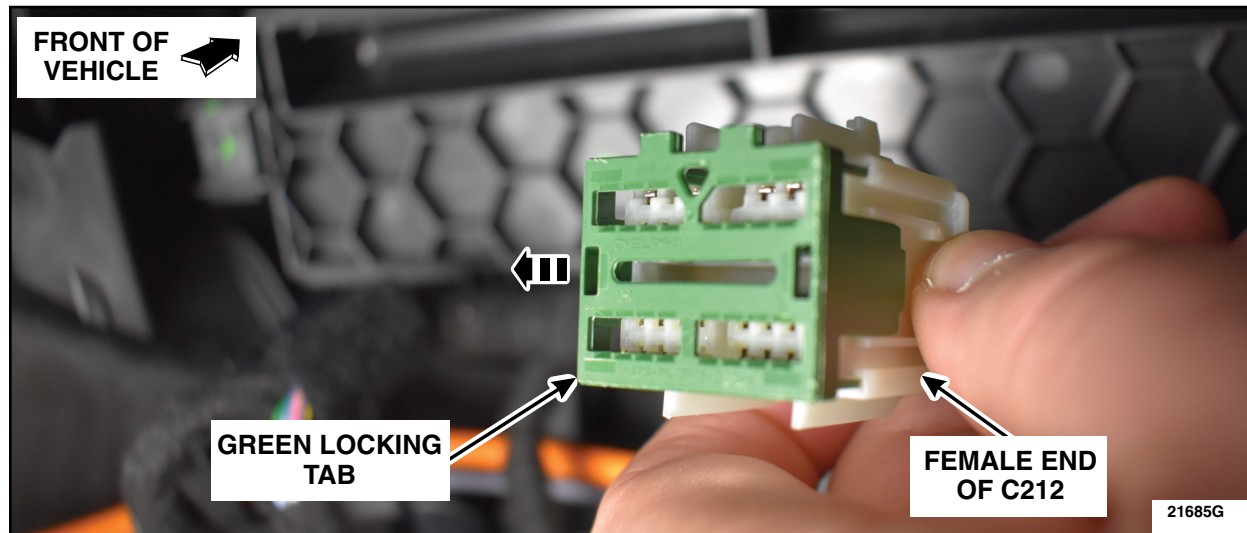
FIGURE 6

10. Remove the green locking tab on the female end of C212. See Figure 6.

- 1. Page 7, Step 10, Figure 6. Inspect the female end of C212 for a Gray (GY) wire in pin 1 and a Gray-Orange (GY-OG) wire in pin 4. If both wires are present, Proceed to Step 2.*
- 2. Page 28, Step 48, Figure 45. Inspect the male end of C212 for a Blue-Gray (BL-GY) wire in pin 1 and a GY-OG wire in pin 4. If both wires are present, Proceed to Step 3.*
- 3. Page 19, Step 35, Figure 30. Inspect the female end of C4002 for a Black-Violet (BK-VT) wire in pin 2. If the wire is present, Proceed to Step 4.*

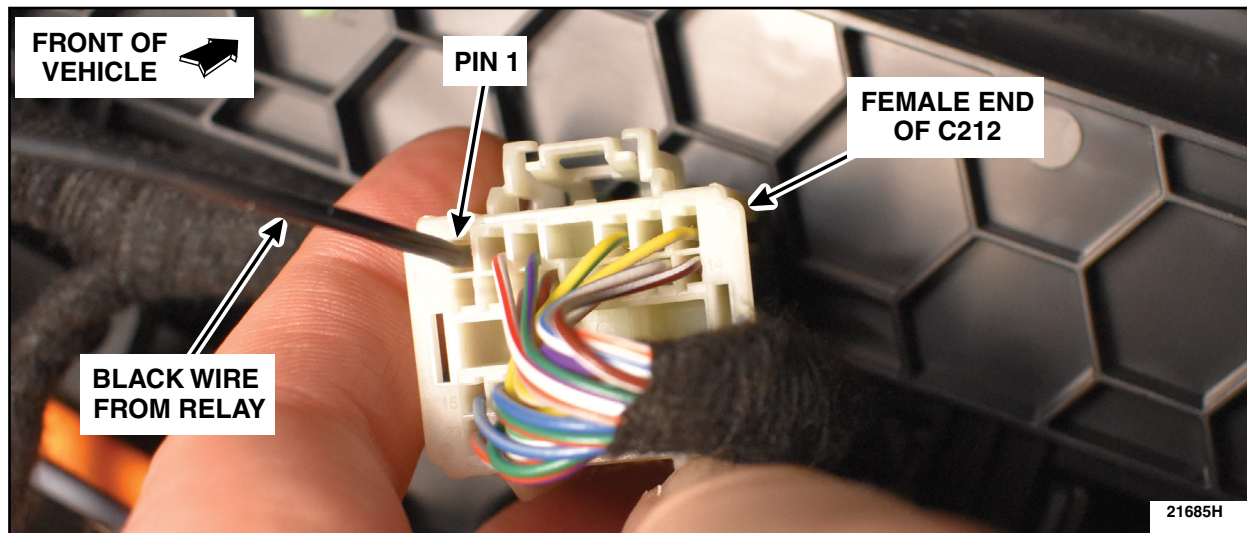
FIGURE 7

11. Install the Black (BK) wire from the relay into Pin 1 of the female end of C212. See Figure 7.

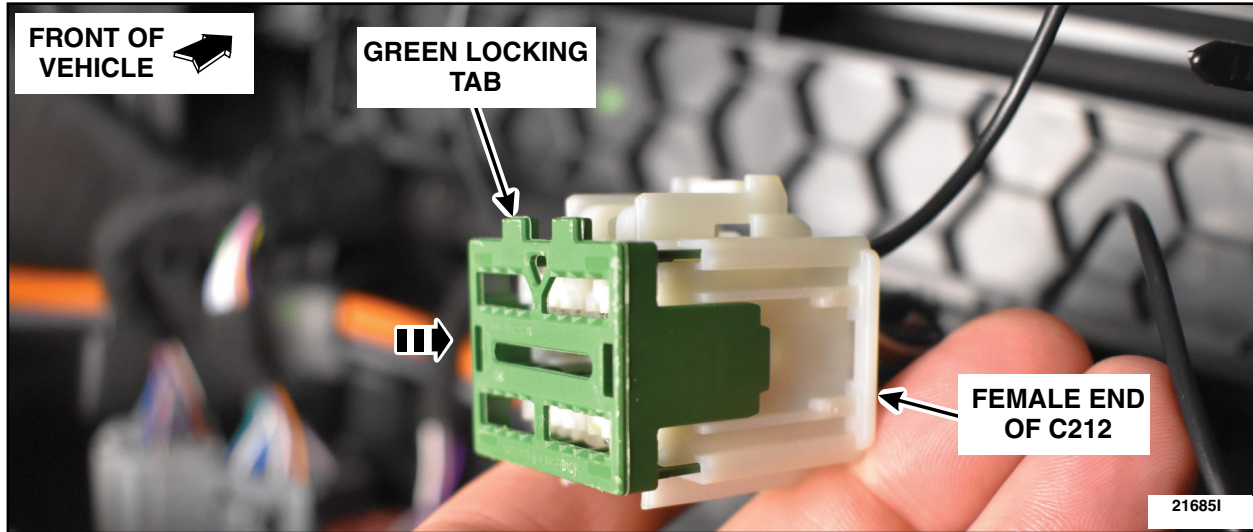
**FIGURE 8**

12. Install the green locking tab into the female end of C212. See Figure 8.

**NOTE:** Do not reconnect the electrical connector at this time.

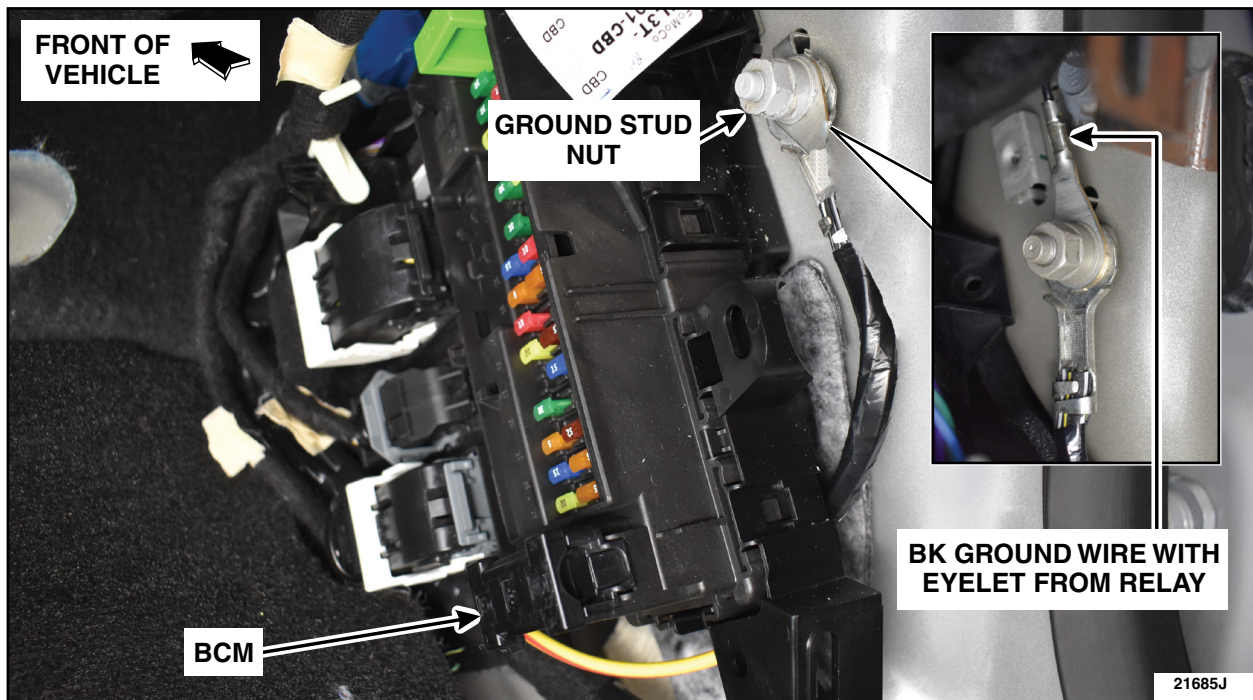
**FIGURE 9**

**CAUTION:** Do not over torque the ground stud nut.

13. Install the ground eyelet to the ground stud. See Figure 9.

- Remove the nut from the ground stud.
- Install the BK ground wire with the eyelet onto the ground stud.
- Reinstall the nut to the ground stud.
- Torque: 70 lb. in (8 Nm)

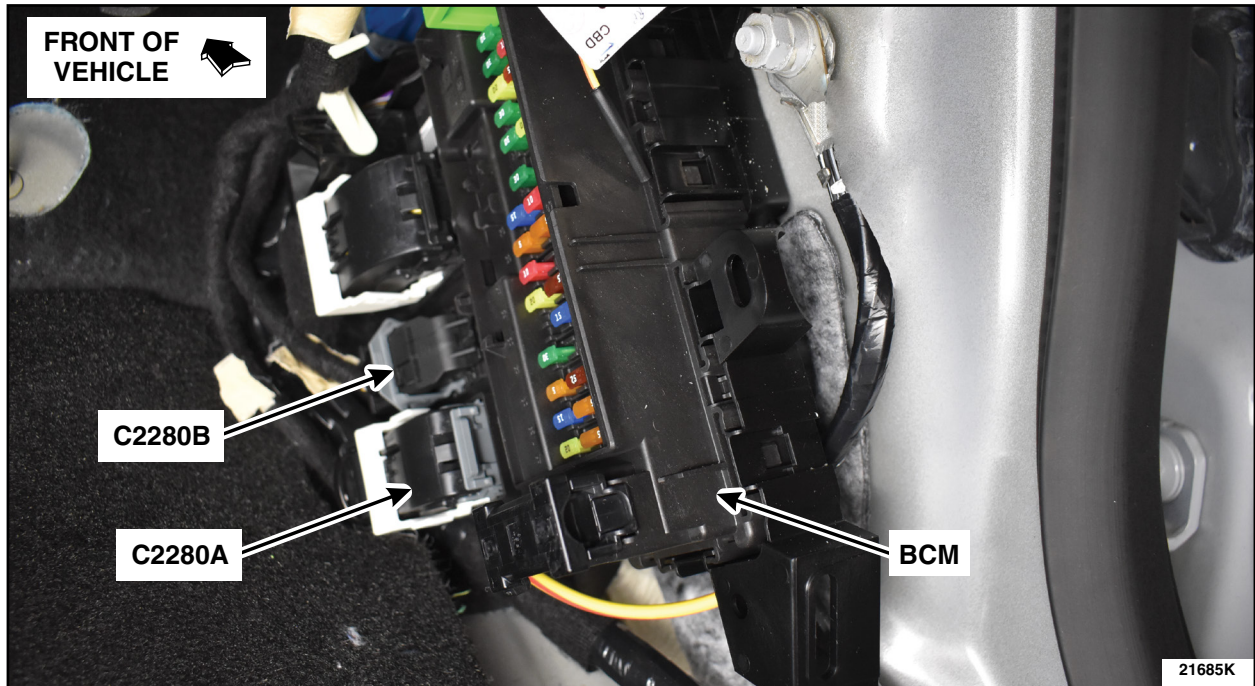
FIGURE 10

14. Disconnect C2280A and C2280B from the BCM. See Figure 10.

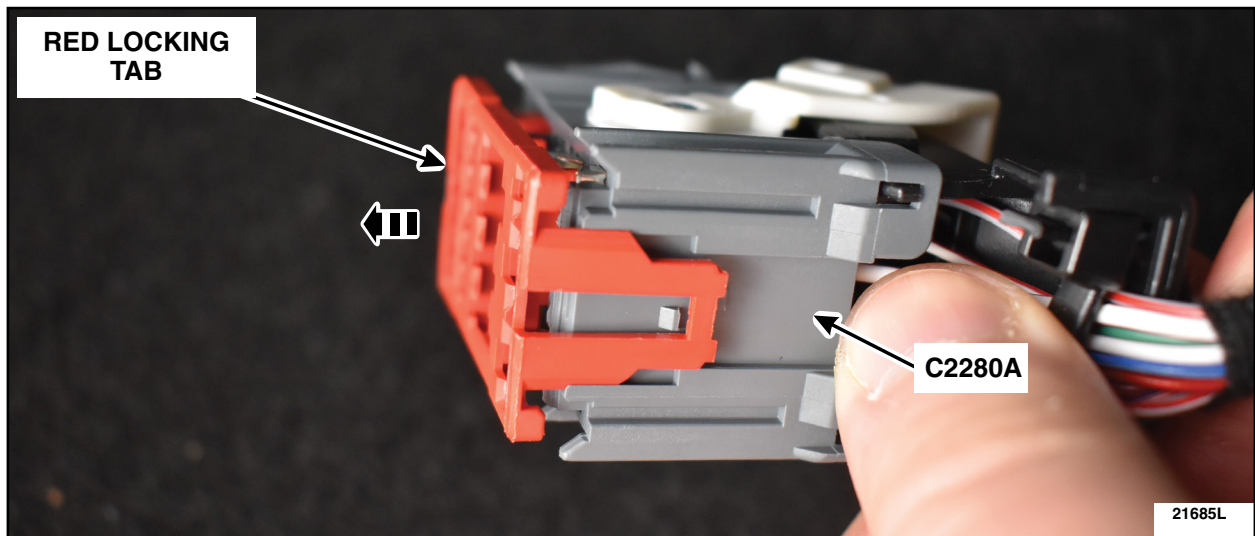
FIGURE 11

15. Remove the red locking tab of C2280A. See Figure 11.

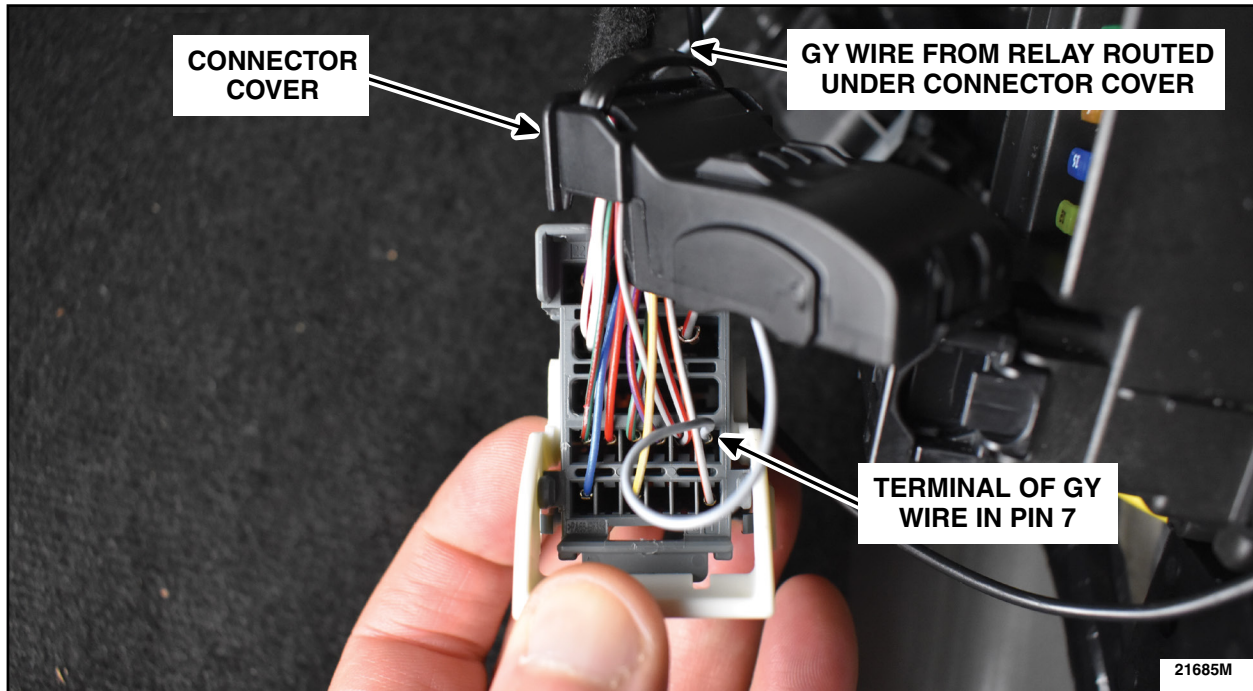
FIGURE 12

16. Release and position aside the connector cover. Route the Grey (GY) wire from the relay through the cover and install the terminal into Pin 7. See Figure 12.

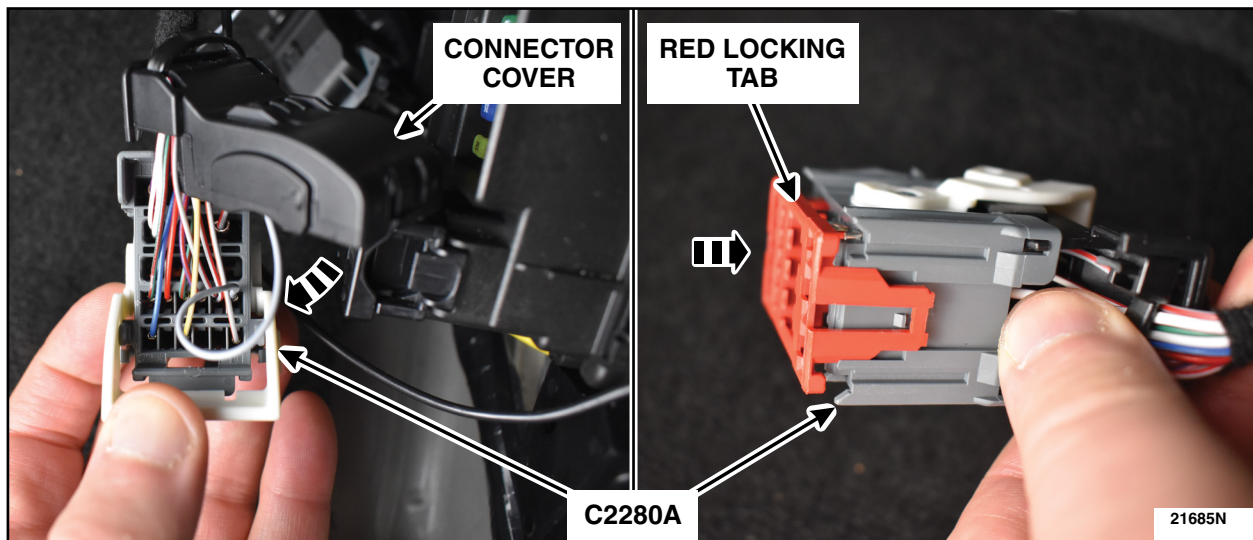
FIGURE 13

17. Position back the connector cover and install the red locking tab of C2280A. See Figure 13.

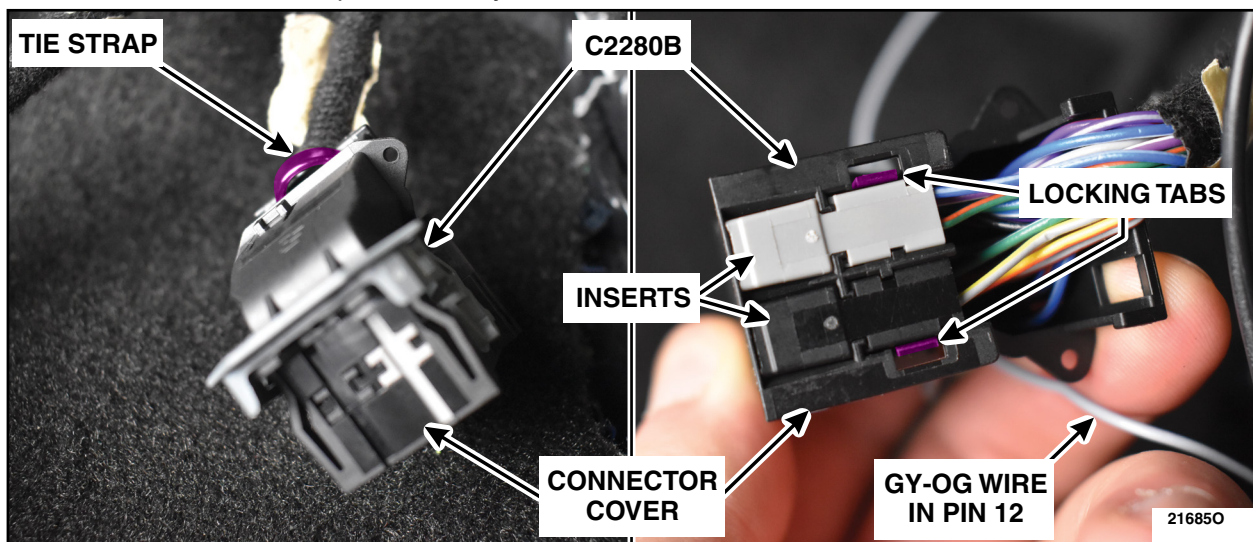
FIGURE 14

18. Install the Grey-Orange (GY-OG) wire from the relay into C2280B. See Figure 14.

- Remove the tie strap.
- Release the locking tabs.
- Remove the inserts from the connector cover.
- Install the GY-OG wire into Pin 12.
  - **If Pin 12 is occupied**, remove the terminal and follow sub-steps a through d.
    - a. Cut off the terminal from the GY-OG wire from the relay.
    - b. In-line splice the GY-OG wire from the relay onto the wire that occupied Pin 12.
    - c. Apply solder to the splice and seal using heat shrink tubing.
    - d. Reinstall the wire into Pin 12.
- Reinstall the inserts into the connector cover.
- Install a *new* tie strap and trim any excess.

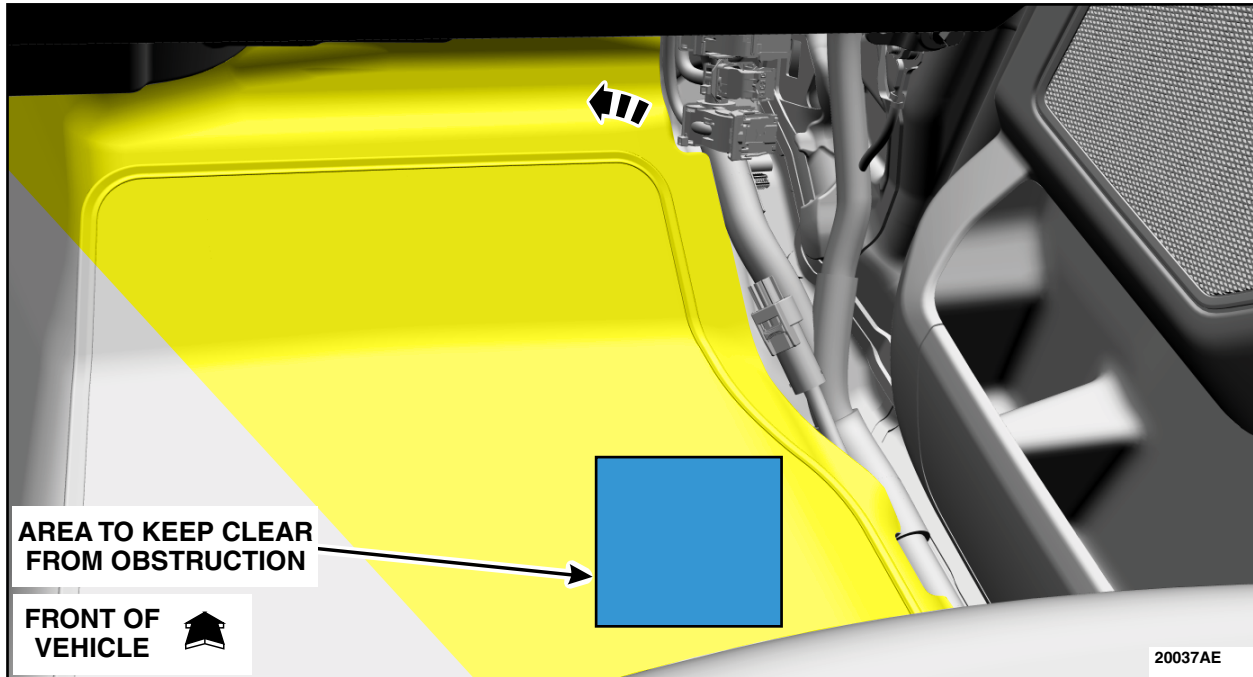
FIGURE 15

19. Position aside the RH carpet to expose the floorboard. Use a block of wood or similar device to retain the carpet away from the area to be clear of obstruction. See Figure 15.

**CAUTION:** The area highlighted below should be kept clear from obstruction to avoid any damage to carpeting and/or wiring.

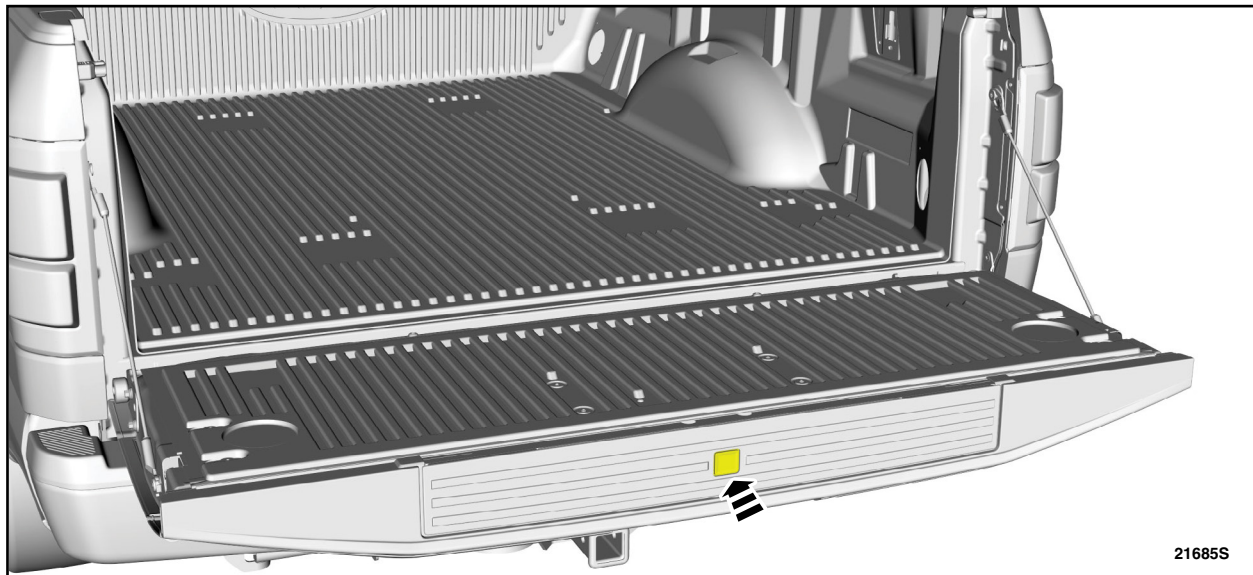
FIGURE 16

20. If equipped, push the tailgate step release button. See Figure 16.

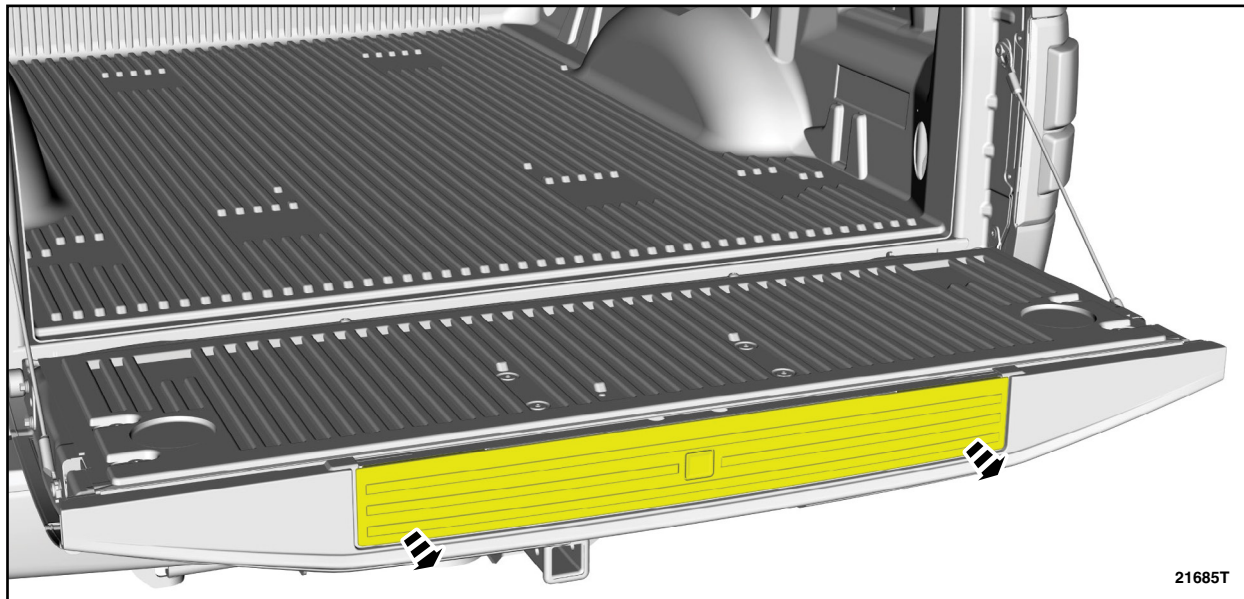
**FIGURE 17**

21. If equipped, open the tailgate step. See Figure 17.

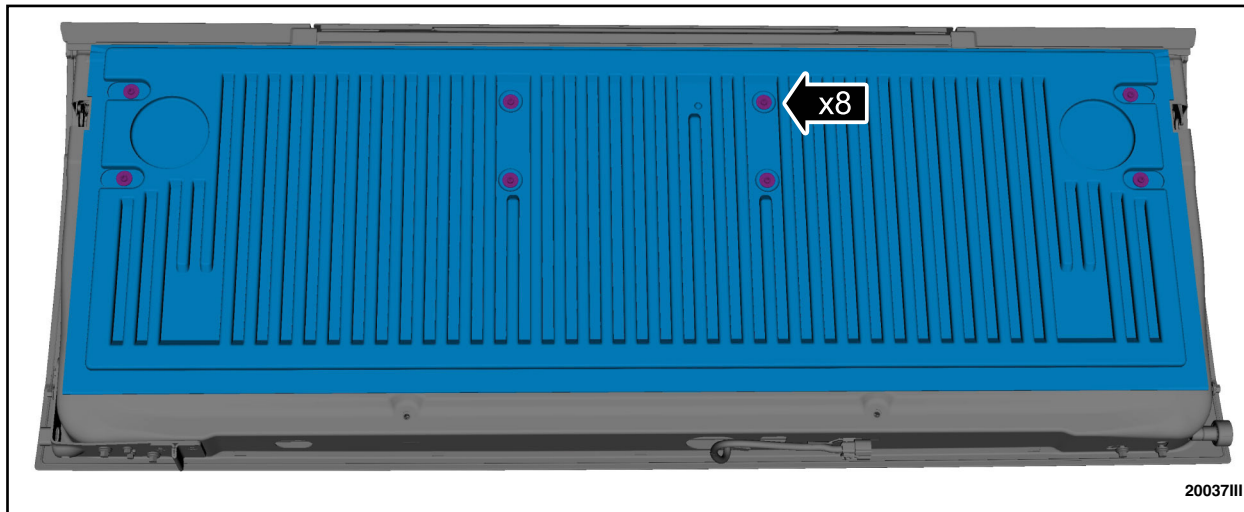
**FIGURE 18**

22. If equipped, remove the bedliner tailgate cover. See Figure 18.

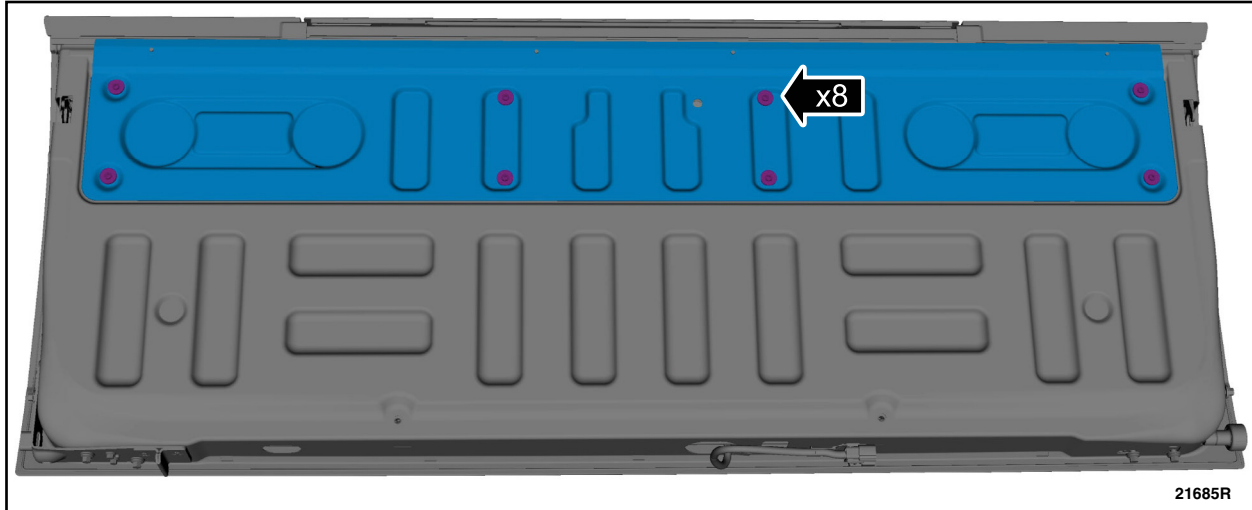
FIGURE 19

23. If equipped, remove the tailgate access panel bolts and the tailgate access panel. See Figure 19.

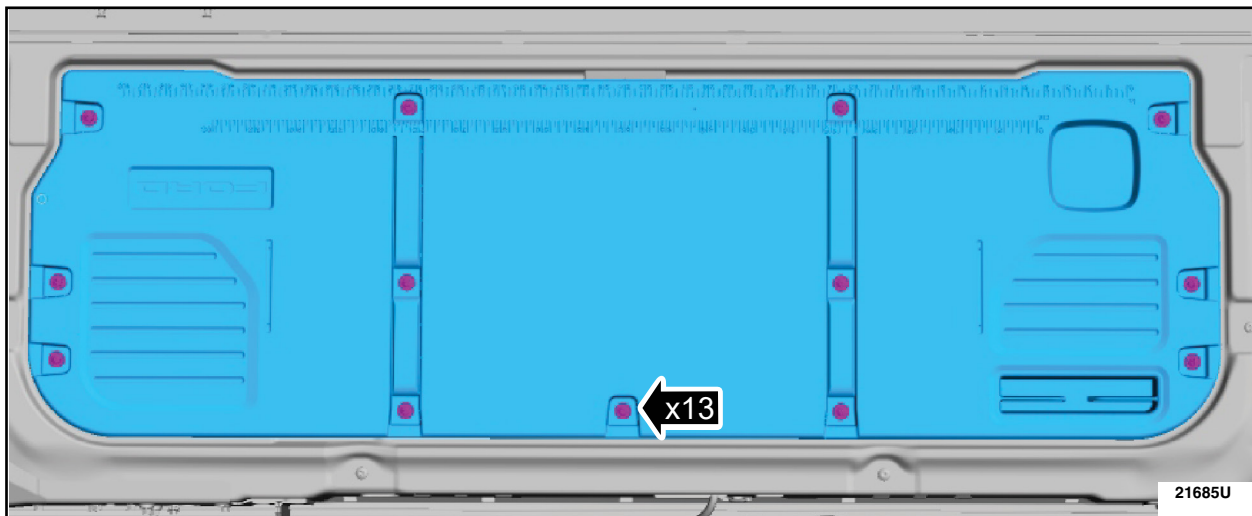
FIGURE 20

24. If equipped, remove the workspace tailgate access panel bolts and the workspace tailgate access panel. See Figure 20.

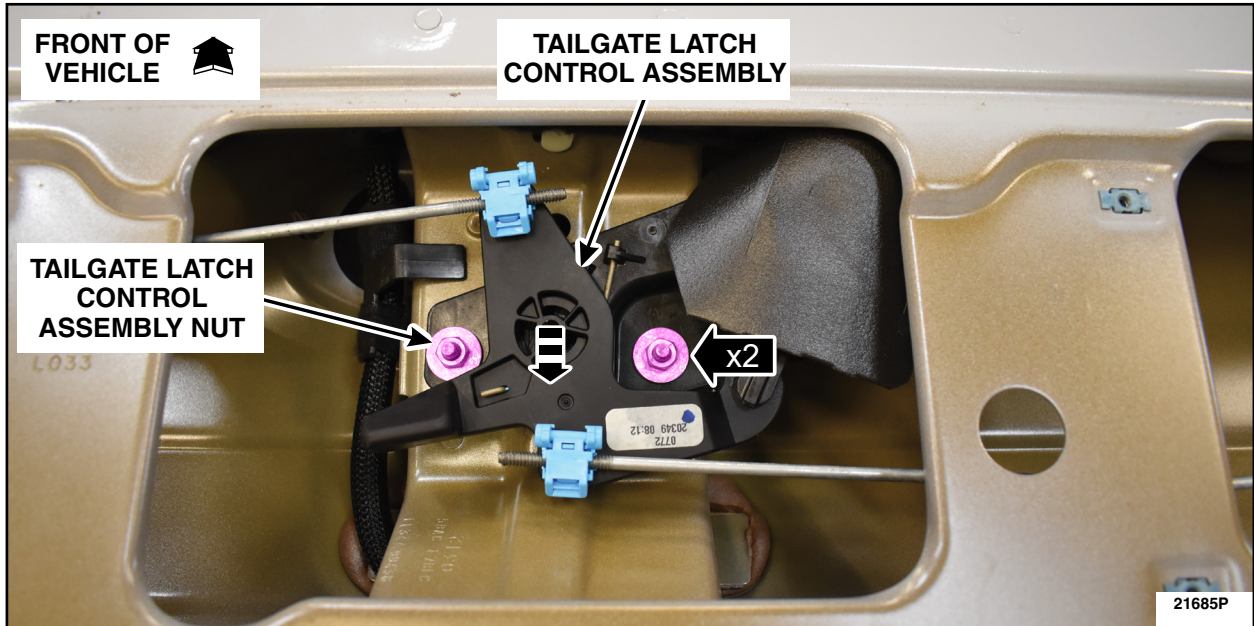
FIGURE 21

25. Remove the tailgate latch control assembly nuts and position the tailgate latch control assembly towards the rear of the vehicle. See Figure 21.

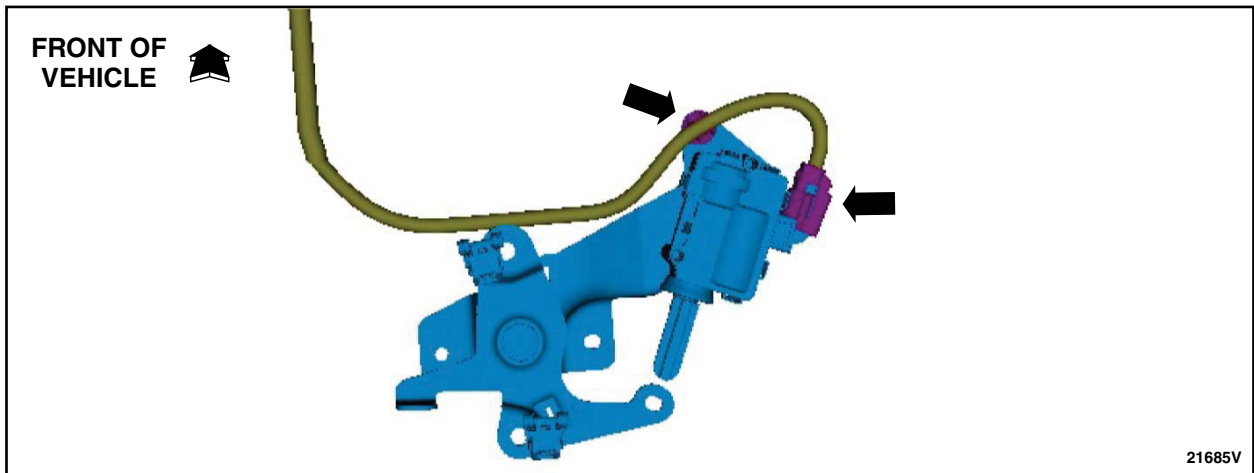
FIGURE 22

26. Disconnect the electrical connector and the push pin retainer. See Figure 22.

**NOTE:** Tailgate latch control assembly shown outside of the vehicle for clarity.

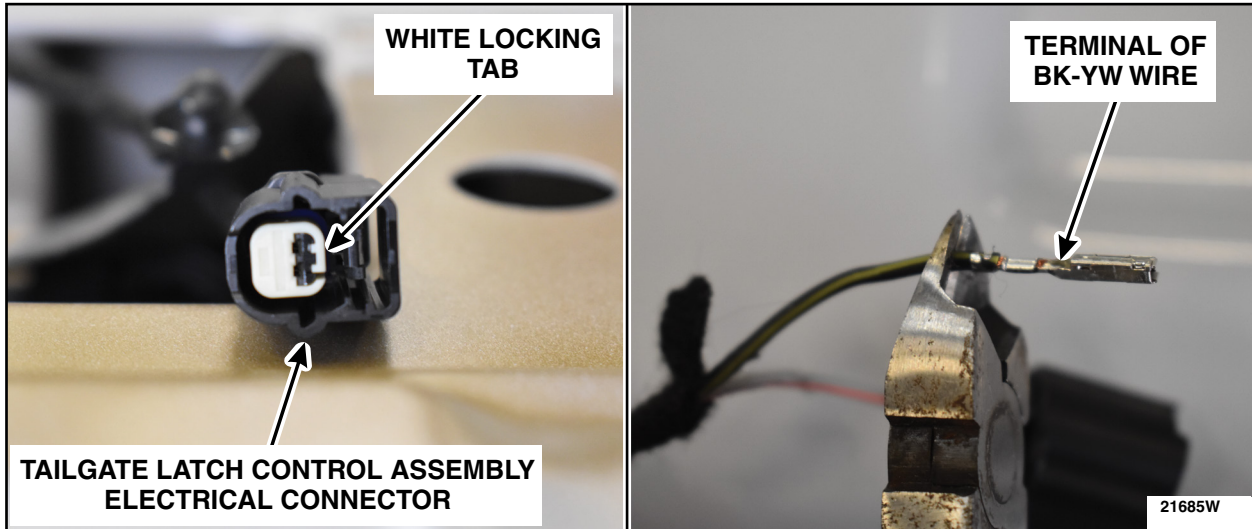
**FIGURE 23**

27. Remove the white locking tab and the Black-Yellow (BK-YW) wire from the tailgate latch control assembly connector. Cut off the terminal of the BK-YW wire. See Figure 23.

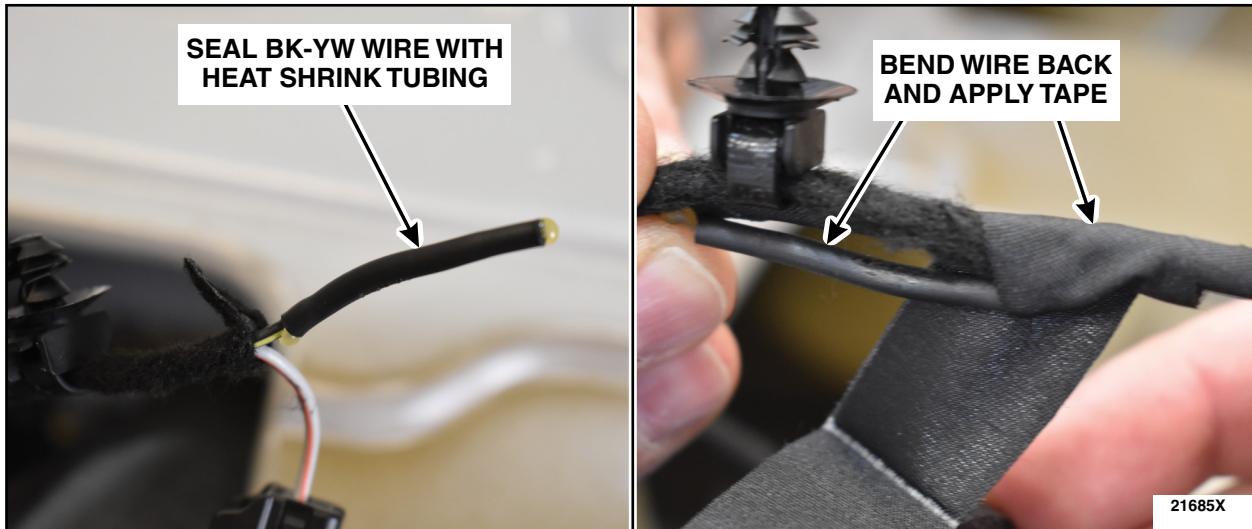
**FIGURE 24**

28. Seal the BK-YW wire using heat shrink tubing. Bend back the sealed wire and secure using Coroplast® 837 or Equivalent Electrical Wire Harness Tape. See Figure 24.

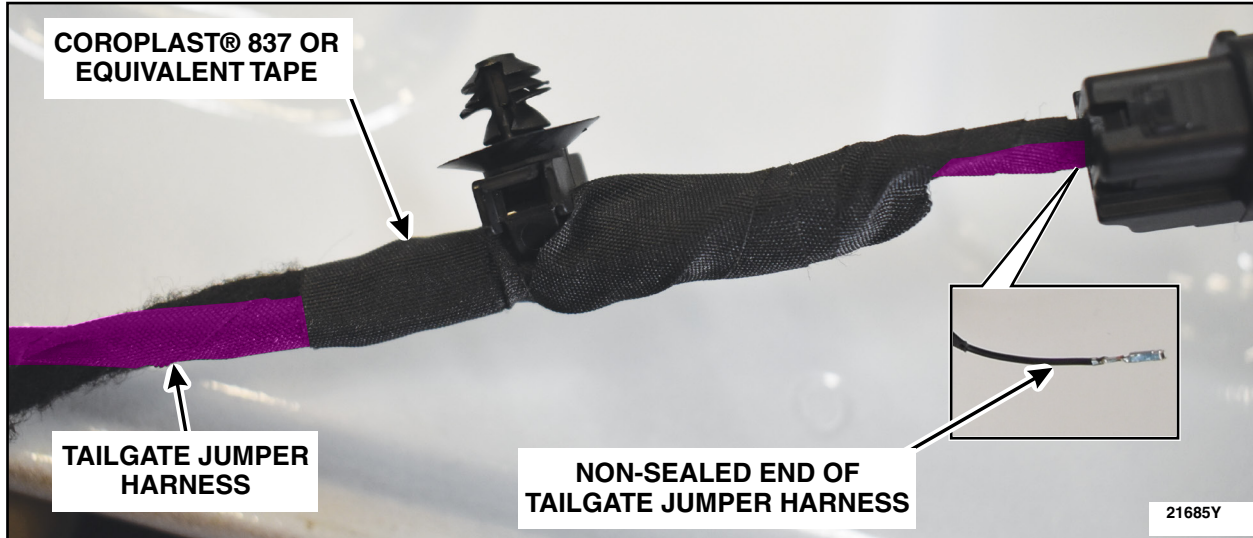
FIGURE 25

29. Install the Tailgate Jumper Harness non-sealed end terminal into the open pin in the tailgate latch control assembly electrical connector. Secure using Coroplast® 837 or Equivalent Electrical Wire Harness Tape. Reinstall the white locking tab. See Figure 25.

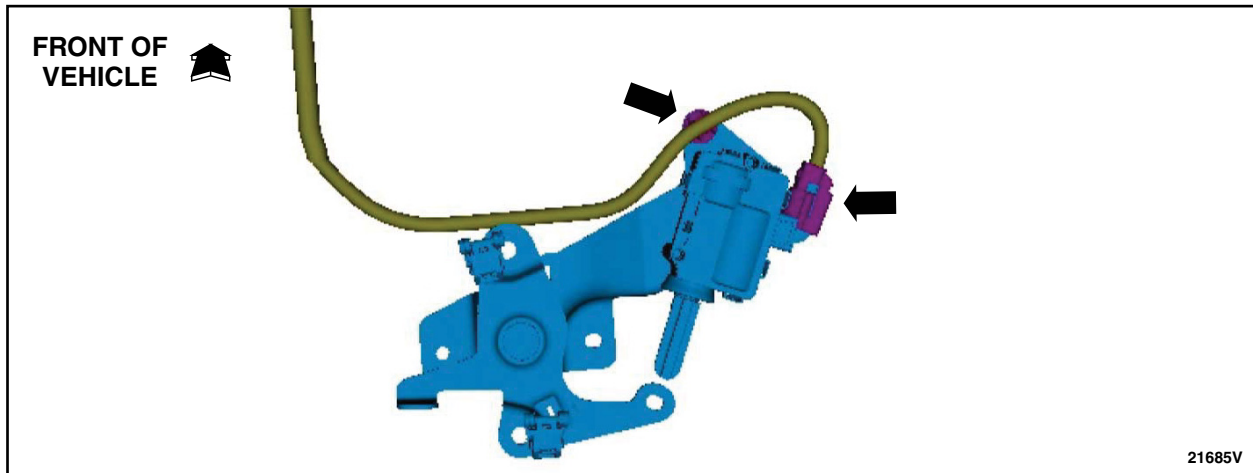
FIGURE 26

30. Reconnect the electrical connector and the push pin retainer. See Figure 26.

**NOTE:** Tailgate latch control assembly shown outside of the vehicle for clarity.

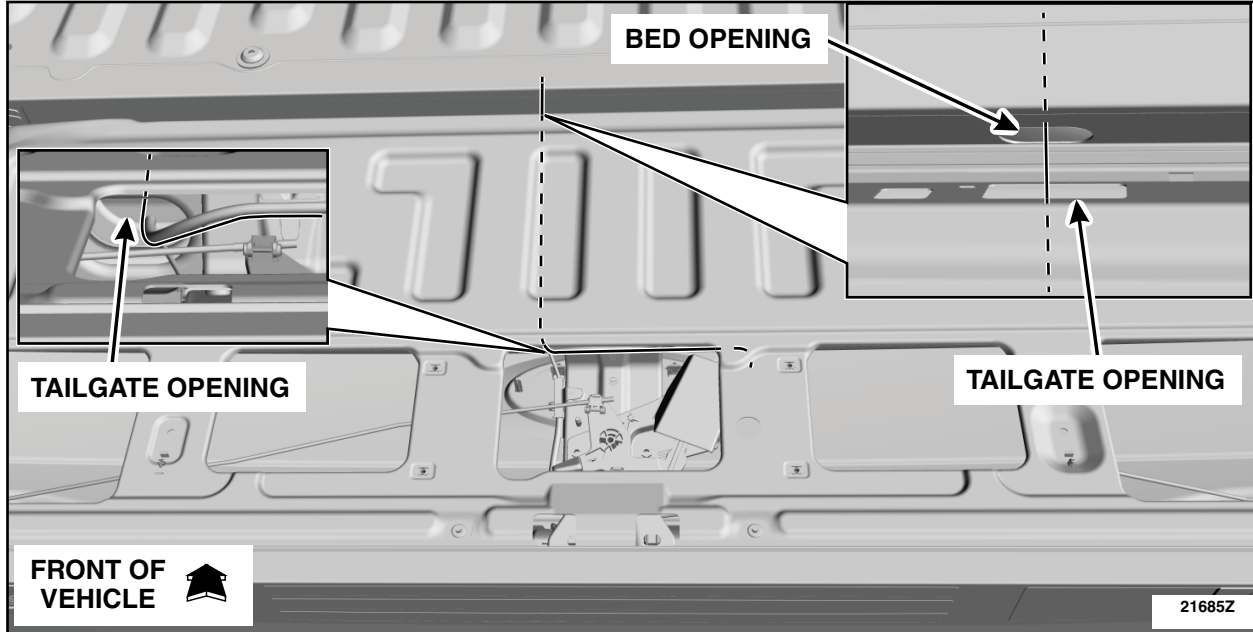
FIGURE 27

31. Using a straightened coat hanger, tape the sealed terminal end of the Tailgate Jumper Harness Wire to one end of the coat hanger. Route the wire and coat hanger on the Left Hand (LH) side of the tailgate latch control assembly and through the opening in the center bottom of the tailgate. Continue to pass through the opening in the bed and down through the bottom of the vehicle. See Figure 27.

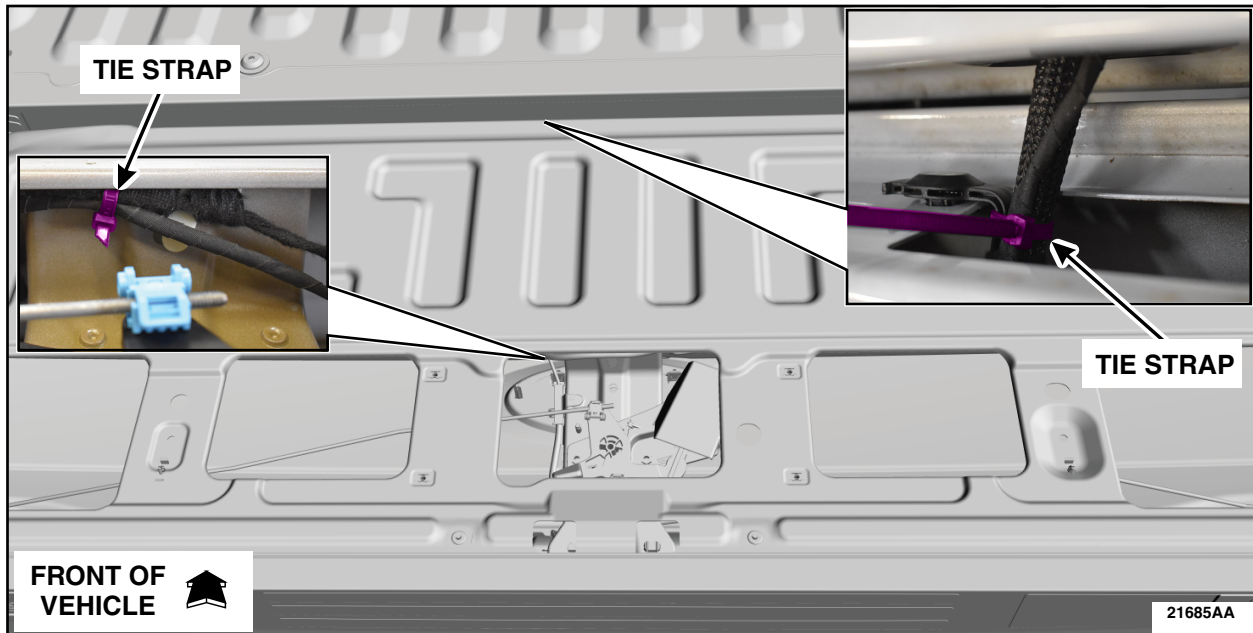
FIGURE 28

32. Secure the Tailgate Jumper Harness using tie straps and trim any excess length of tie strap. See Figure 28.
