Stacy L. Balzer  
 Operating Director  
 Service Engineering Operations  
 Ford Customer Service Division

**SUBJECT:** **Customer Satisfaction Program 21M08 - Supplement #2**  
 Certain 2021-2022 Model Year F-150 Vehicles Equipped with a Power Release Tailgate - Unintended Tailgate Opening

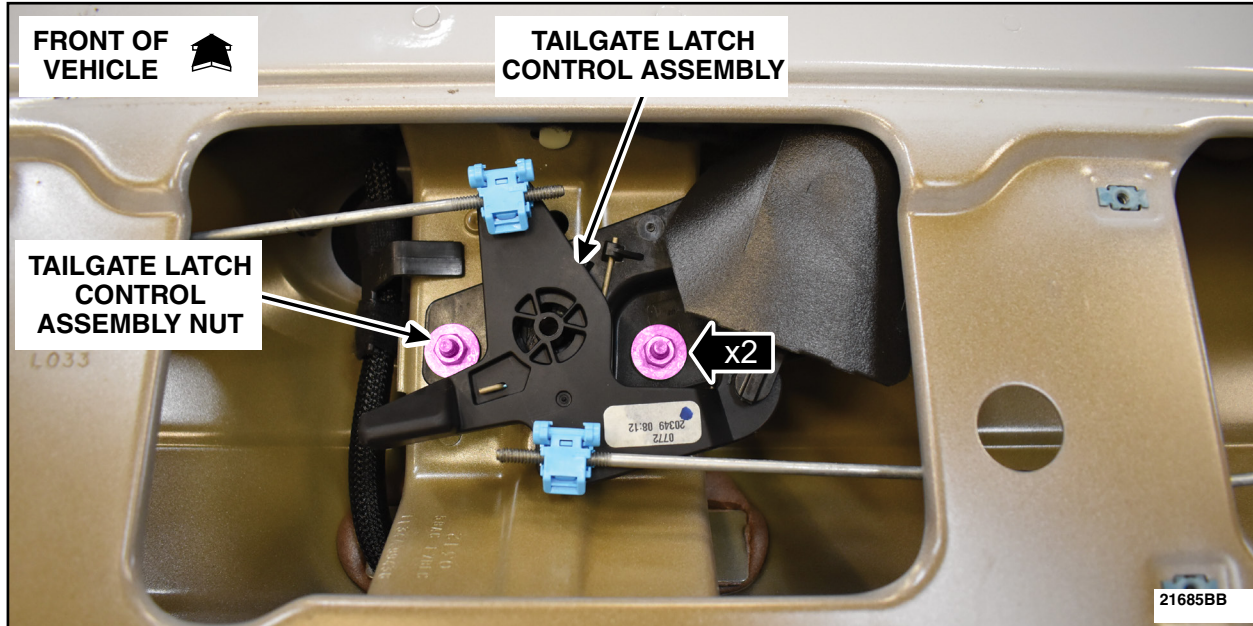
FIGURE 29

33. Position back the tailgate latch control assembly and install the nuts. See Figure 29.

- Torque 80 lb.in (9 Nm)

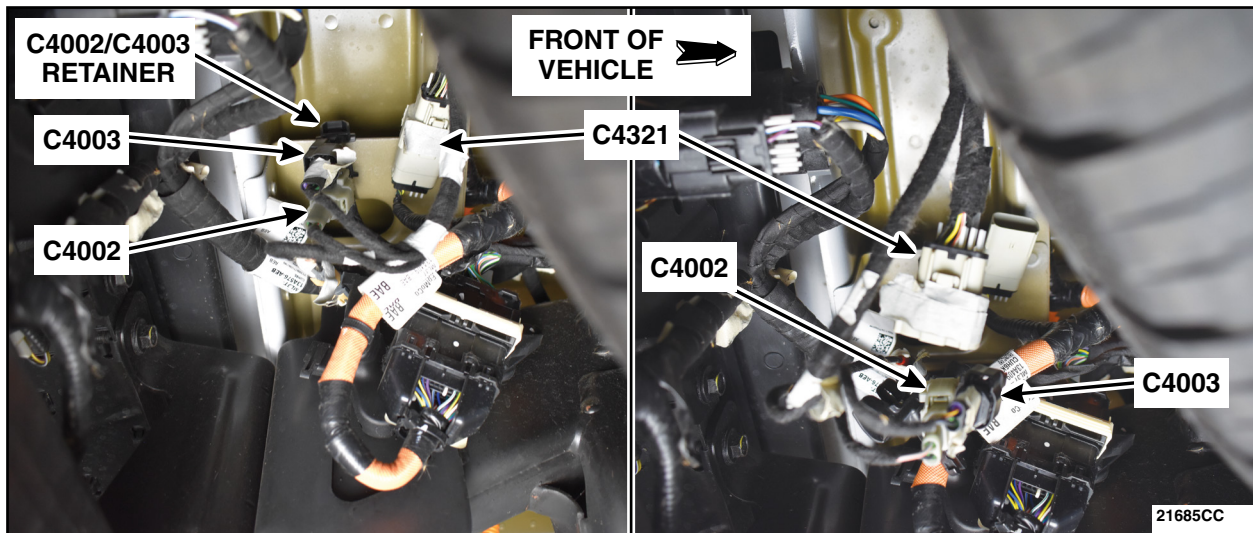
FIGURE 30

35. Release the C4002/C4003 retainer and disconnect C4002, C4003 and C4321. See Figure 30.

**NOTE:** *Service Procedure Steps on Page 6, Step 8, Figure 4 through Page 11, Step 18, Figure 14, and Page 19, Step 35, Figure 30 through Page 29, Step 50, Figure 47 can be skipped if the wires are in the correct pin locations for ALL 3 of the following inspections. ALL of the Service Procedure Steps listed above will need to be completed if any one of the circuits in Steps 1, 2, or 3 are missing. This may require depinning circuit(s) to install the Relay Harness and Body Length Harness.*

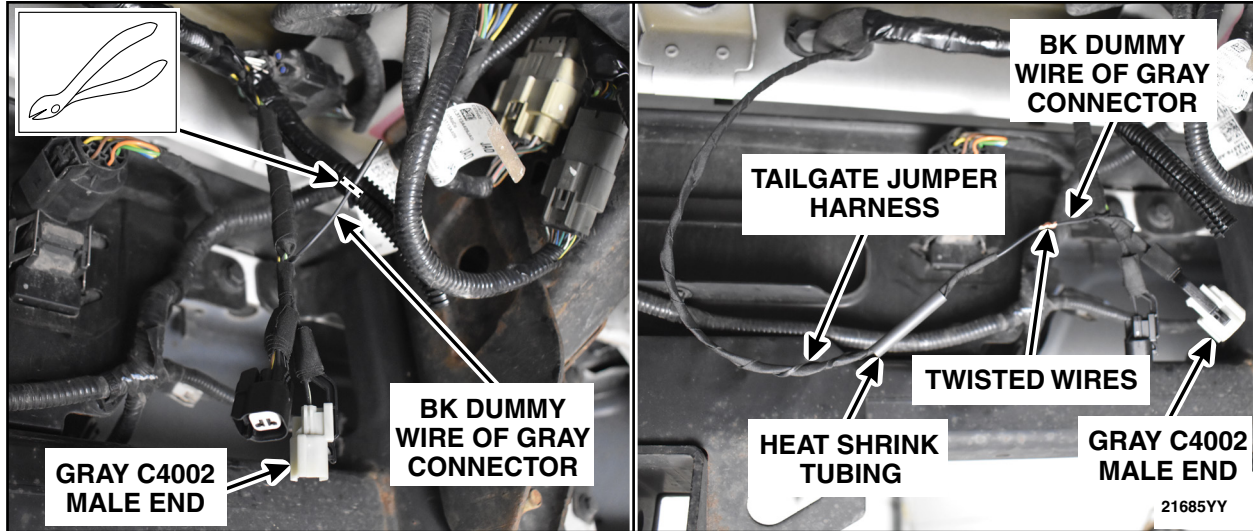
FIGURE 31

36. Remove any tape and/or convolute from the gray C4002 male end to expose the Black (BK) dummy wire. Cut the BK dummy wire just in front of the heat shrink tubing and discard the heat shrink end. Cut off the sealed terminal on the Tailgate Jumper Harness. Install a *new* piece of heat shrink tubing, twist the Tailgate Jumper Harness and the C4002 male end BK dummy wire together. See Figure 31.

- 4. Page 20, Step 36, Figure 31. Inspect the male end of C4002 for a BK-VT wire in pin 2. If the wire is present the tailgate harness rework will not need to be completed. If any other color of wire is present, then the tailgate harness rework must be completed.*

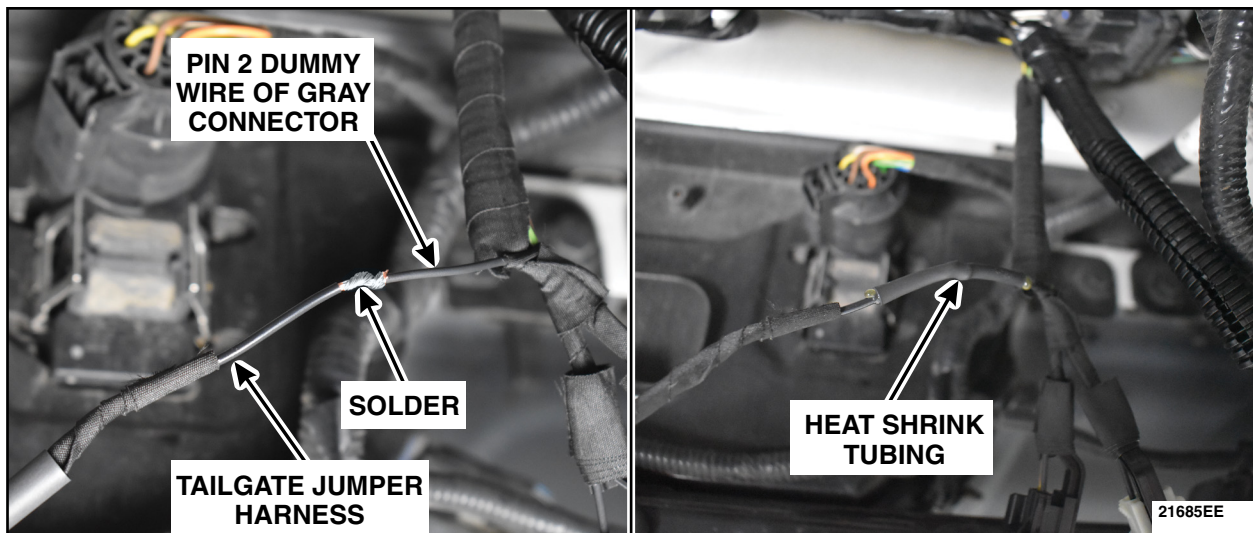
FIGURE 32

37. Solder the twisted wires and apply and seal the heat shrink tubing. See Figure 32. Reapply the convolute and/or black electrical tape.

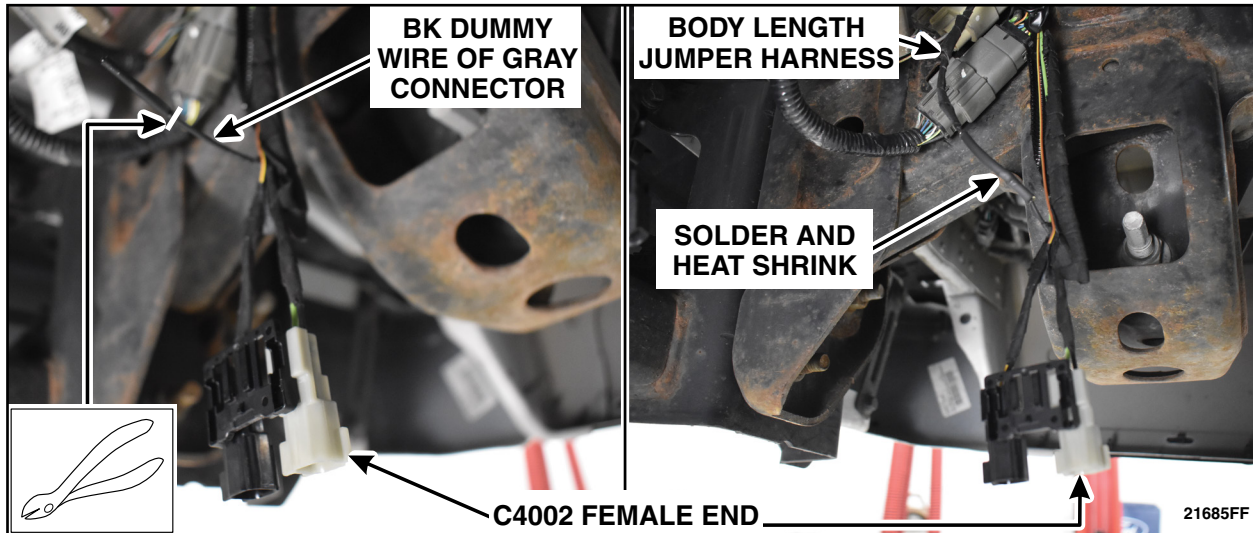
FIGURE 33

38. Remove any tape and/or convolute from the gray C4002 female end to expose the Black (BK) dummy wire. Cut the BK dummy wire just in front of the heat shrink tubing and discard the heat shrink end. Cut off the sealed terminal on the Body Length Jumper Harness. Install a *new* piece of heat shrink tubing, twist the Body Length Jumper Harness and the C4002 female end black dummy wire together. Solder the twisted wires and apply and seal the heat shrink tubing. Reapply the convolute and/or black electrical tape. See Figure 33.

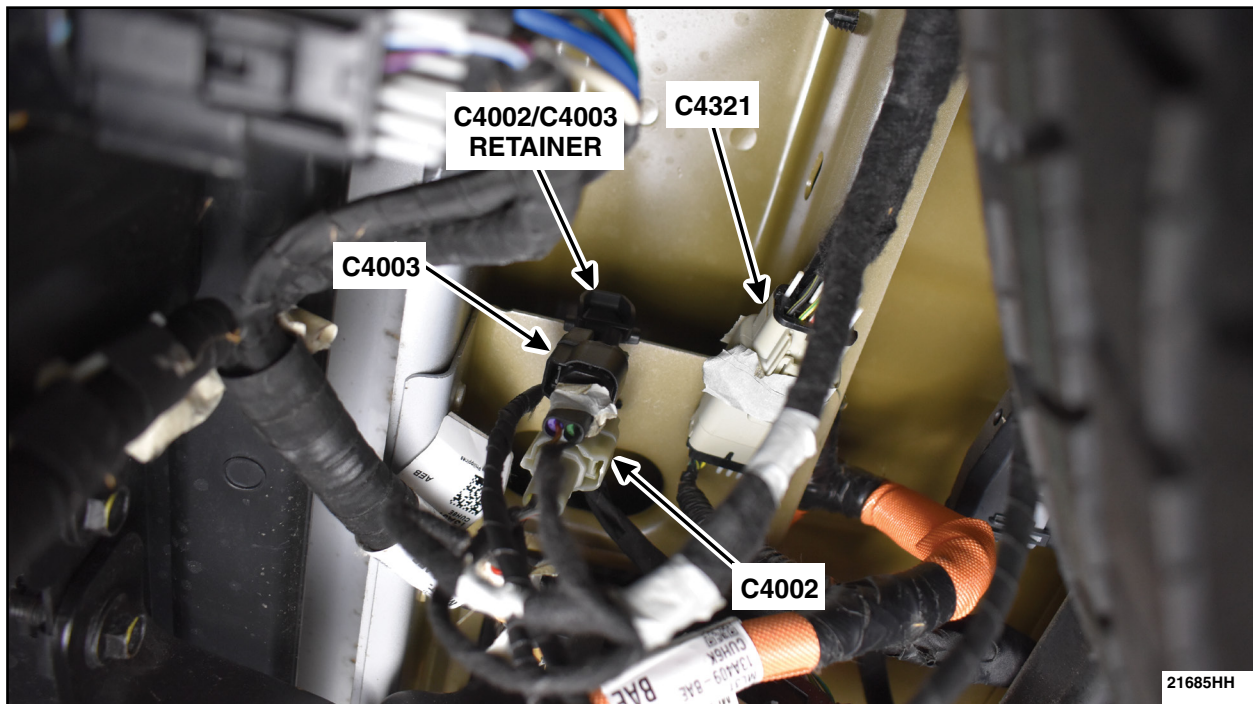
FIGURE 34

39. Reconnect C4002, C4003, C4321 and the C4002/C4003 retainer. See Figure 34.

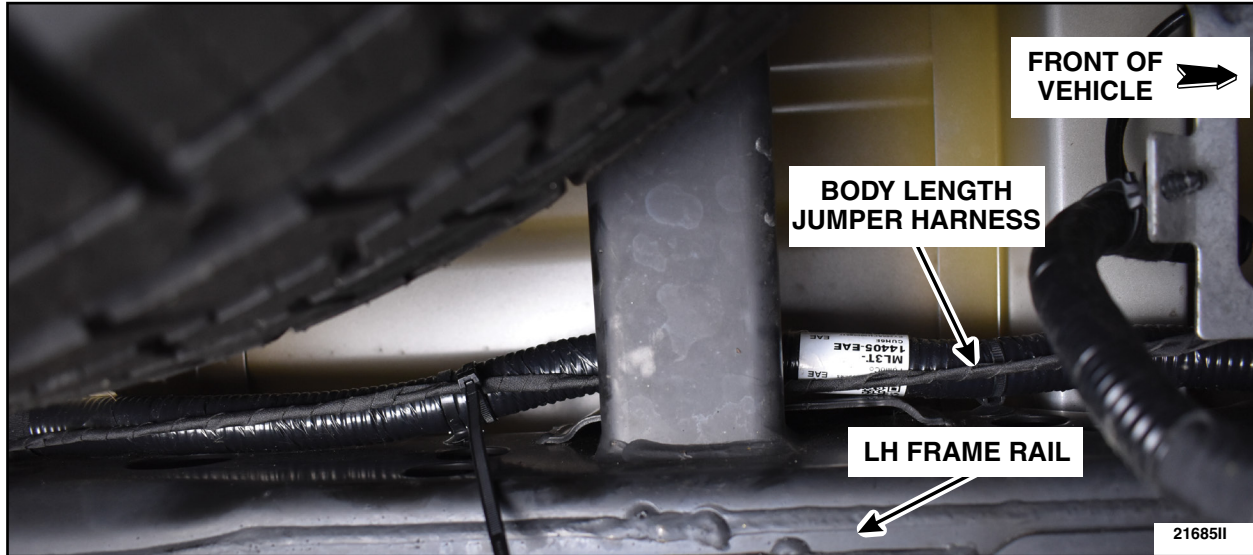
**FIGURE 35**

40. Route the Body Length Jumper Harness along the LH frame rail towards the front of the vehicle keeping the harness as close to the bed as possible. Secure using tie straps approximately every 12 in (305 mm). See Figure 35.

**NOTE:** The tie straps were left untrimmed for clarity. Trim any excess from the tie straps once installed.

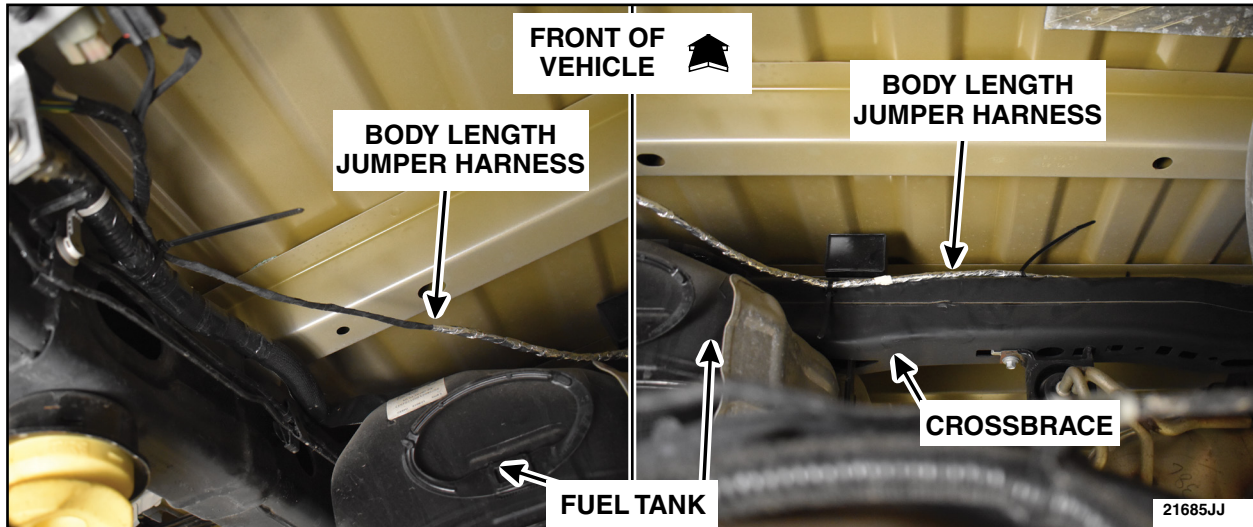
**FIGURE 36**

41. Continue to route the Body Length Jumper Harness along the LH frame rail. Once at the fuel tank, route the Body Length Jumper Harness across the crossbrace to the RH side of the frame rail. Secure the Body Length Jumper Harness to the existing harness and to the holes within the crossbrace using the assorted supplied tie straps approximately every 12 in (305 mm). See Figures 36 and 37.

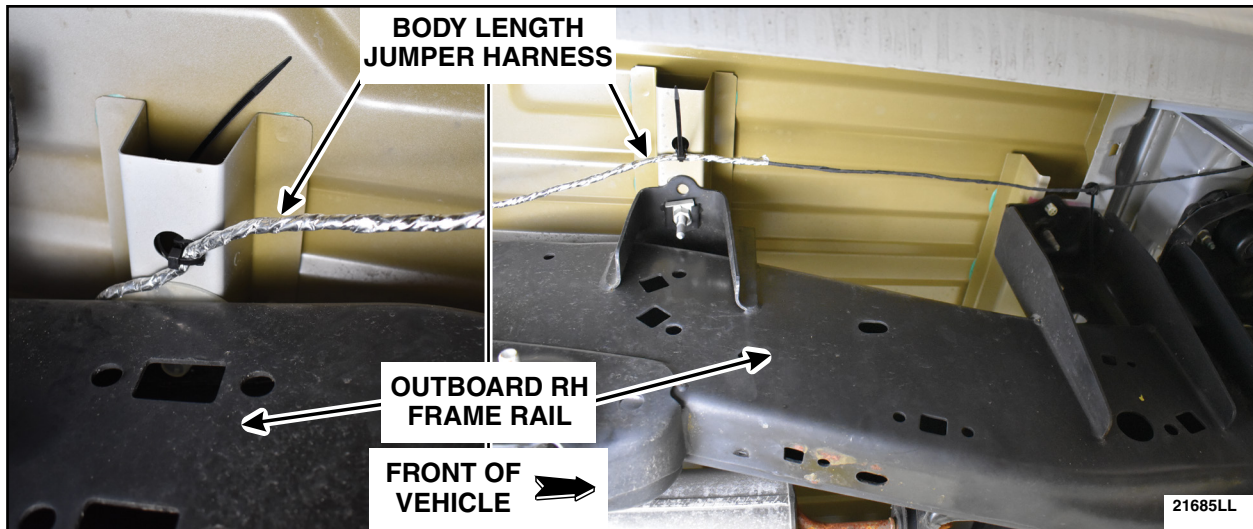
**FIGURE 38**

42. Route the Body Length Jumper Harness over the RH frame rail and continue on the outboard RH frame rail as close to the bed as possible. Secure the Body Length Jumper Harness to the holes within the underside of the bed and the outboard RH frame using the assorted supplied tie straps approximately every 12 in (305 mm). See Figure 38.

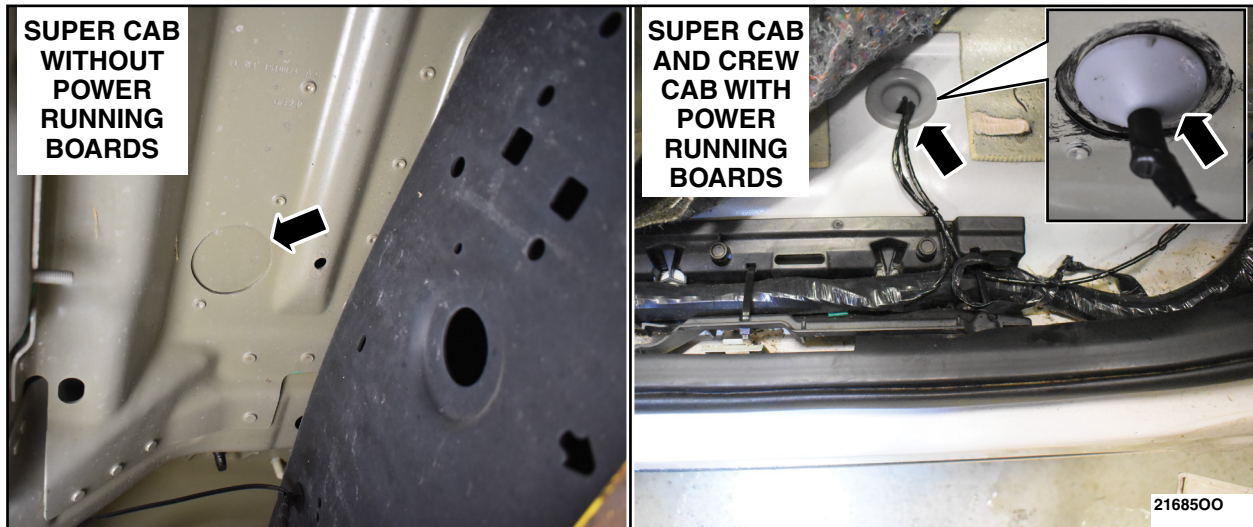
**FIGURE 39**

43. **ALL** vehicles equipped **WITH** power running boards have a grommet located on the front passenger floorboard. **Super Cab** vehicles **WITHOUT** power running boards have no hole present on the front passenger floorboard. **Crew Cab** vehicles **WITHOUT** power running boards have a plug on the front passenger floorboard. See Figure 39.

**NOTE:** Floorboard grommet shown, floorboard plug similar.

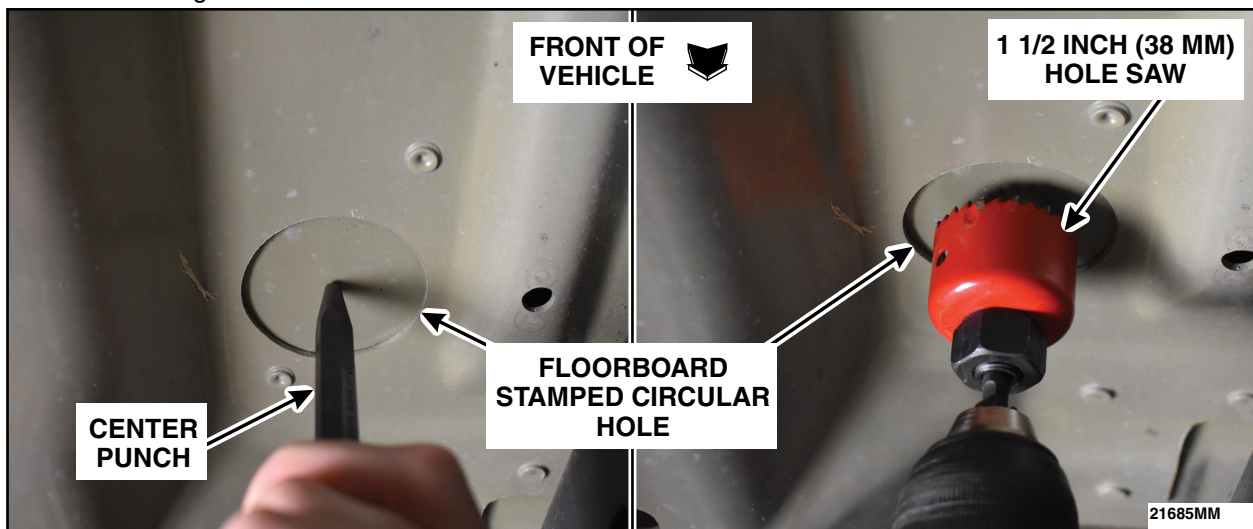
**FIGURE 40**

44. Locate the floorboard stamped circular hole on the under side of the front passenger floorboard. Using a Center Punch, mark the center of the circular hole. Using a 1-1/2 inch (38 mm) Bi-Metal Hole Saw with arbor and pilot bit, drill through the floorboard towards the inside of the vehicle. De-burr the hole. See Figure 40.

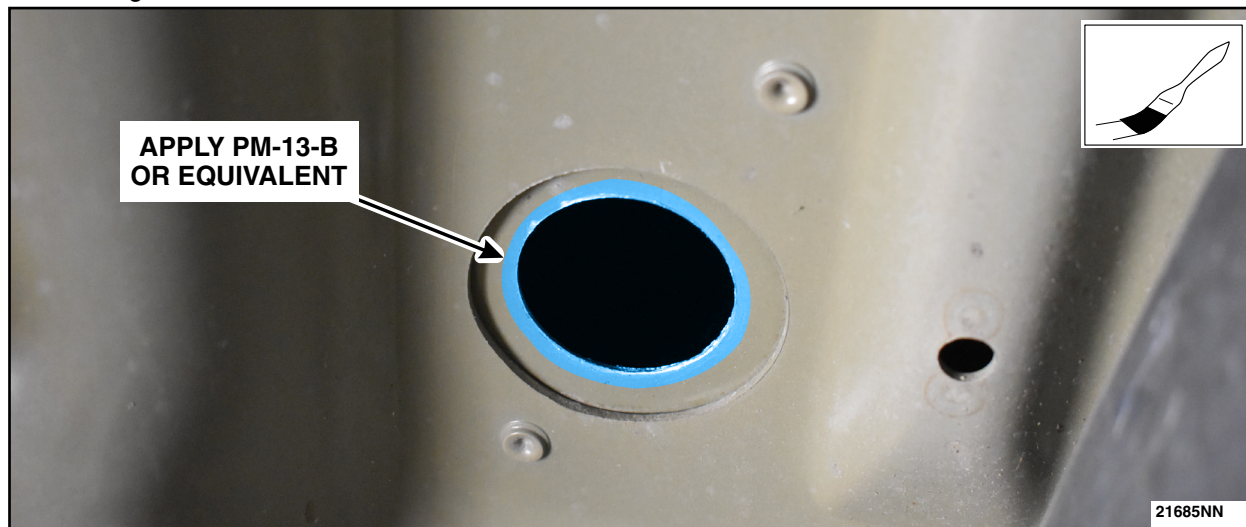
FIGURE 41

45. Following the directions on the can, liberally apply some PM-13-B Anti Corrosion Coating or equivalent to the edge and surface around the hole drilled into the floorboard. Allow to fully dry. See Figure 41.

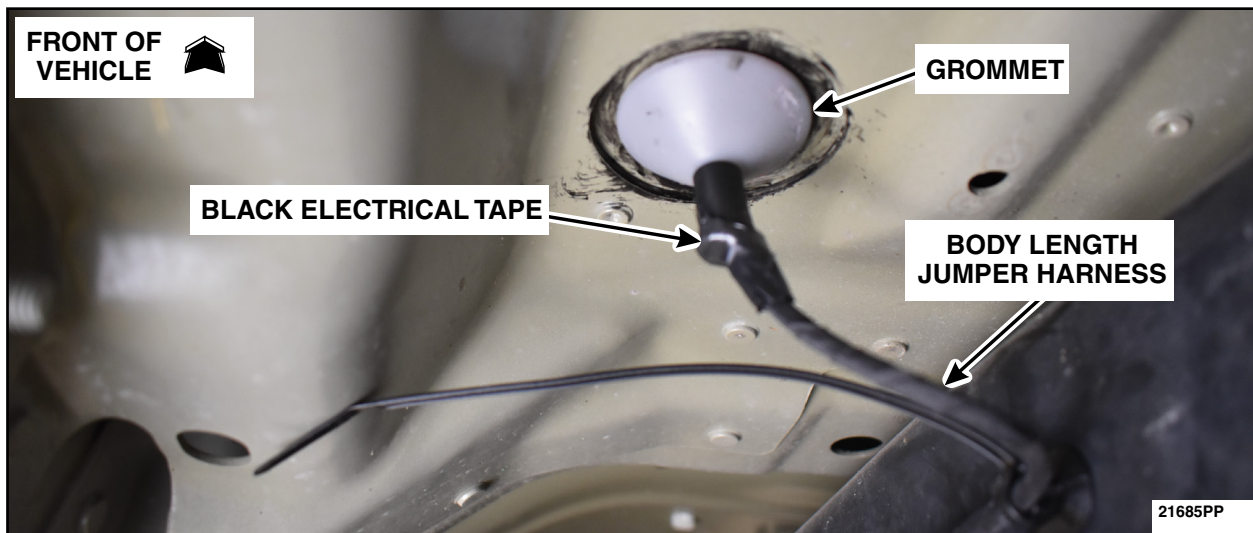
FIGURE 42

46. Install the grommet and route the Body Length Jumper Harness. See Figure 42.

- As needed, install the grommet included in the Tailgate Actuator Ground Wiring Part Kit into the hole drilled into the floorboard being sure that the grommet is fully seated.
  - a. **If equipped with power running boards**, remove the electrical tape off of the grommet that is already installed into the floorboard.
- Route the Body Length Jumper Harness through the center of the grommet.
  - b. **If equipped with power running boards**, route the Body Length Jumper Harness through the center of the existing grommet along side of the existing wire. See Figure 43.
- Apply black electrical tape over the end of the grommet and the Body Length Jumper Harness.

**NOTE:** Grommet on vehicle without power running boards shown, other similar.

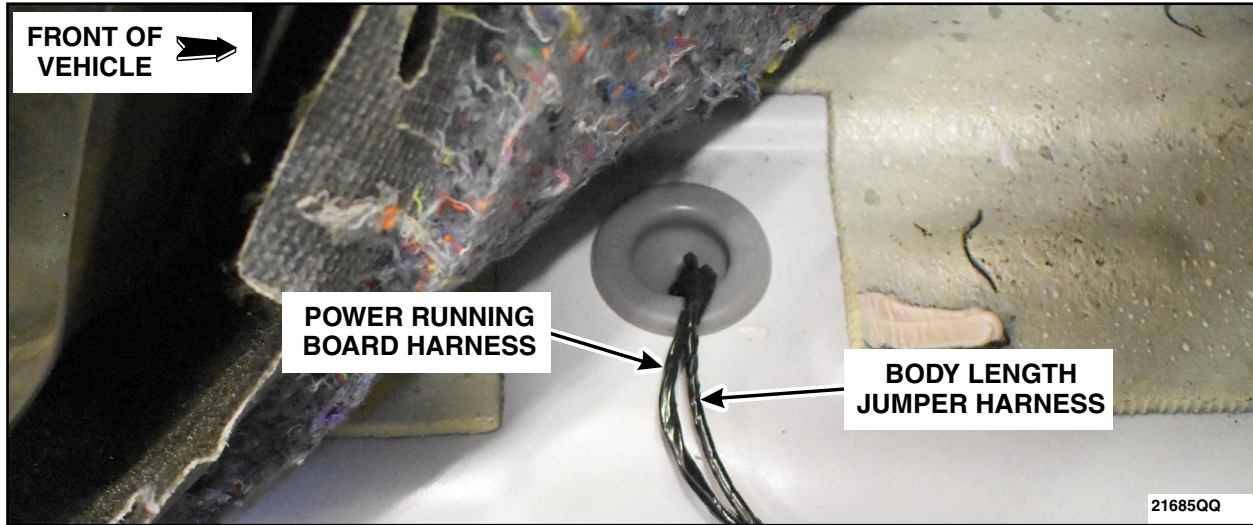
**FIGURE 43**

**NOTE:** Grommet on vehicle with power running boards shown, other similar.

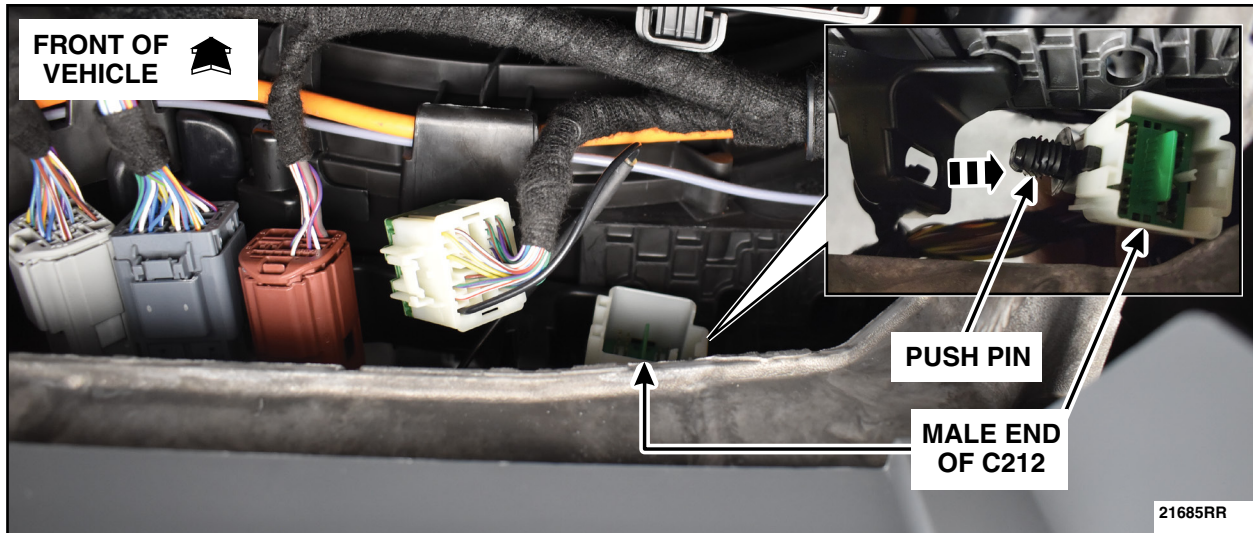
**FIGURE 44**

47. Disconnect the push pin of the male end of C212 from the instrument panel bracket. See Figure 44.

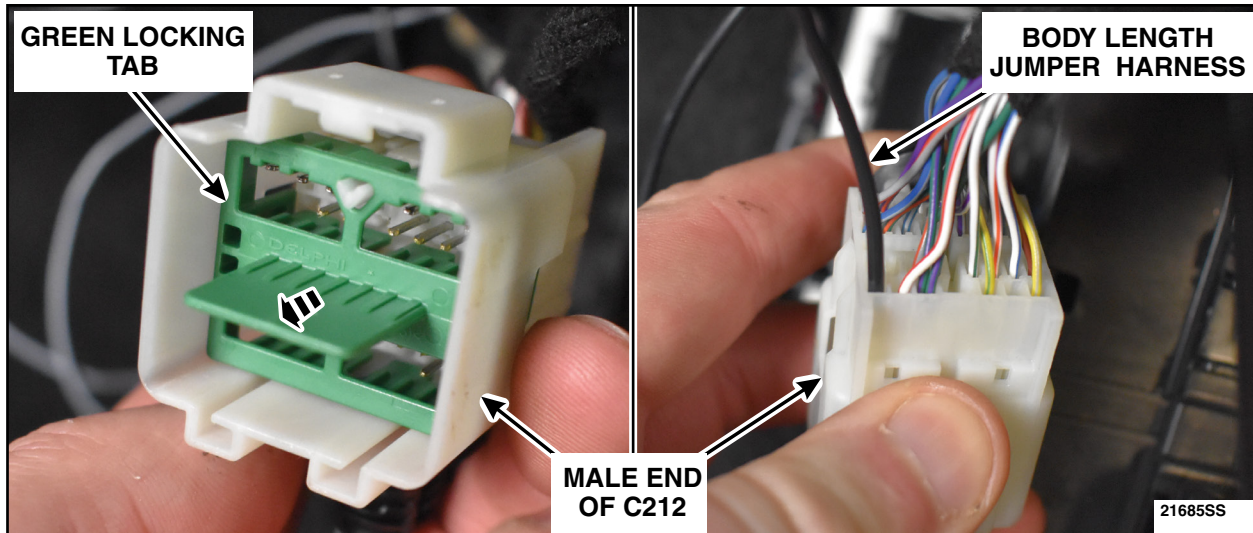
FIGURE 45

48. Remove the green locking tab and install the Body Length Jumper Harness terminal into the Pin 1 cavity of the C212 male end. See Figure 45.

- 1. Page 7, Step 10, Figure 6. Inspect the female end of C212 for a Gray (GY) wire in pin 1 and a Gray-Orange (GY-OG) wire in pin 4. If both wires are present, Proceed to Step 2.*
- 2. Page 28, Step 48, Figure 45. Inspect the male end of C212 for a Blue-Gray (BL-GY) wire in pin 1 and a GY-OG wire in pin 4. If both wires are present, Proceed to Step 3.*
- 3. Page 19, Step 35, Figure 30. Inspect the female end of C4002 for a Black-Violet (BK-VT) wire in pin 2. If the wire is present, Proceed to Step 4.*

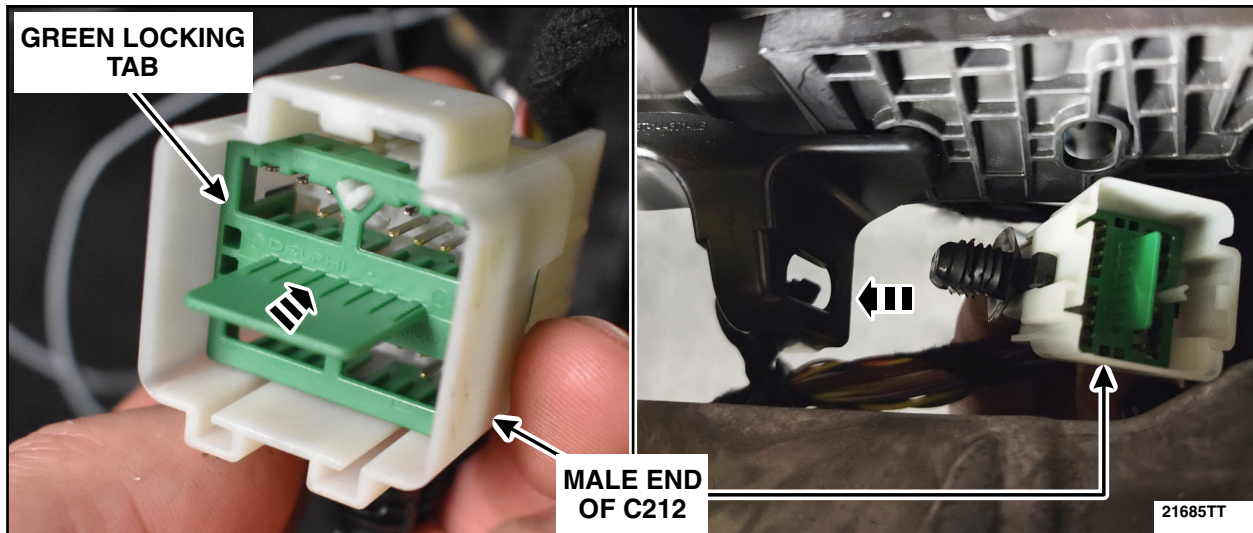
FIGURE 46

49. Reinstall the green locking tab, position back the push pin of the male end of C212 into the instrument panel bracket and reconnect the C212 electrical connector. See Figure 46.

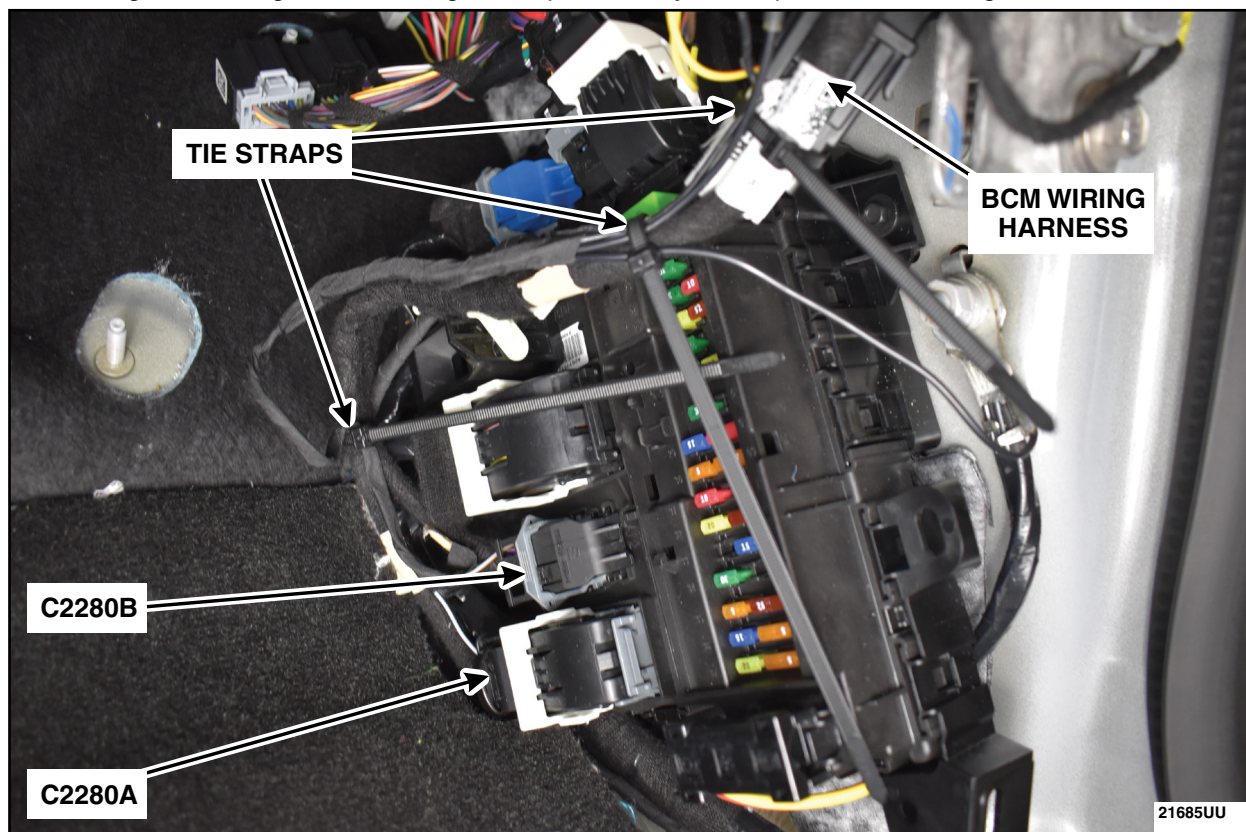
FIGURE 47

50. Position back the carpet. Reconnect C2280A and C2280B to the BCM. Secure the relay wiring to the existing BCM wiring harness using tie straps. Trim any tie straps excess. See Figure 47.

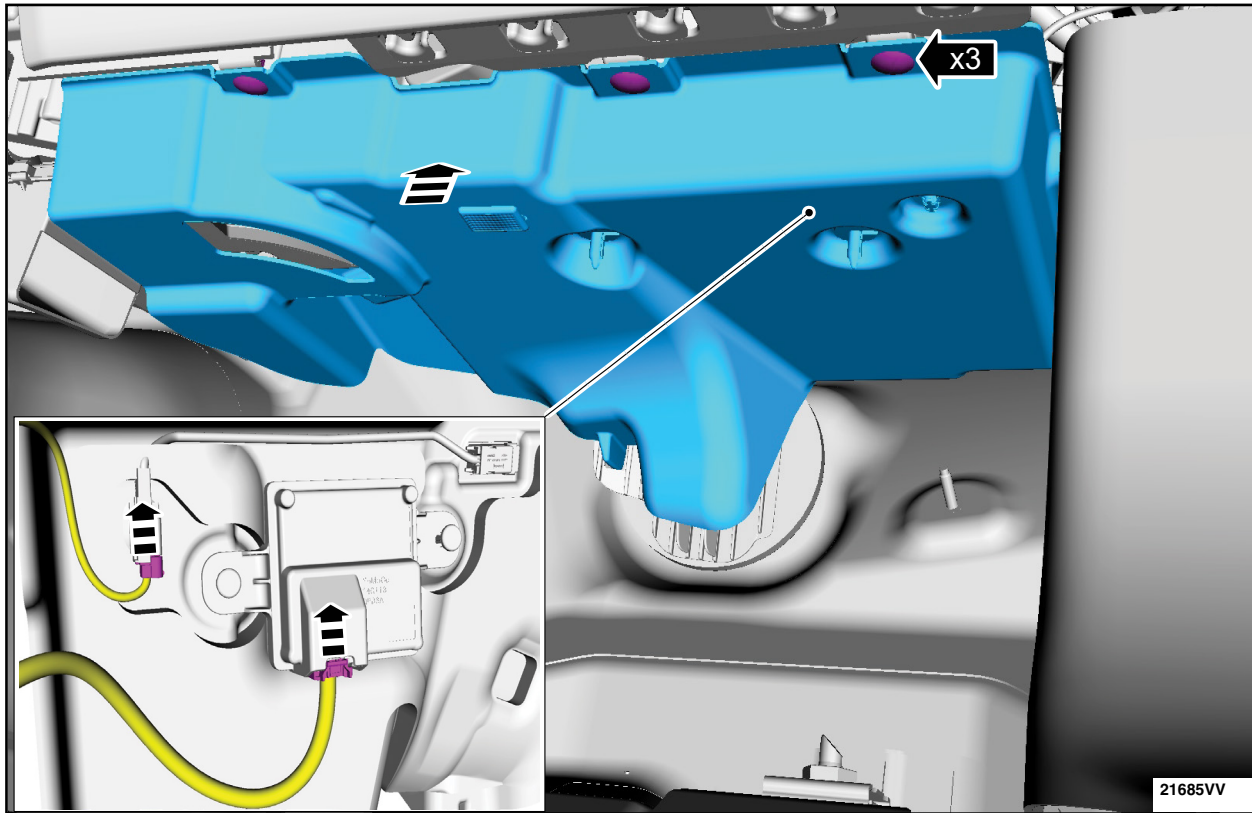
FIGURE 48

51. Connect the electrical connectors, install the RH insulation panel and the push pins. See Figure 48.

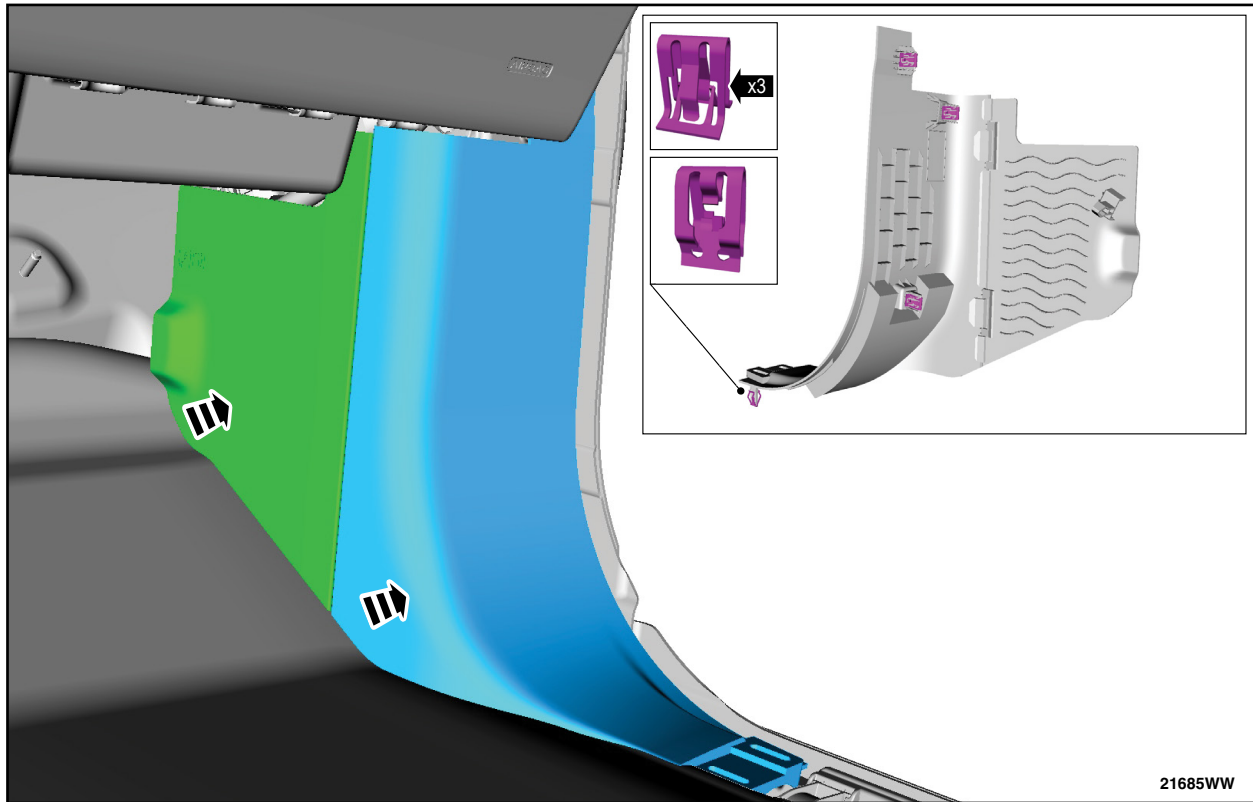
**FIGURE 49**

52. Install the RH lower cowl trim panel and the fuse panel cover. See Figure 49.
