Emissions Service Action

Code: 3704

Subject	Transmission Control Module (TCM) Software														
Release Date	November 29, 2022														
Affected Vehicles	<table border="1"> <thead> <tr> <th>Country</th> <th>Beginning Model Year</th> <th>Ending Model Year</th> <th>Vehicle</th> <th>Vehicle Count</th> </tr> </thead> <tbody> <tr> <td>USA</td> <td>2013</td> <td>2015</td> <td>Q7 TDI</td> <td>7</td> </tr> </tbody> </table>					Country	Beginning Model Year	Ending Model Year	Vehicle	Vehicle Count	USA	2013	2015	Q7 TDI	7
Country	Beginning Model Year	Ending Model Year	Vehicle	Vehicle Count											
USA	2013	2015	Q7 TDI	7											
	<p>Check Campaigns/Actions screen in Elsa on the day of repair to verify that a VIN qualifies for repair under this action. Elsa is the <u>only</u> valid campaign inquiry & verification source.</p> <ul style="list-style-type: none"> ✓ Campaign status must show "open." ✓ If Elsa shows other open action(s), inform your customer so that the work can also be completed at the same time the vehicle is in the workshop for this campaign. 														
Problem Description	Audi has determined that a small number Transmission Control Modules (TCMs) contained an

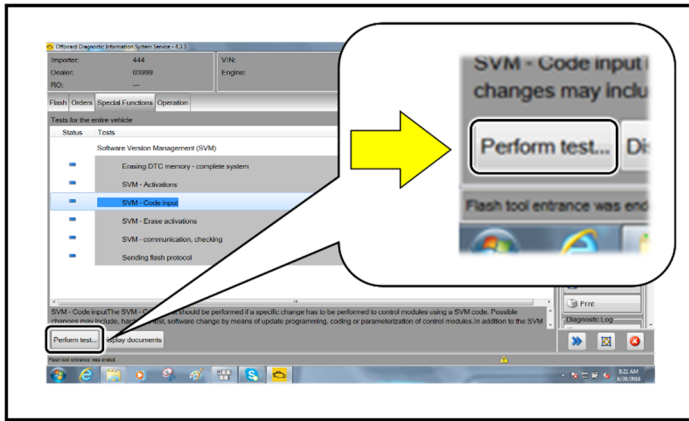
- Select “Perform test”.

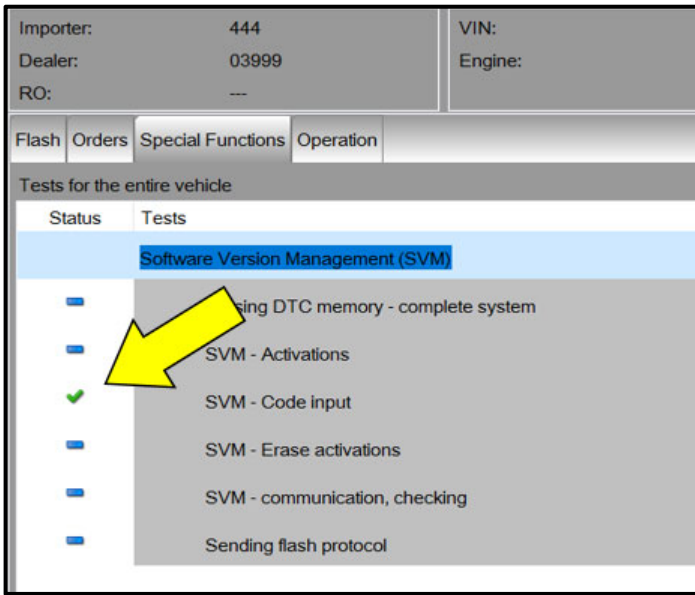
This extra ignition cycle step must be followed, otherwise faults stored during the update may not be cleared upon exiting the Flash program.

- After receiving confirmation that the update completed successfully (green check mark) <arrow>, the ignition must be turned off for 60 seconds and then turned back on.
