# Service Action

## Code: 93P9

<b>Subject</b>	Software Update															
<b>Release Date</b>	November 16, 2022															
<b>Revision Summary</b>	<b>Updated labor operation for GFF operations in the claiming instructions</b>															
<b>Affected Vehicles</b>

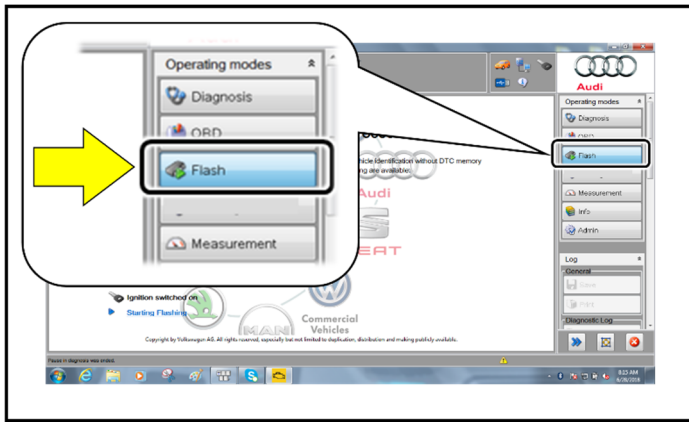
- From the home screen of the scan tool highlight “Flash” <1>.
- Follow the on-screen prompts.

**NOTE**  
 Operating mode “Flash” must be used. Performing this update using “Diagnosis” (Guided Fault Finding) could result in non-payment of the claim.

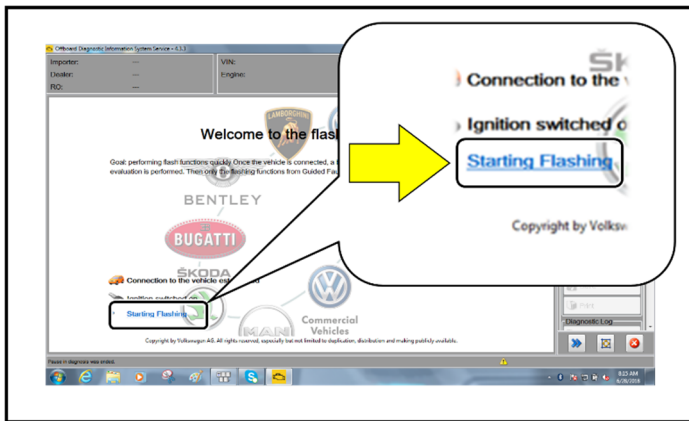
- Select “Starting Flashing” and follow the on-screen prompts.

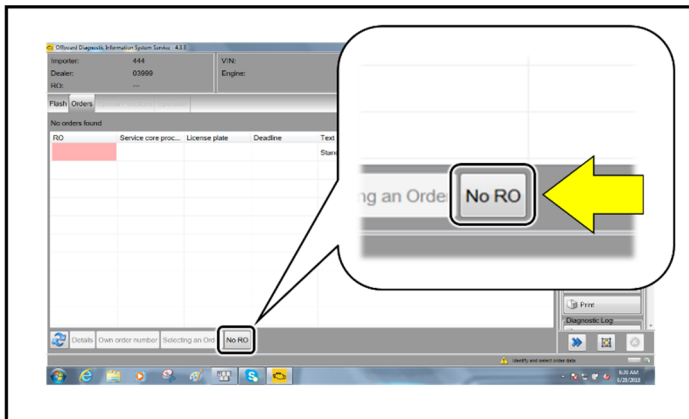
- Select “No RO”.

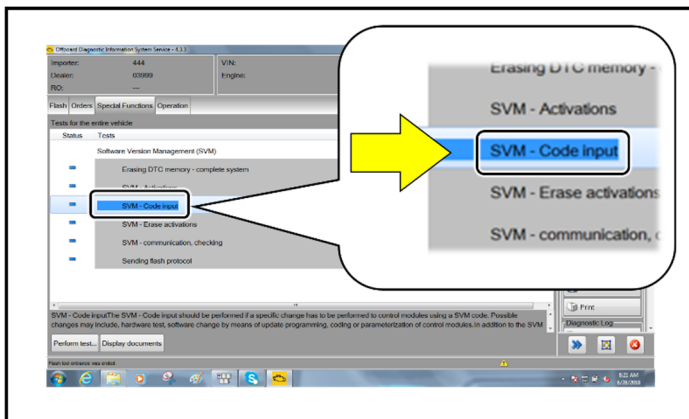
- Highlight “SVM – Code Input”.

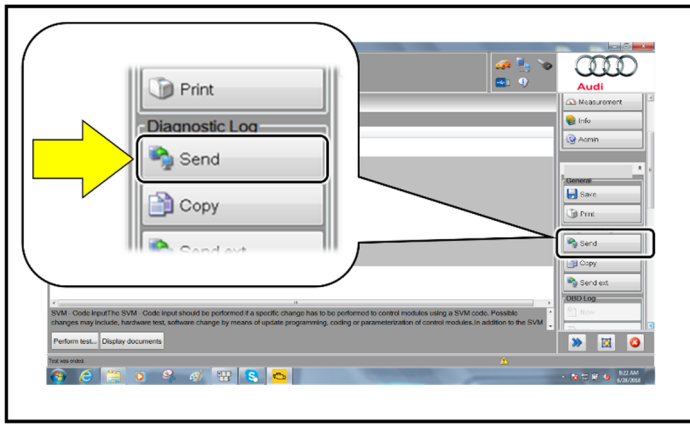
- After receiving confirmation that the flash completed successfully, select “Send” to send the diagnostic protocol online.
- Follow the on-screen prompts.

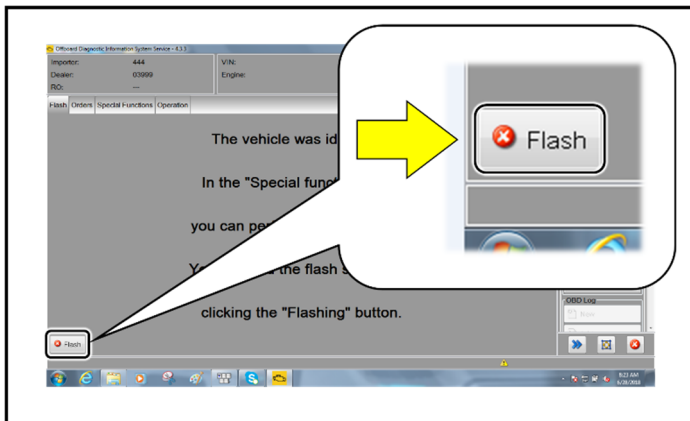
- Click “Flash” to exit the flash session.
