## Turbo Compound 2nd Generation - EGR And/Or DPF Diagnostic Trouble Codes (DTC), Diagnostic And Repair Information

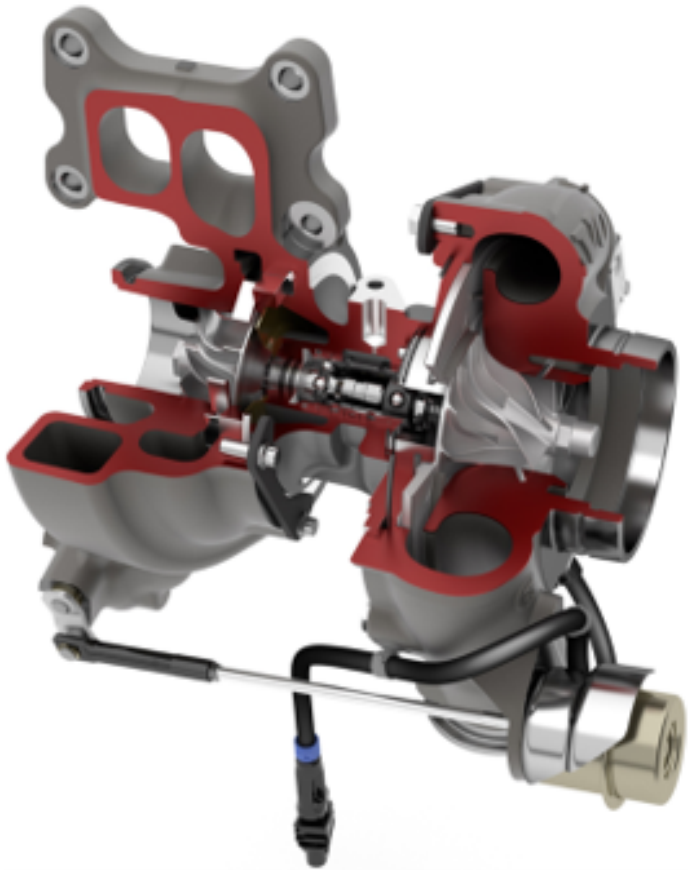
## Product Identification

Vehicles equipped with a 2nd Generation Turbo-compound unit will have a turbocharger equipped with a wastegate as seen below.

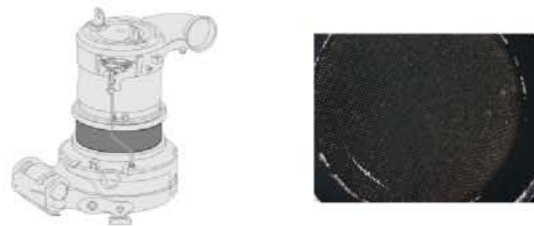
**A DPF 20 - 60 minute(s)**

**A - 2545-08-03-03 Diesel Particulate Filter Service Regeneration**

- This operation is used to perform a "service regeneration" of the diesel particulate filter (DPF)
- During engine operation, the DPF becomes loaded with soot. Regeneration of the DPF takes place during engine operation in order to remove the soot.
- If the soot level becomes greater than what can be removed by the normally-occurring regeneration process, service regeneration may be needed. Service regeneration may also be needed to prepare the filter for ash cleaning.

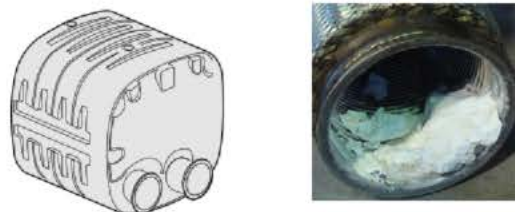
**B SCR 30 - 90 minute(s)**

**B - 2585-11-03-03 SCR, Diesel Exhaust Fluid, Crystal Sublimation**

- Under certain circumstances, the SCR catalyst may become loaded with DEF crystals. These deposits develop when the DEF is injected in cold duty cycles in which the SCR catalyst does not reach the proper temperature needed for chemical reaction. If the crystallization level becomes greater than that which can be removed by normal engine operation, manual regeneration may be needed.
- In this process the solid crystals are converted to a gaseous state. This conversion is performed by heating the SCR unit to a temperature that causes the conversion of the crystals to occur, thereby removing them from the system.
- Heating of the **SCR** catalyst is accomplished by heating of the diesel particulate filter (DPF), similar to the DPF regeneration except that the temperatures are higher and it can take longer time.

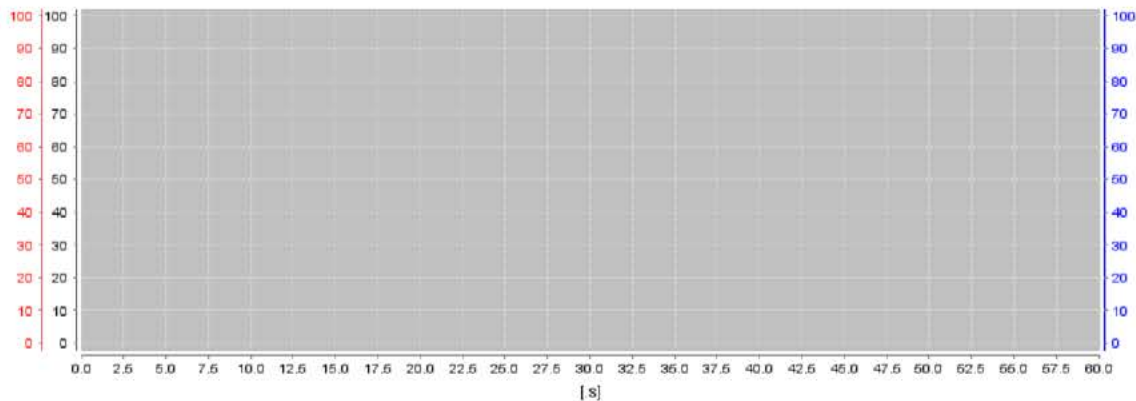
### Exhaust gas temperatures

T1 - EGT [°F]

T2 - EGT [°F]
