## Technical product information

| <b>Topic</b> | New Continental GTC - Boot open/close function inoperative |

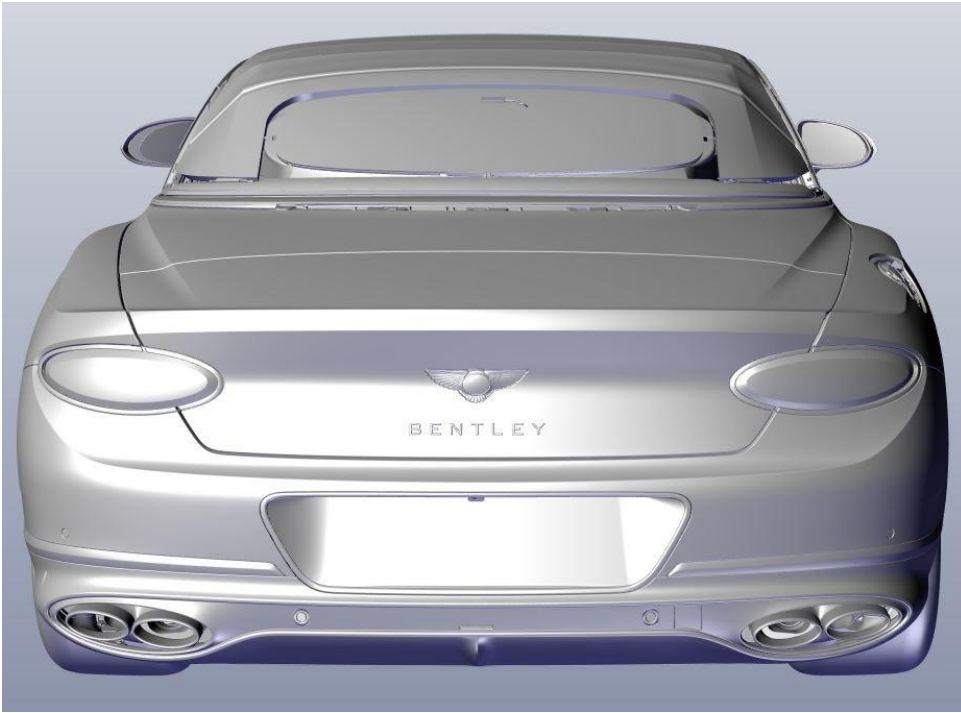
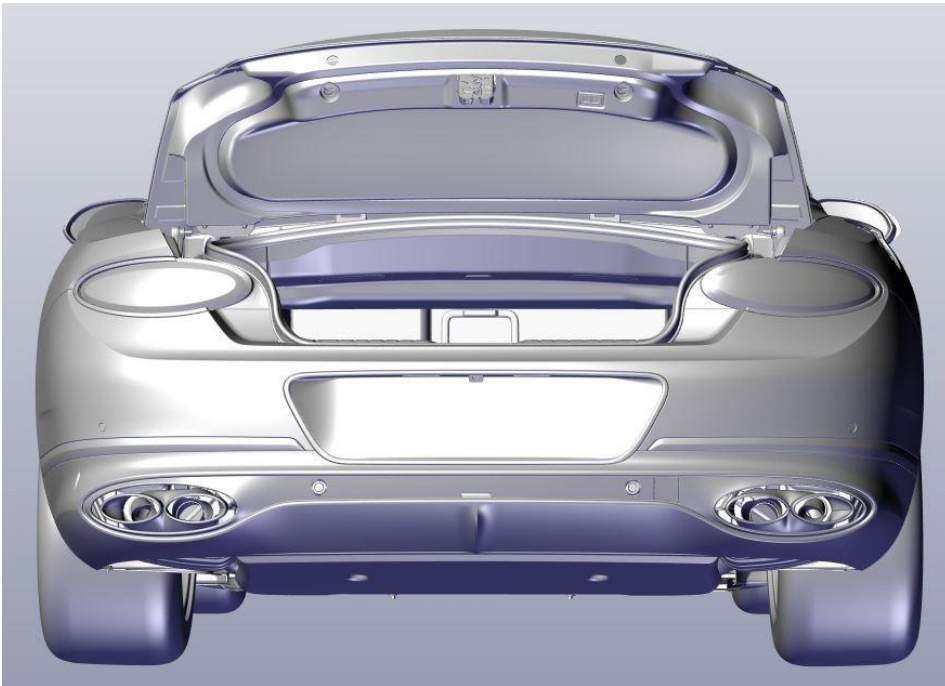
▪  
If any area of the visual inspection is NOK please highlight on the applicable images below
