Airstream Service Bulletin

Bulletin Number: #194

Product Line: Interstate 19 and Interstate 24

Subject: Exhaust Vent Firefly Software Update

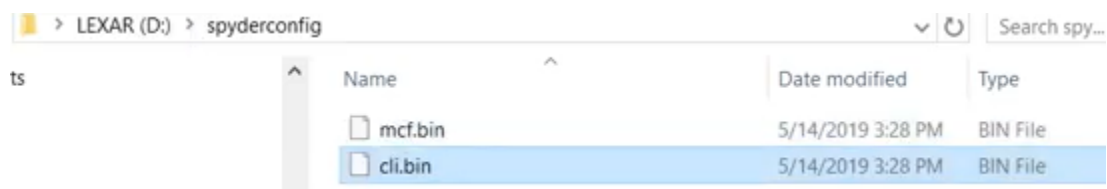
4. Copy the attached software files into the "SpyderConfig" folder (**cli.bin and mcf.bin – these files CANNOT be renamed**).

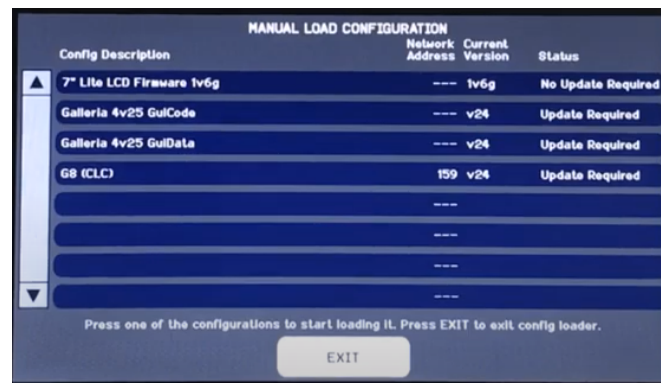
5. Plug the USB drive into the back of the screen.
6. Power cycle the screen. For a minimum of 10 seconds.
7. On the new screen page, select "Manual." There should be at least 4 entries under the "Config Description" header:
 - a. Firmware
 - b. GuiCode
 - c. GuiData
 - d. CLC Device i.e., G12 "7" screen shown below"

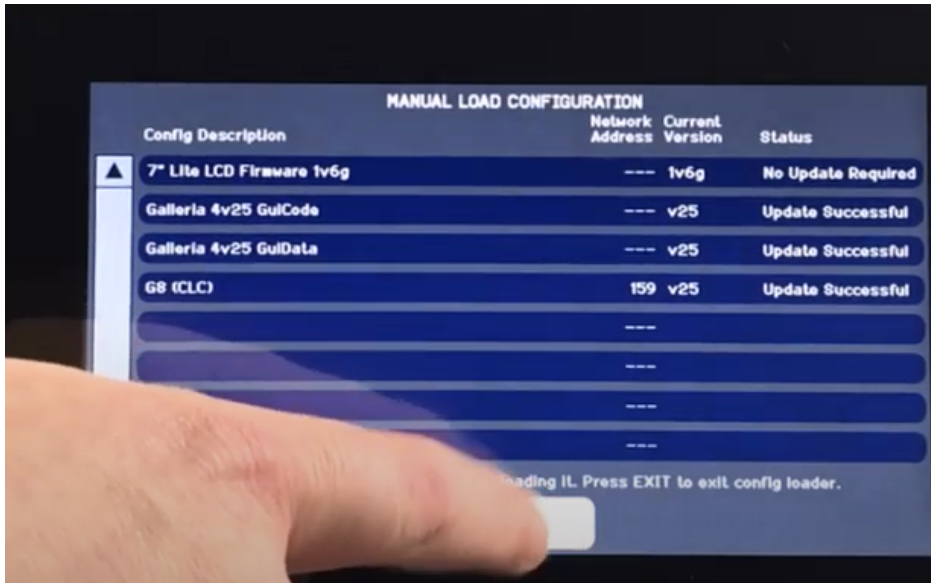
8. If you have at least 4 entries, press:
 - a. Firmware button first, even if it says “No Update Required.” Wait for status to say, “Update Successful.”
 - b. GuiCode button, even if it says “No Update Required.” This will also load the GuiData line, so wait for both files to finish.
 - c. Finally, press the CLC button, even if it says “No Update Required.”
9. Once everything is complete, and all entries say “Update Successful,” press Exit.

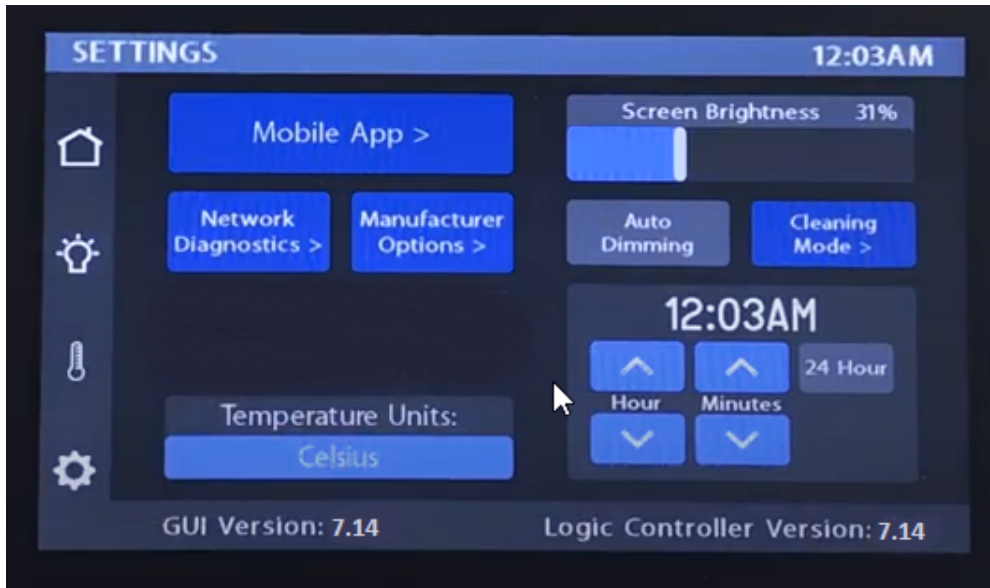
10. Remove the USB drive from the screen and put the screen back in its proper location.
11. Power cycle the coach with shore power disconnected and the 12v battery disconnect off, for 5 seconds.
12. After power is restored, press the Settings button (gear icon) on the screen to verify that the GUI and LC versions are correct (7.14).
