Technical Service Bulletin

| GROUP CAMPAIGN | NUMBER 22-01-084G-1 |
| DATE NOVEMBER, 2022 | MODEL(S) G90 (RS4) |

SUBJECT: G90 POWER SEAT MODULE (DPSM/PSM) & ASSIST POWER SEAT MODULE (APSM) SOFTWARE UPDATE (SERVICE CAMPAIGN T28G)

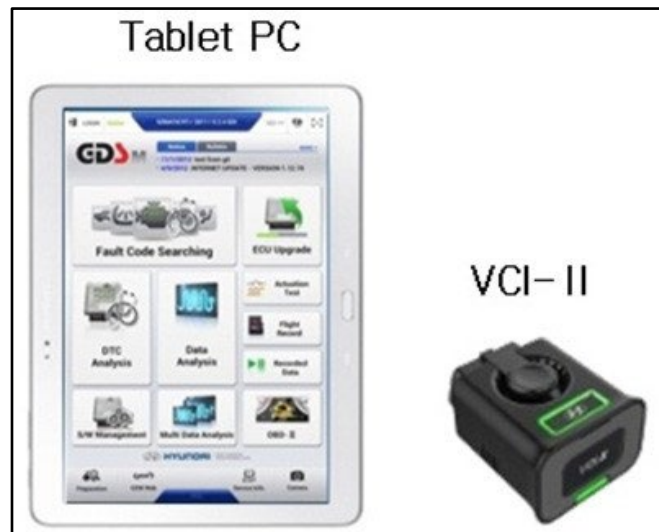
ECU upgrade function on GDS-Mobile is basically operating in wireless communication and Wi-Fi direct. Also, it is possible to be performing via USB cable between Tablet PC and VCI-II.

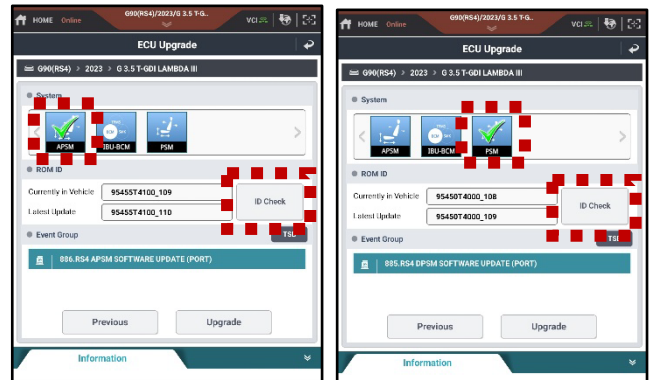
3. Select the applicable systems (**APSM** and **PSM**) and select **ID check** to check the vehicle's current ROM ID.

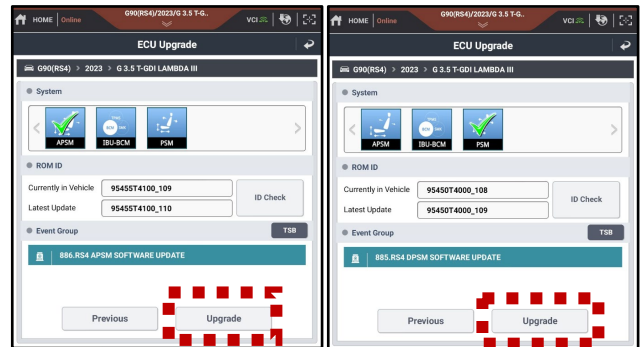
4. Select **Upgrade** after confirming correct Event is selected:

"885.RS4 DPSM SOFTWARE UPDATE"
 "886.RS4 APSM SOFTWARE UPDATE"

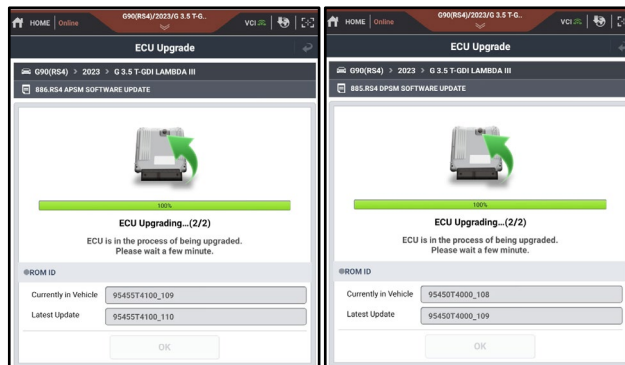
7. Upgrade (2/2) will begin, and the progress of the upgrade will appear in the bar graph.

Upgrade (2/2) will occur until 100% is reached on the bar graph.

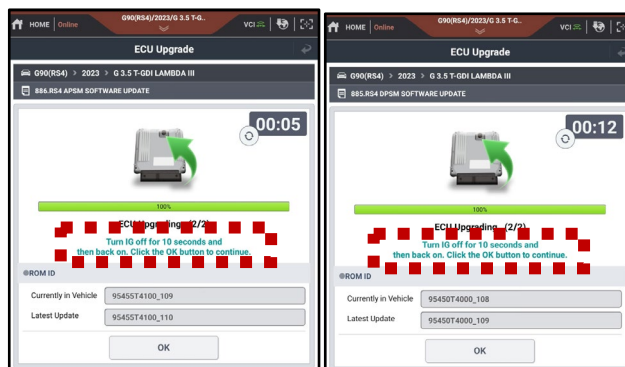
8. When upgrade reaches 100%, follow GDS instructions to “Turn IG off for 10 seconds and then back on. Click the **OK** button to continue.”

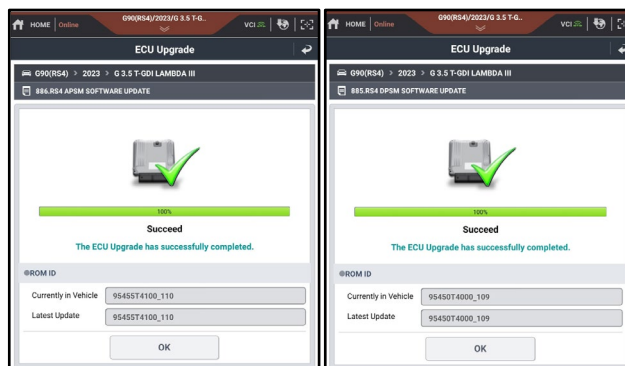
9. Click **OK** on the final screen, which indicates upgrade is complete.

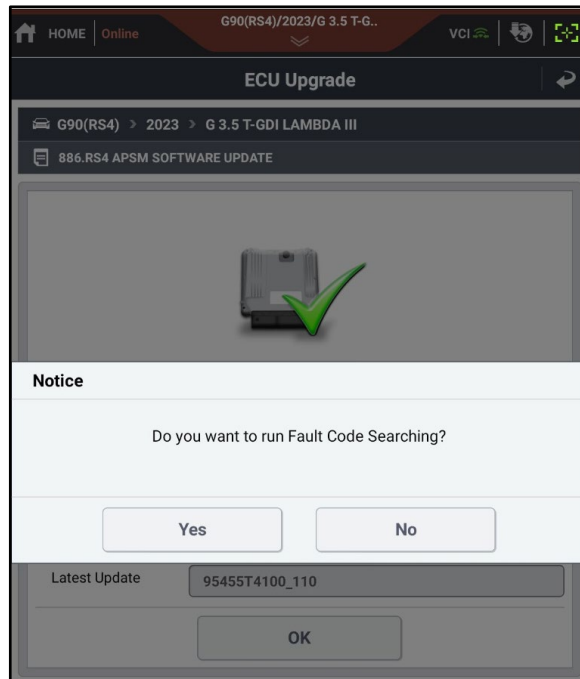
11. Check if any incidental Diagnostic Trouble Codes (DTC) or check engine lights have been created by the update and clear the DTC(s) present.

Start the engine to confirm proper operation of the vehicle.

Confirm proper functionality of driver and passenger seats (seat recline, seat slide forward and backward, seat tilt, and seat height up and down).

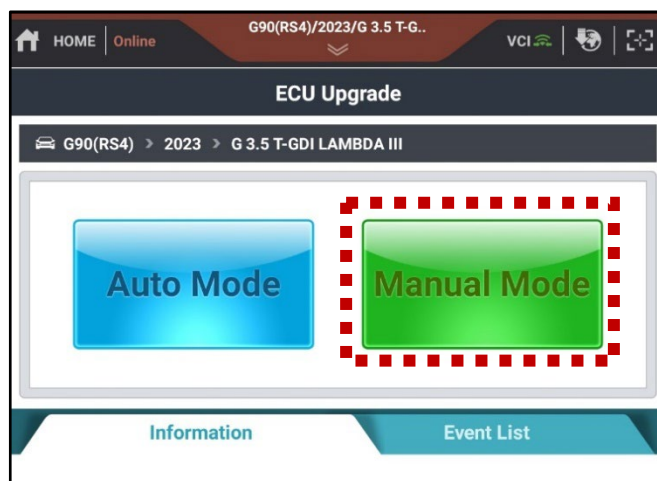
12. Select ECU Upgrade on the initial screen after entering the vehicle information and select Manual Mode.

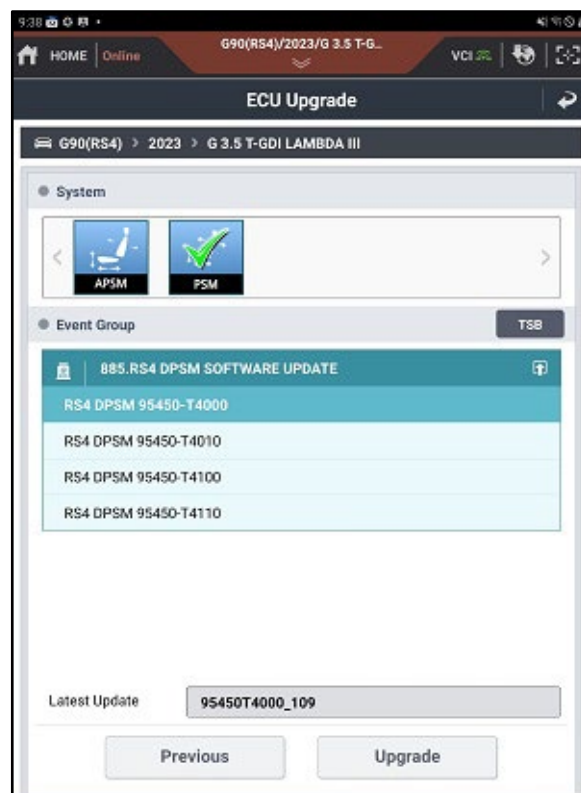
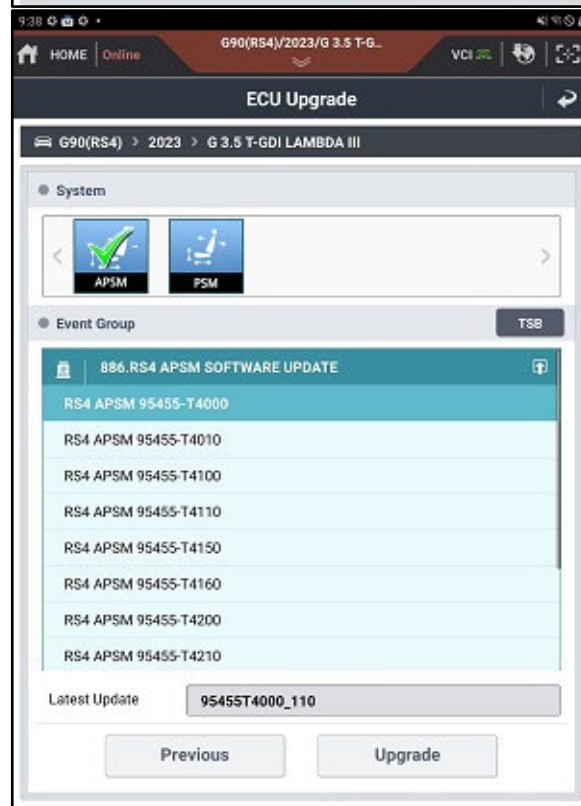
13. Select the module and the part number with reference to the above ROM ID Information Table and tab Upgrade.

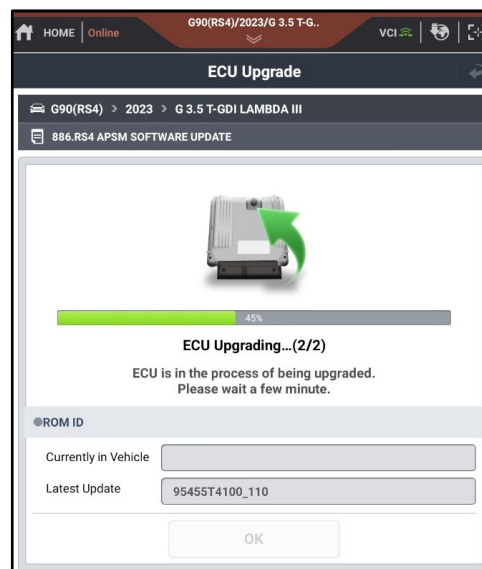
17. Upgrade (2/2) will begin, and the progress of the upgrade will appear in the bar graph.

Upgrade (2/2) will occur until 100% is reached on the bar graph.

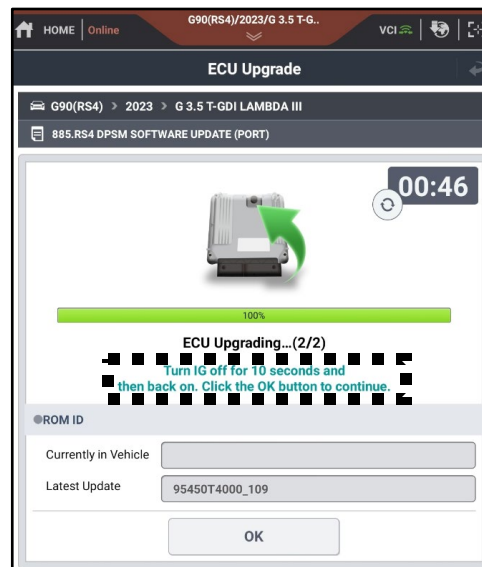
18. When upgrade reaches 100%, follow GDS instructions to “Turn IG off for 10 seconds and then back on. Click the OK button to continue.”

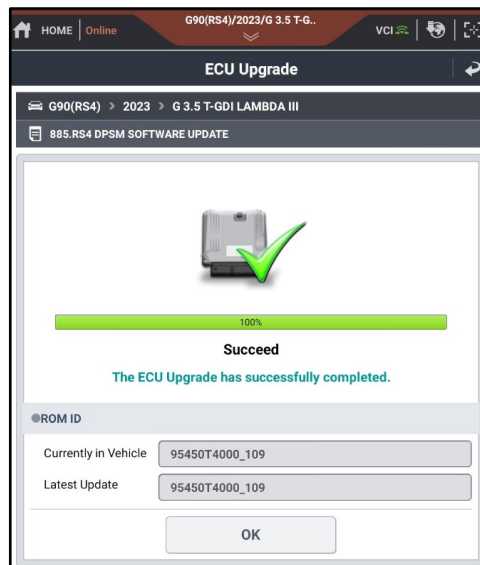
19. Click OK on the final screen, which indicates upgrade is complete.

Check the ICU ROM ID and compare it to the ROM ID Information Table to confirm latest ROM ID was updated.

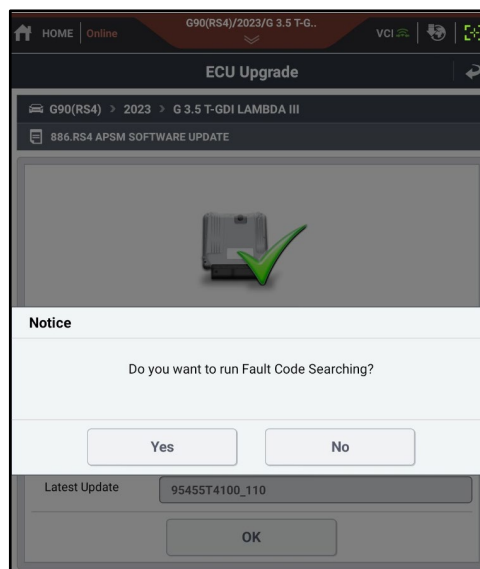
20. Check if any incidental Diagnostic Trouble Codes (DTC) or check engine lights have been created by the update and clear the DTC(s) present.

Start the engine to confirm proper operation of the vehicle.

Confirm proper functionality of driver and passenger seats (seat recline, seat slide forward and backward, seat tilt, and seat height up and down).
