GROUP	MODEL
FUE	2022-2023MY Carnival (KA4)
NUMBER	DATE
062	December 2022

SUBJECT: **SERVICE ACTION: ECM LOGIC UPDATE FOR DTC P2118  
AND THROTTLE BODY FREEZING (SA514)**

This bulletin provides the procedure to update the software logic of the Engine Control Module (ECM) system on some 2022-2023MY Carnival (KA4) vehicles produced from January 4, 2021 through October 26, 2022, which may exhibit an MIL "ON" with DTC P2118. The throttle body plate may freeze after a cold soak in very cold temperatures, possibly causing the vehicle to go into "limp-home" mode. Once the vehicle is warmed up, the throttle body performs normally. Follow the procedure outlined in this publication to apply the improved logic to the 'Engine' system using the KDS ECU Upgrade function as described in this bulletin. For confirmation that the latest reflash has been applied to a vehicle you are working on, verify the ROM ID using the table on pages 3-4 of this bulletin. Before conducting the procedure, verify that the vehicle is included in the list of affected VINs.

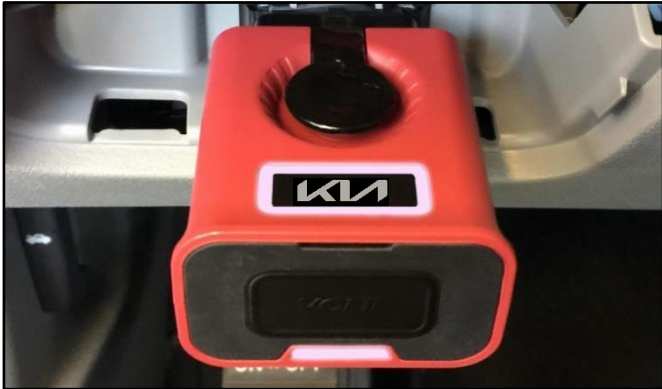
1. Connect the VCI-II to the OBD-II connector, located under the driver's side of the instrument panel.

**NOTICE**  
The ECU upgrade function on KDS operates wirelessly. It is not necessary to perform the upgrade via USB cable.

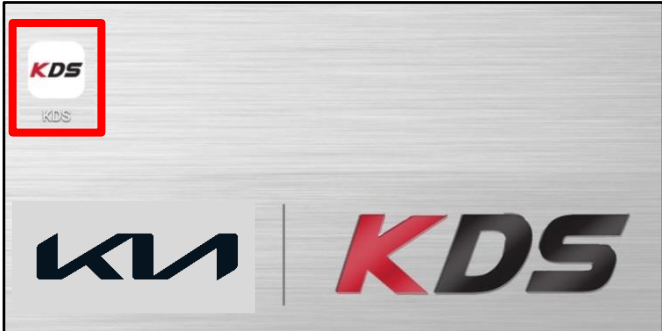
2. With the ignition ON, turn ON the KDS tablet. Select 'KDS' from the home screen.

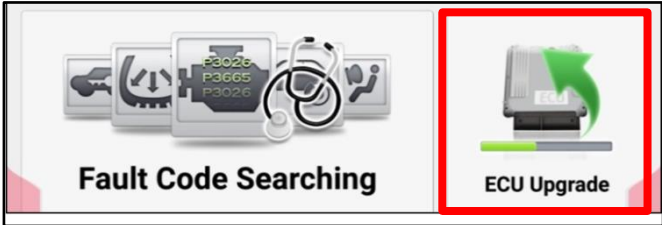
4. Select 'ECU Upgrade'.

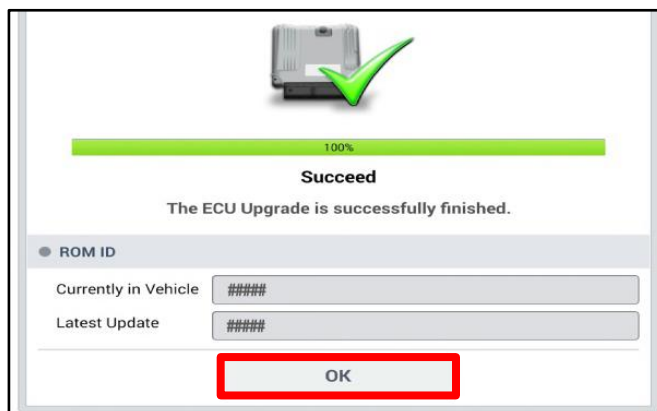
11. Once the upgrade is complete, select 'OK' to finalize the procedure.

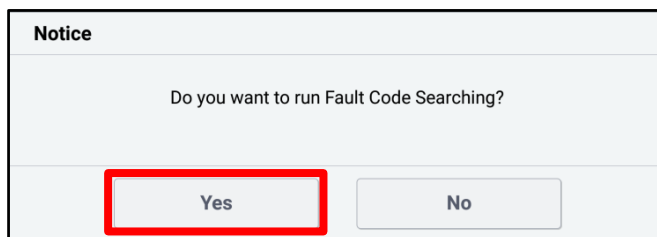
12. When prompted, select 'YES' to check for Diagnostic Trouble Codes (DTC) and erase any DTCs stored such as EPS, ESC, and TPMS that may have been set during the upgrade.
