**NUMBER:** 08-062-22 REV. A

**GROUP:** 08 - Electrical

UPD UFD UBD UED UBC UEC Radio Enhancements

This bulletin involves inspecting the software level and updating the software if needed. The software will be updated to 141.01.12.00.

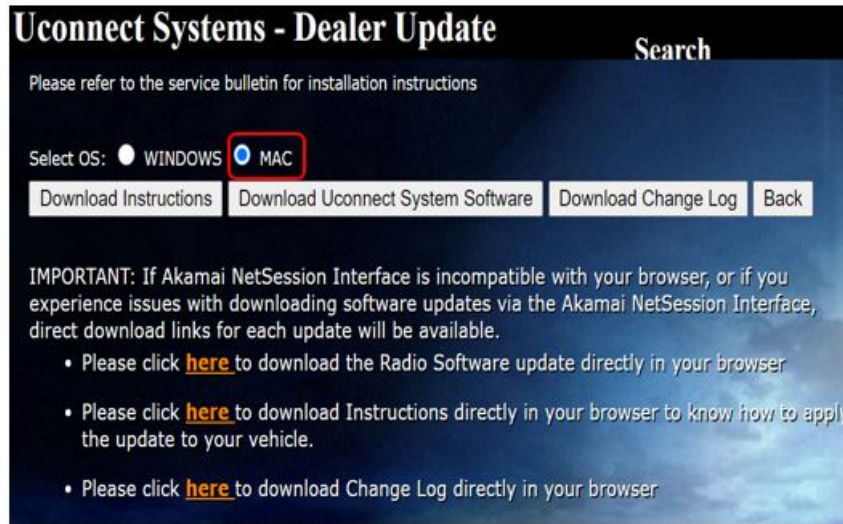
5. Use a blank USB flash drive with at least 4 GB of space. Follow the on-screen instructions to download the software files.
6. Download the software update file to your local PC's desktop. Make sure to select the "MAC" radial button for all downloads (Fig. 3) .

Fig. 3  
MAC Download Steps

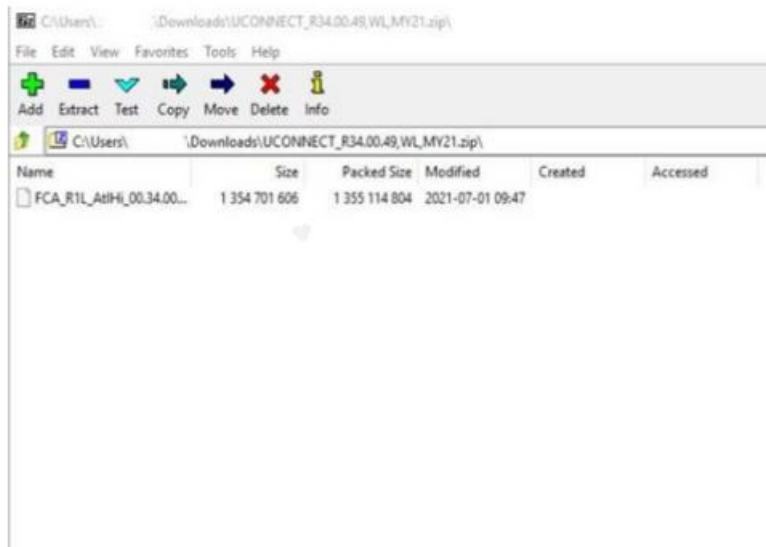
7. Be sure to download the file to your designated folder before extracting the zip file to the blank USB flash drive (Fig. 4) .

Fig. 4  
Zip File

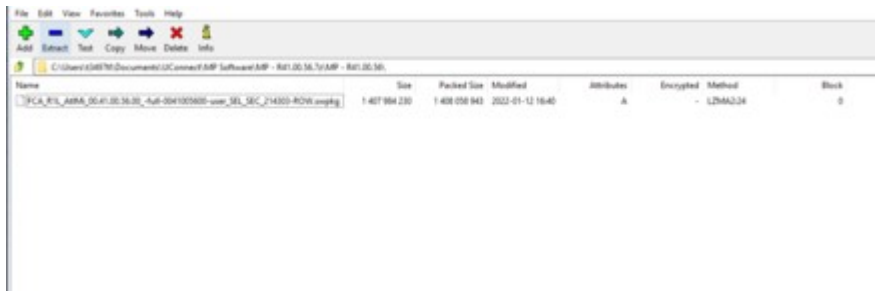
- 8. Unzip the file to the root folder of USB flash drive. File should not be within a zip folder. Your USB file should look like when you open it. Unzip the file to the root folder of USB flash drive. File should not be within a zip folder. Your USB file should be look like when you open it (Fig. 5) .

**Fig. 5**  
**Extract File To USB**

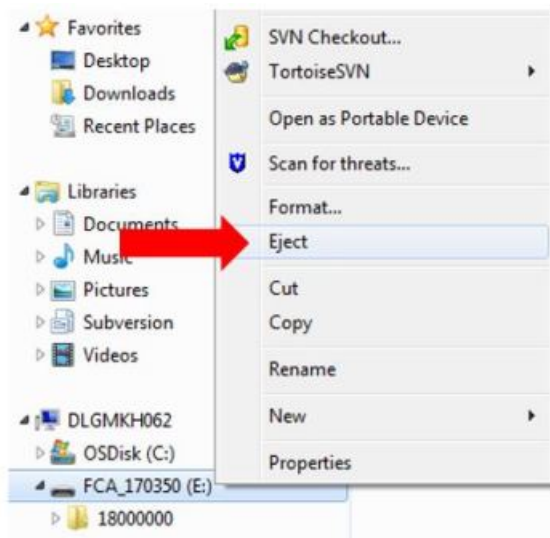
- 10. Perform the following steps to properly eject the USB flash drive (Fig. 6) :
  - a. Right click on the location of the USB flash drive.
  - b. Click “Eject” to avoid data corruption.
  - c. Remove the USB flash drive from the PC.

**Fig. 6**  
**Ejecting The USB Flash Drive**

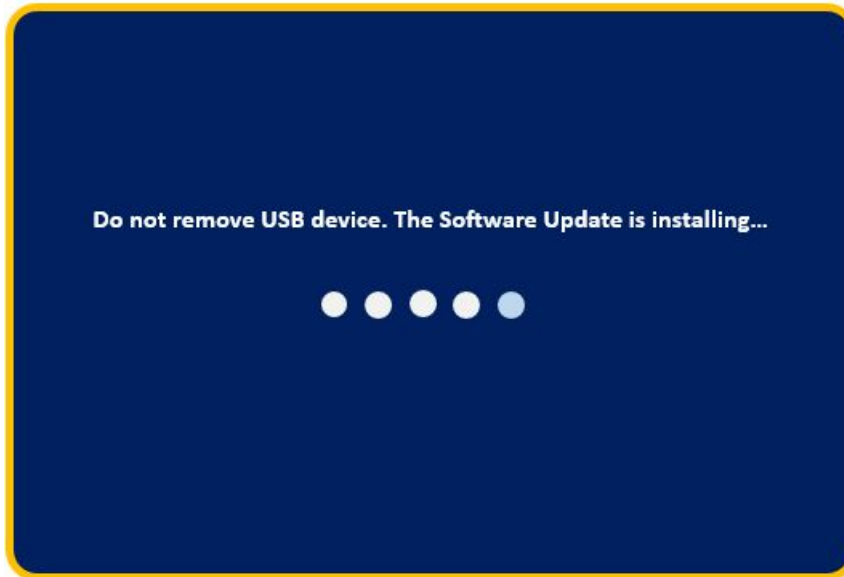
19. Select "Continue" (Fig. 10) .

Fig. 10  
Installing Update Screen

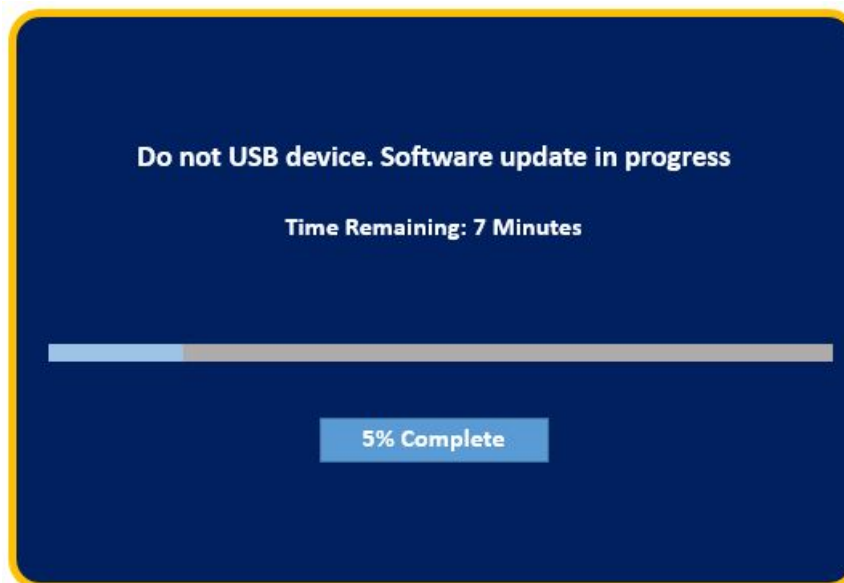
20. The update will take approximately 15-20 minutes (Fig. 11) .

Fig. 11  
Update In Progress Screen

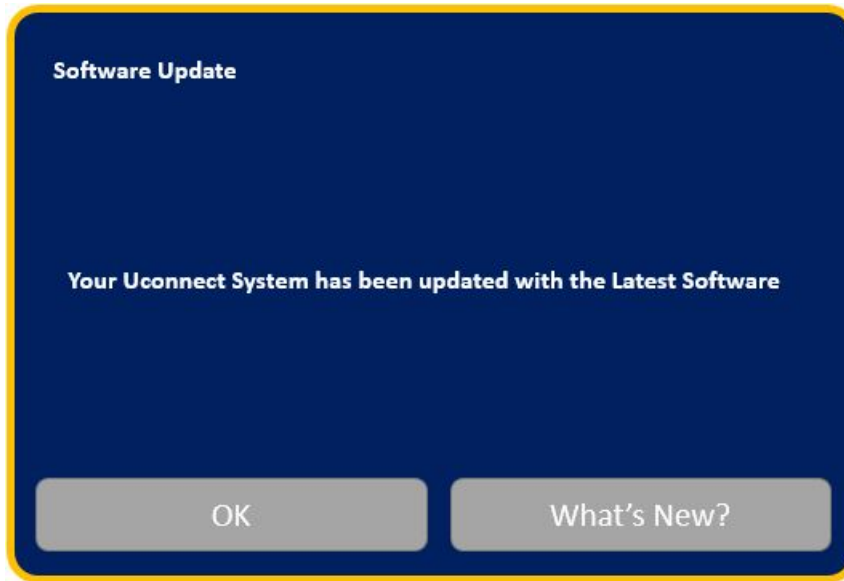
21. The radio will reboot and you will observe the update screen after the splash screen once the update has been successful (Fig. 12) .

**Fig. 12**  
**Software Updated Screen**
