**TECHNICAL INSTRUCTIONS
FOR
SPECIAL SERVICE CAMPAIGN 22LC03
SOFTWARE UPDATE FOR A GEAR SHIFT CONTROL MODULE
CERTAIN 2022 NX 350 AND NX 250 VEHICLES**

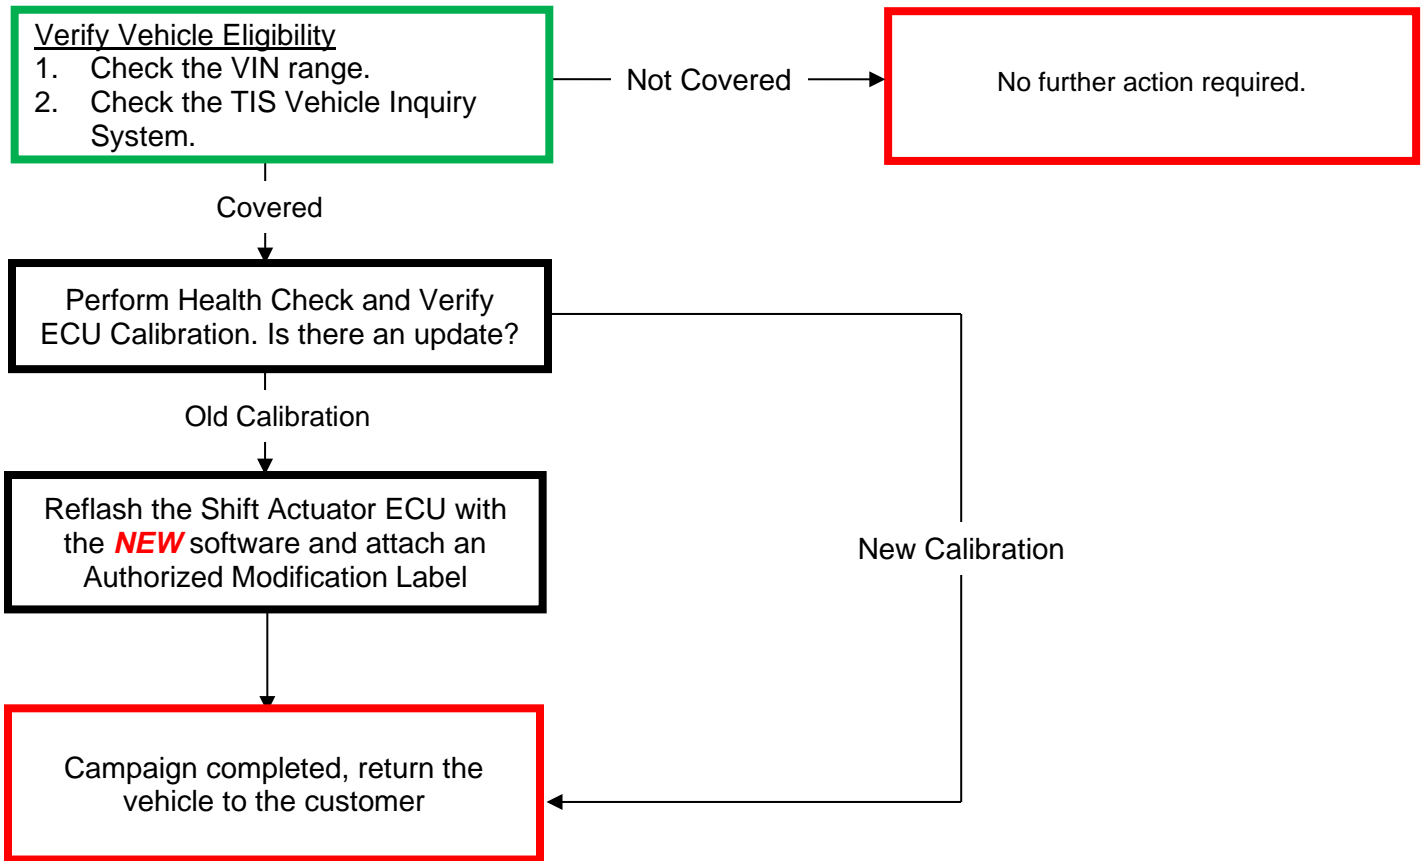
I. OPERATION FLOW CHART

The flow chart is for reference only. DO NOT use it in place of the full technical instructions. Follow ALL steps as outlined in the full technical instructions to confirm the campaign is completed correctly.

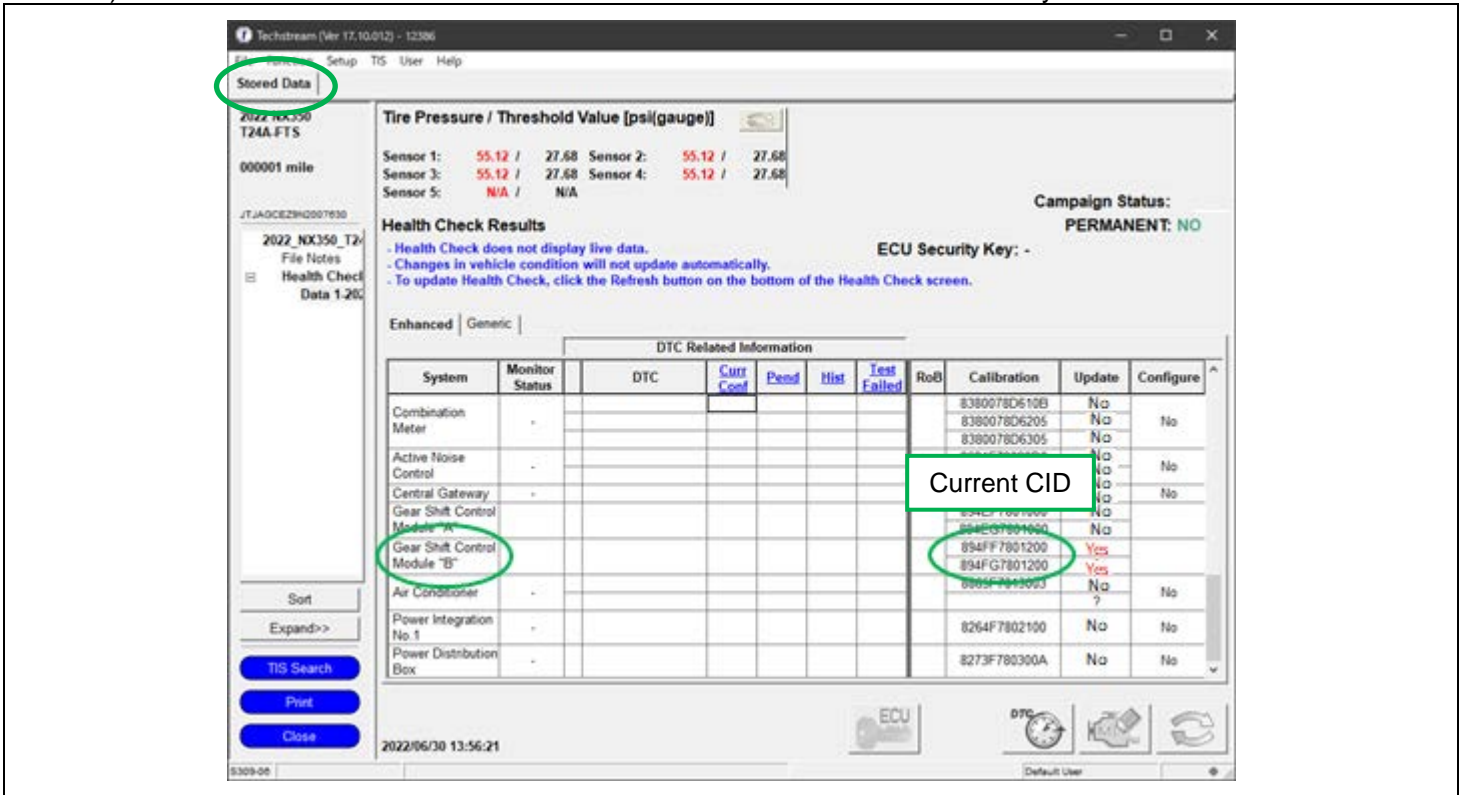
a) Confirm the current calibration ID in the Gear Shift Control Module “B” System.

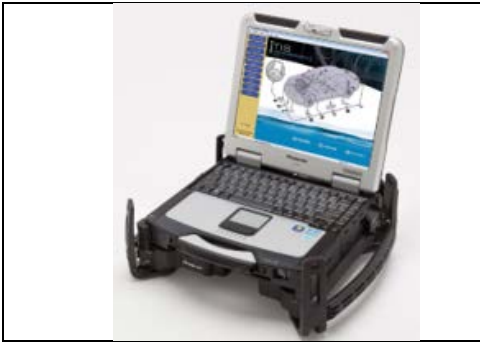
THIS VERIFICATION HEALTH CHECK IS NECESSARY to update the results and CID's to the National database.

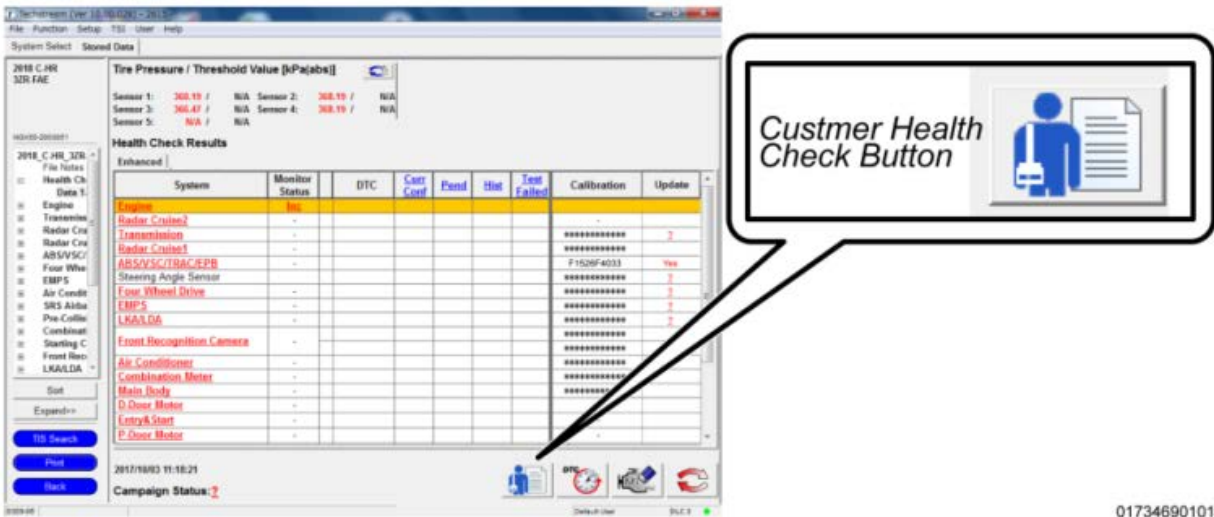
- a) From the Stored Data tab, select the Customer Health Check Report button (TIS will launch when button is pressed).

The screenshot shows the TIS software interface with the 'Health Check Results' table. The table has columns for System, Monitor Status, DTC, Cost, Pendl, Hist, Test Failed, Calibration, and Update. A callout box labeled 'Customer Health Check Button' points to a button icon in the bottom right corner of the interface.

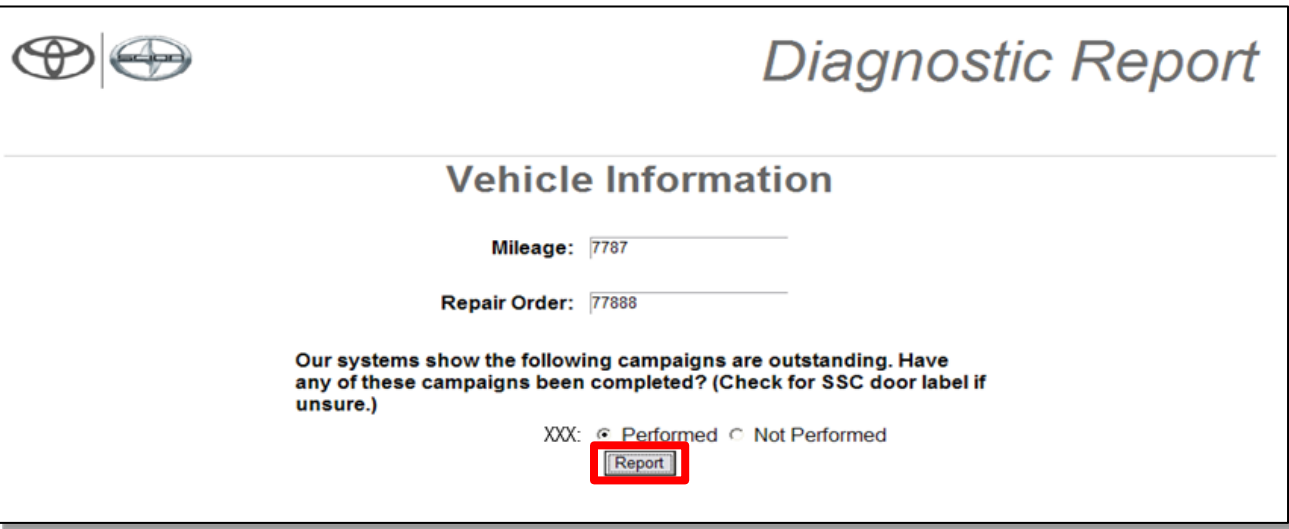
- b) Log in to TIS.
- c) Input Vehicle Mileage and Repair Order number.
- d) Check the "Performed" campaign button for the applicable campaigns.
- e) Select the Report button.

The screenshot shows the 'Diagnostic Report' form. It includes the Toyota and Lexus logos, the title 'Diagnostic Report', and a section for 'Vehicle Information' with fields for Mileage (7787) and Repair Order (77888). Below this, there is a section for outstanding campaigns with a 'Report' button highlighted in red.

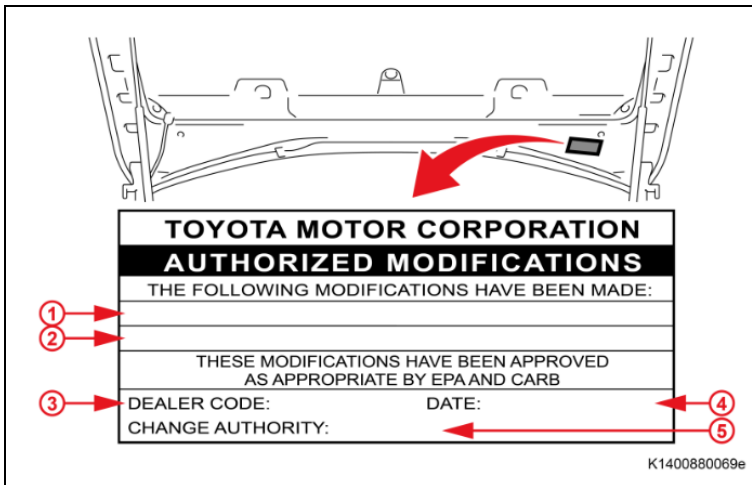
- a. Fill out the label.
- b. Affix the label to the under-side of the hood.

1	Repair ECU P/N
2	Calibration ID
3	Dealer Code
4	Date Completed
5	Campaign Code (22LC03)
