SPECIAL SERVICE CAMPAIGN 22TC11

SOFTWARE UPDATE – DC COLD WEATHER CHARGING

CERTAIN 2023 MODEL YEAR bZ4X

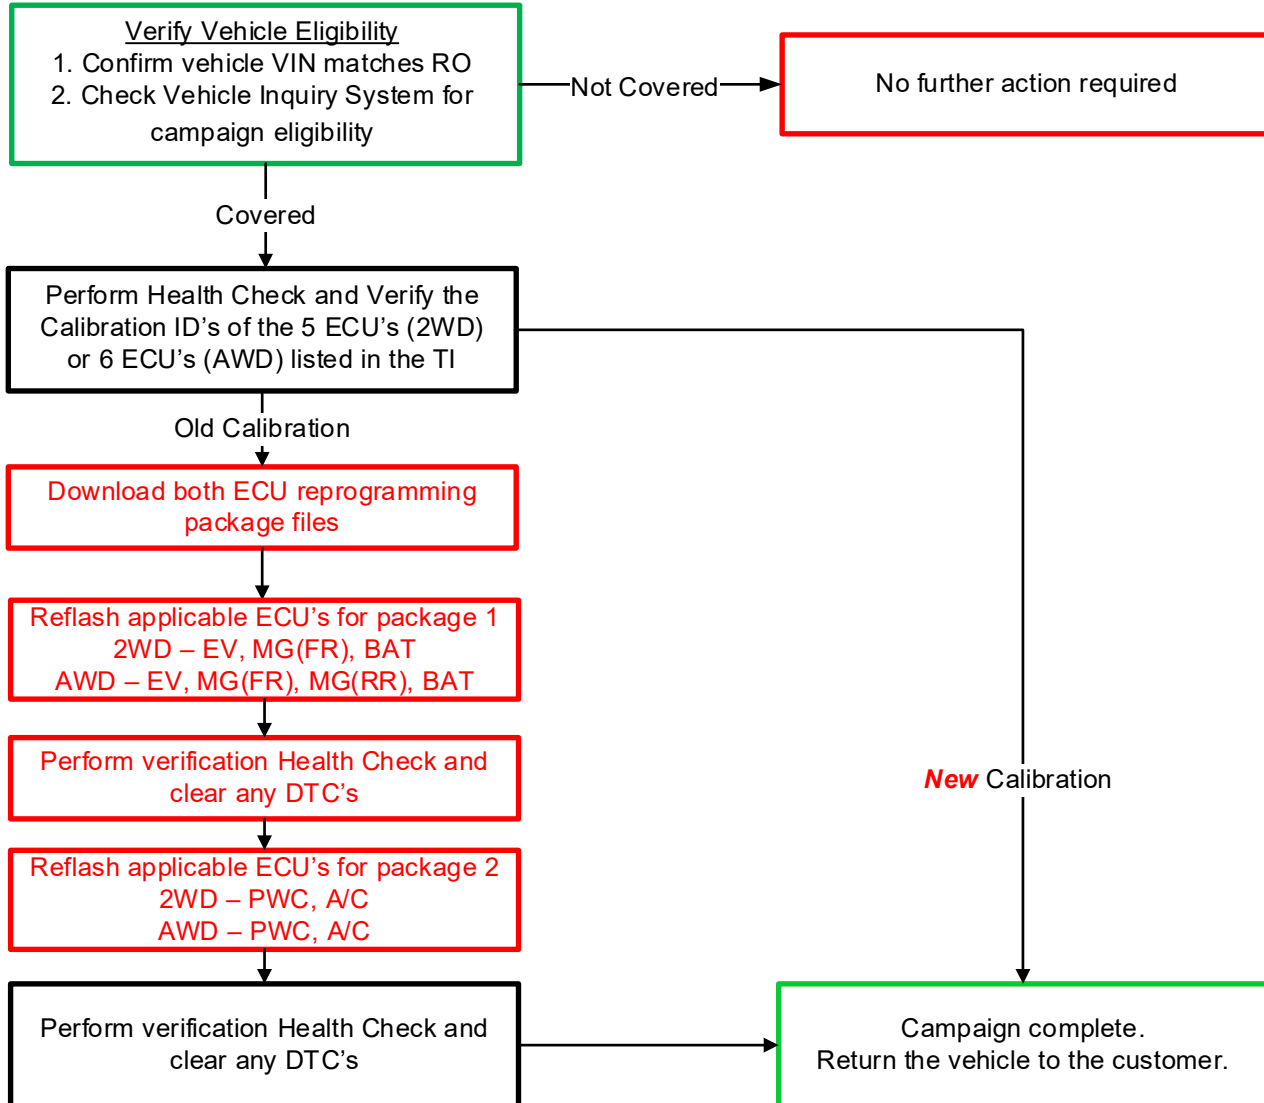
I. OPERATION FLOW CHART

The flow chart is for reference only. **DO NOT** use it in place of the full technical instructions. Follow **ALL** steps as outlined in the full technical instructions to confirm the campaign is completed correctly.

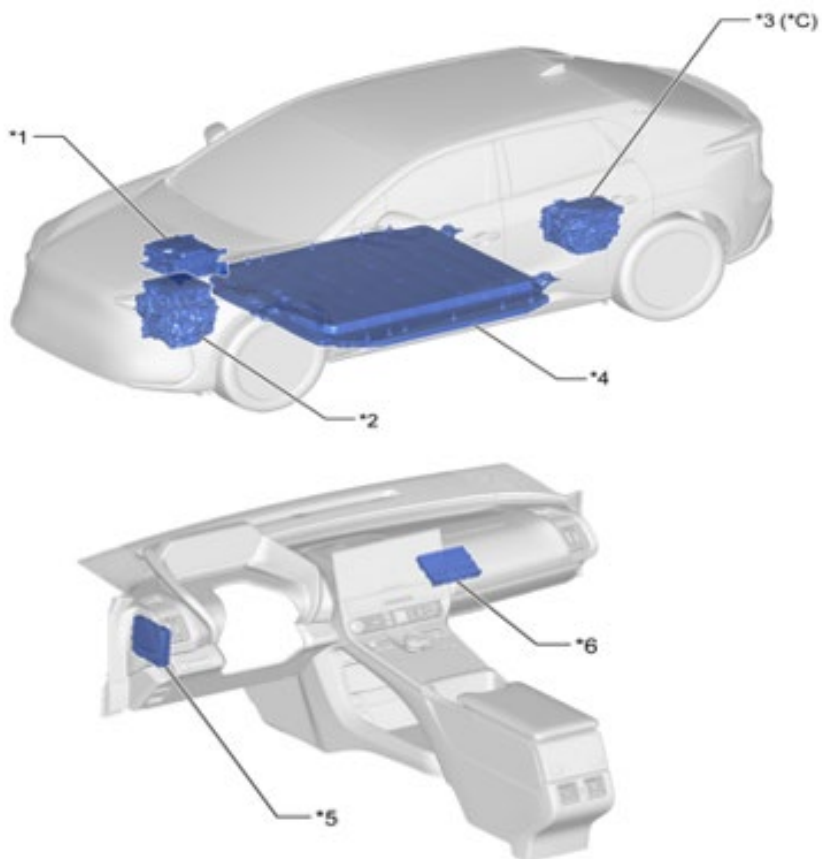
The software update will require reprogramming each of the following ECUs using Techstream: EV, MG, BAT, PWC and A/C.

*C	for AWD	-	-
*1	PWC ECU (ELECTRIC CONVERTER UNIT ASSEMBLY)	*2	MG ECU (FR E-AXLE ASSEMBLY)
*3	MG ECU (RR E-AXLE ASSEMBLY)	*4	BAT ECU (EV SUPPLY BATTERY ASSEMBLY)
*5	EV ECU (EV CONTROL ECU)	*6	A/C ECU (AIR CONDITIONING AMPLIFIER ASSEMBLY)

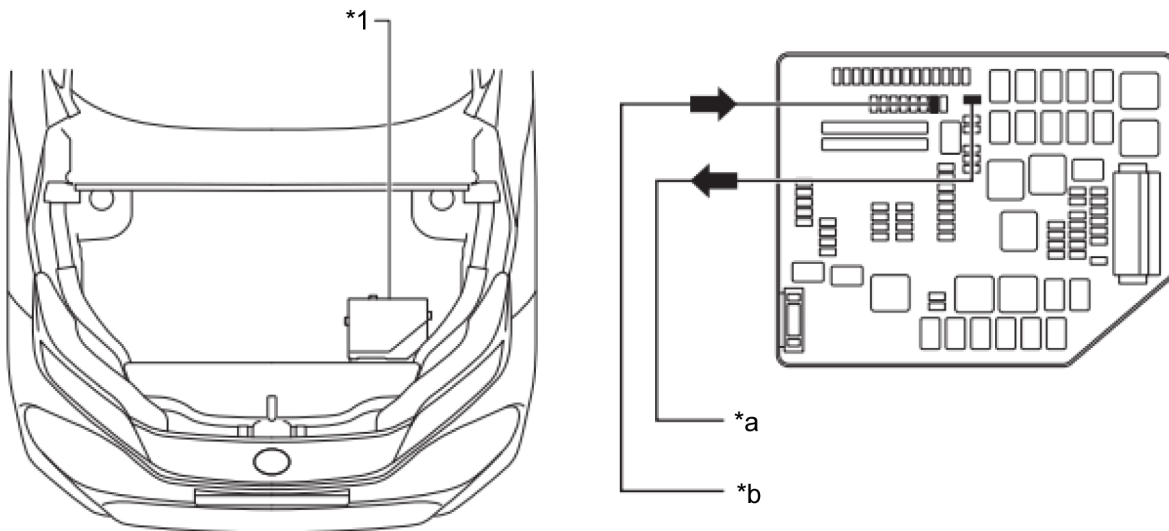
S220600307029aS

- a) In order to perform ECU reprogramming the cut fuse must be in location *b. If Pre-Delivery Service (PDS) was not performed on the vehicle, please remove cut fuse from location *a and install into location *b.

*1	Relay Block	-	-
*a	Remove D/C CUT FUSE (30A)	*b	Install D/C CUT FUSE (30A) (Original Location)

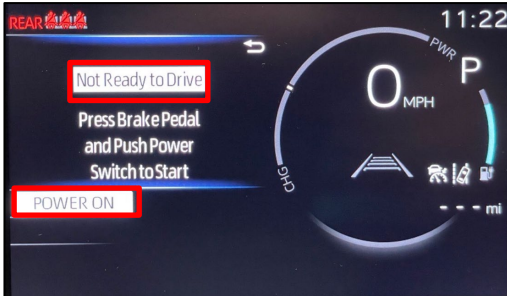
1. PLACE VEHICLE IN “POWER ON”, “READY OFF”

- a) Press the power button until “POWER ON” and “Not Ready to Drive” is displayed on the dash

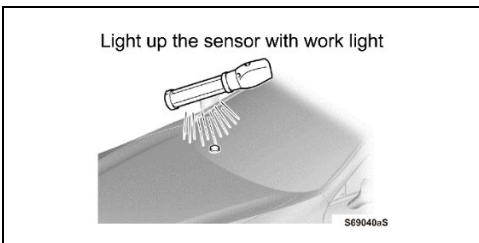
2. CONFIRM ALL ELECTRICAL LOADS ARE OFF

- Vehicle in the IG position (READY OFF).
- Transaxle in Park.
- Parking brake engaged.
- Turn off all electrical accessories (i.e. climate control, audio system, etc.)
- Headlight switch in the DRL OFF position. (w/ DRL OFF position)
- Windshield wiper switch in the OFF position.

- a) When the vehicle has no “OFF position” in the light control switch:
 - 1) Turn the IG ON.
 - 2) Set the light control switch to the AUTO position and make sure that the exterior lights are turned on.
 - 3) Light up the automatic light control sensor with work light to keep the exterior lights turned off.

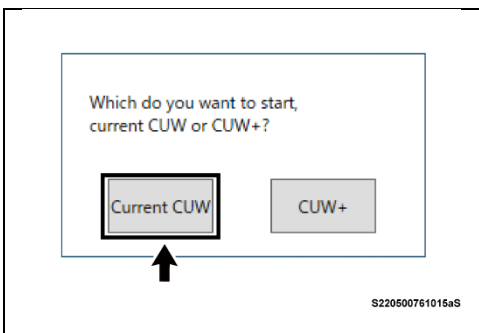
1. DOUBLE-CLICK THE DOWNLOADED PROGRAM PACKAGE

- a) Start reprogramming with package 1
- b) When all reprogramming steps are completed for package 1 you will restart the process with package 2

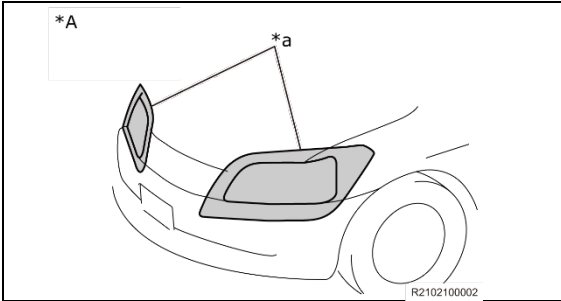
15. DUE TO COMMUNICATION BETWEEN ECUs BEING LOST DURING REPROGRAMMING THE HEADLIGHTS MAY TURN ON AS A FAIL-SAFE.

- a) **Do not** cover the headlights
- b) If the headlights turn on they cannot be turned off

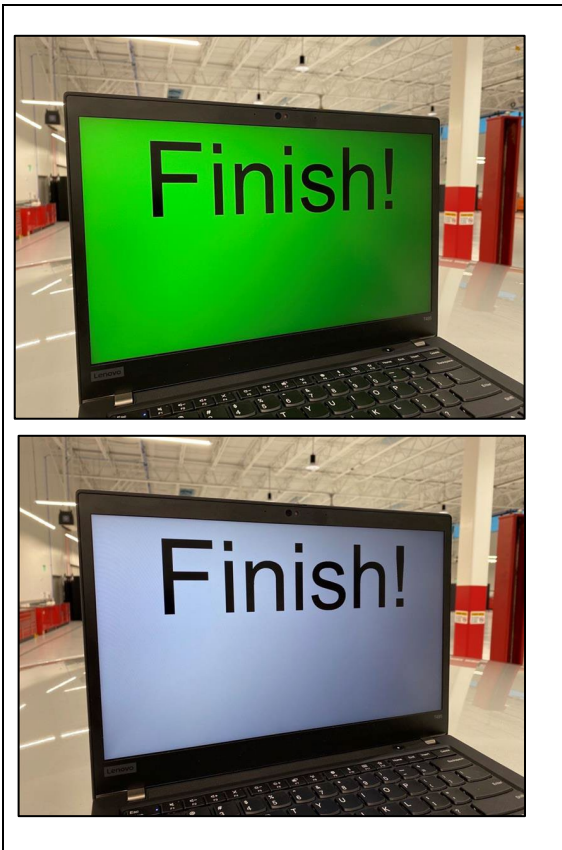
17. CALIBRATION UPDAED

- a) The following Screens will appear at the end of each reflash.
- b) Press a key or operate the mouse to close the window.

18. REPEAT PROGRAMMING STEPS FOR EACH CAL ID IN THE PROGRAM PACKAGE

- a) The IG OFF and ON operation and the security signature verification need to be conducted whenever the Calibration process finishes. Follow the instructions shown on the screen.

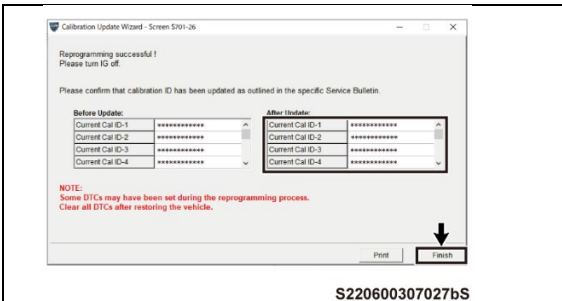
19. AFTER REPROGRAMMING, MAKE SURE THAT THE “CURRENT CAL ID” IS CORRECT

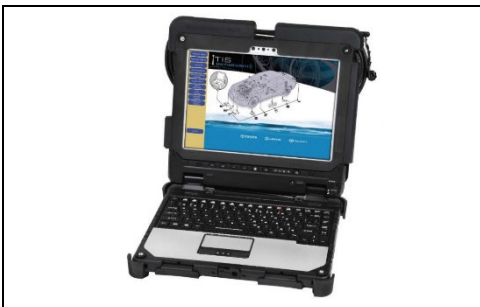
1. PERFORM VERIFICATION HEALTH CHECK

- a) Using a Techstream, perform a Health Check.
- b) Clear DTC's that may have set during the re-flash procedure.
- c) Re-run the Health Check to confirm that no DTC's reappear.

Critical THIS VERIFICATION HEALTH CHECK IS NECESSARY to update the results and CID's to the National database.

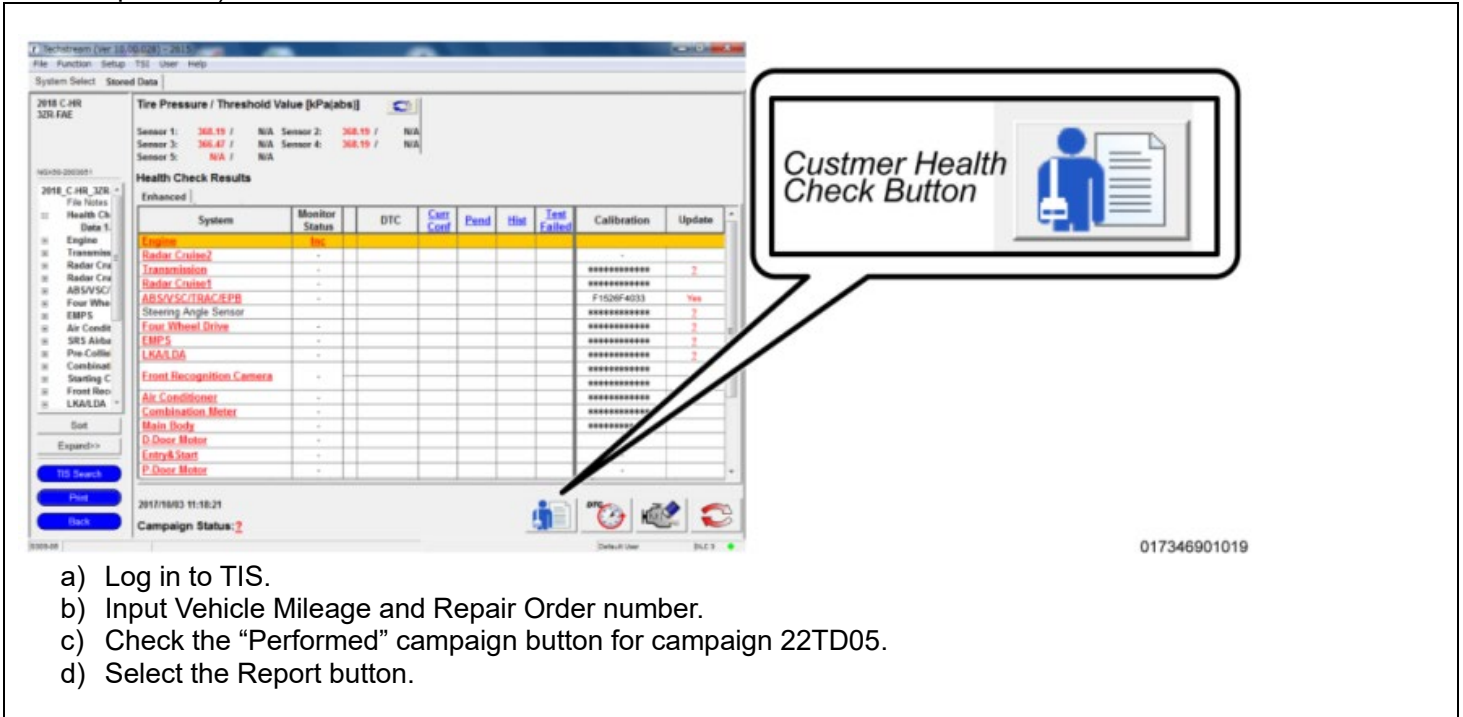
The screenshot shows the TIS software interface with the 'Health Check Results' table. The table has columns for System, Monitor Status, DTC, Calc Conf, Pend, Hist, Test Failed, Calibration, and Update. A callout box labeled 'Customer Health Check Button' points to the 'Report' button in the bottom right corner of the interface.

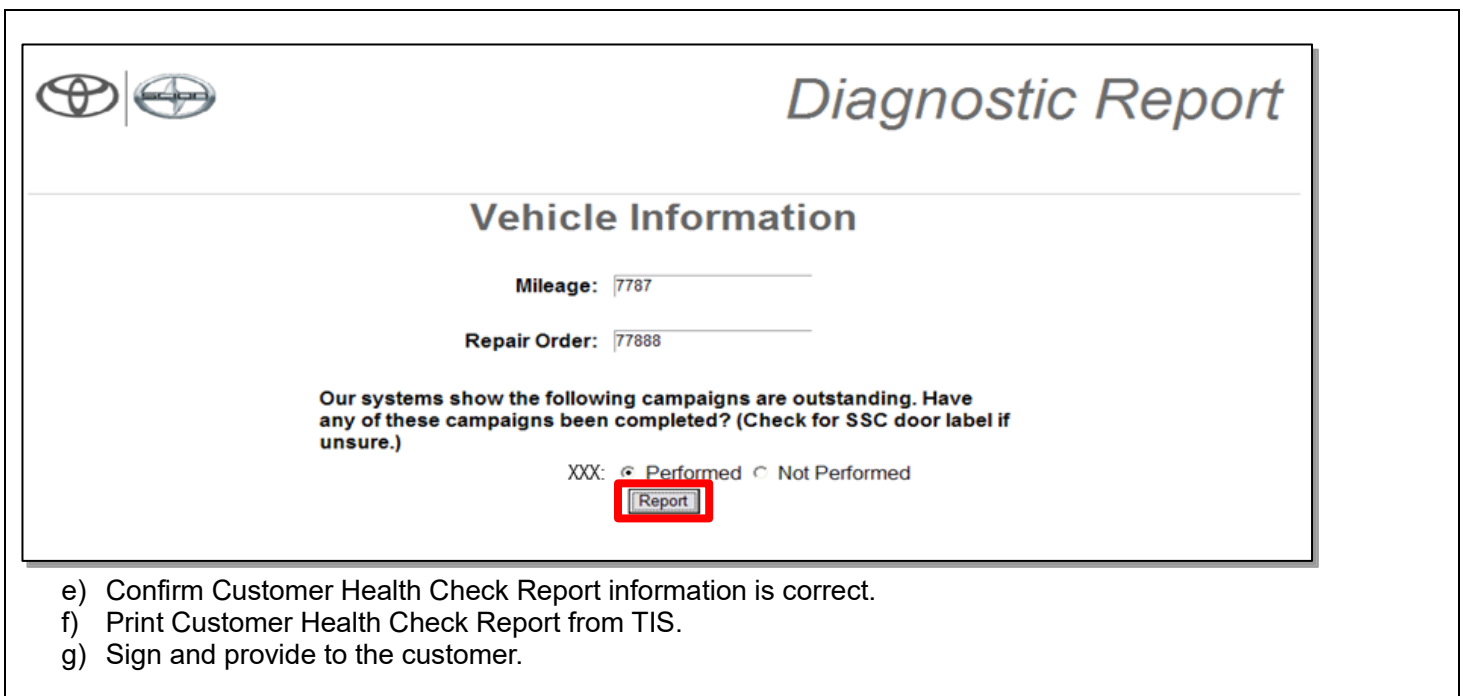
The screenshot shows the 'Diagnostic Report' form. The form has a header with the Toyota and Lexus logos and the title 'Diagnostic Report'. Below the header is the 'Vehicle Information' section, which includes fields for Mileage (7787) and Repair Order (77888). A message states: 'Our systems show the following campaigns are outstanding. Have any of these campaigns been completed? (Check for SSC door label if unsure.)'. Below this message are radio buttons for 'Performed' (selected) and 'Not Performed'. A red box highlights the 'Report' button.
