Service Action Code: 97FY

Subject	Volkswagen ID.4 Update Package															
Release Date	December 17, 2022															
Revision Summary	Added instruction in Step 9 to check temperature unit settings before returning vehicle to customer															
Affected Vehicles	<p>Vehicles included in this service action are being released in preselected phases.</p> <ul style="list-style-type: none"> The first group will be released and visible in ELSA in December 2022. Customer notification for the first group will take place in December 2022 as well. Dealers will receive updates when future groups/waves are released and customer notifications are scheduled. As always, dealers should ensure the service action shows OPEN in ELSA on the day of repair before performing any work under this service action.

Repair Overview

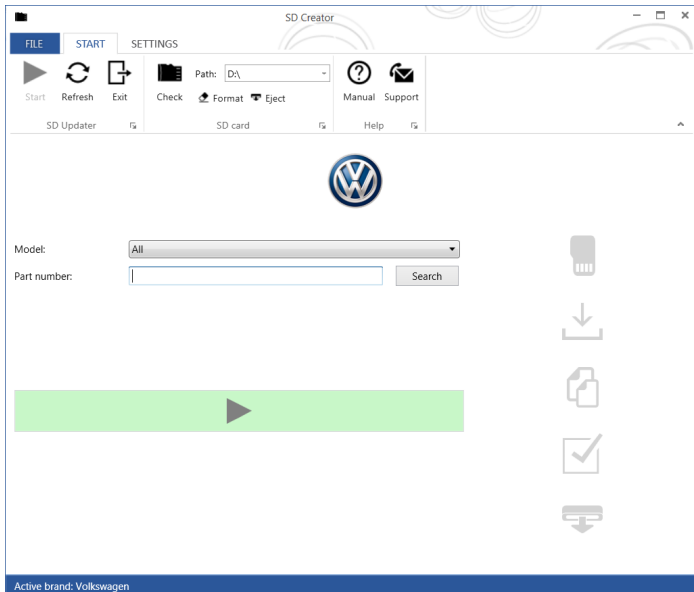
Required USB Drive

- The required software will have to be downloaded onto a USB (or USB-C) drive using the SD Creator program
- **Reference the latest version of TSB 2054866 for additional information on the use of the SD Creator program.**
- **Use a 32 GB USB stick.**

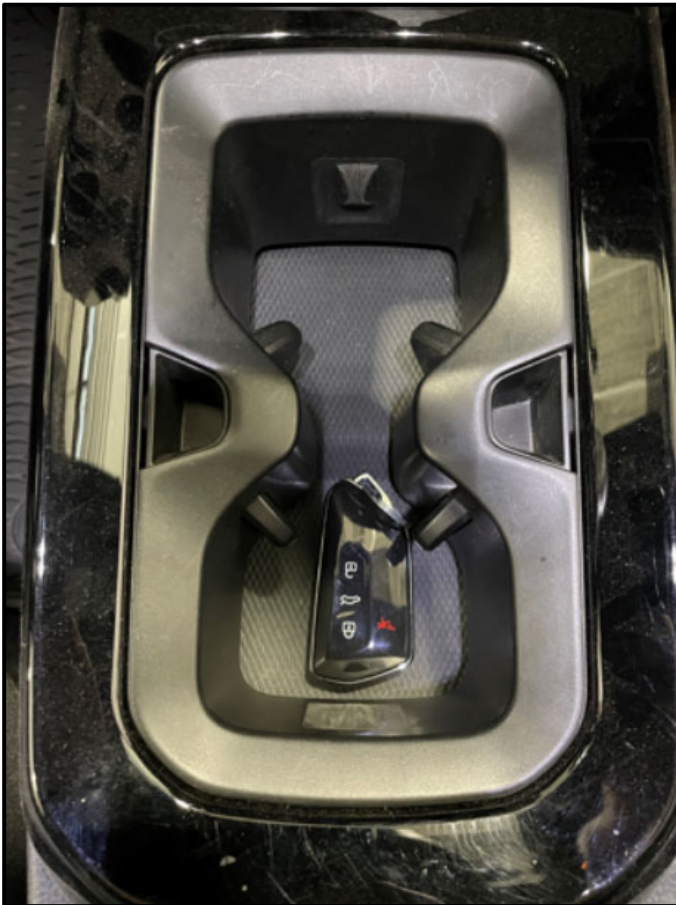
- Place the vehicle key over the reader coil in the center console cupholder.
- Any additional keys must be a minimum of 20 meters away from the vehicle.

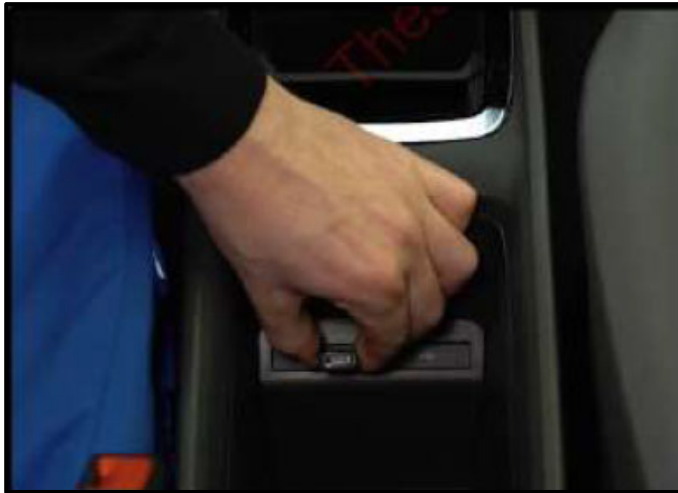
- Insert the USB drive into one of the USB ports.
- Turn the ignition ON.

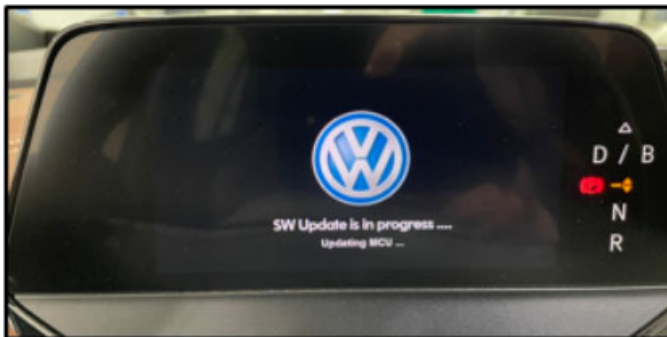
- The update will start on its own after about two minutes.
- During the update, the instrument cluster display will change multiple times.

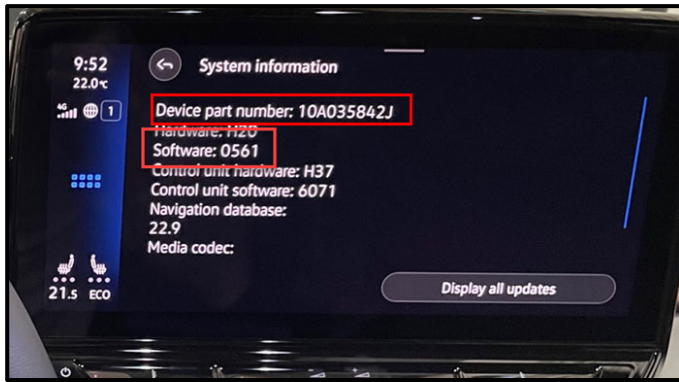
- Check SW version on infotainment display.

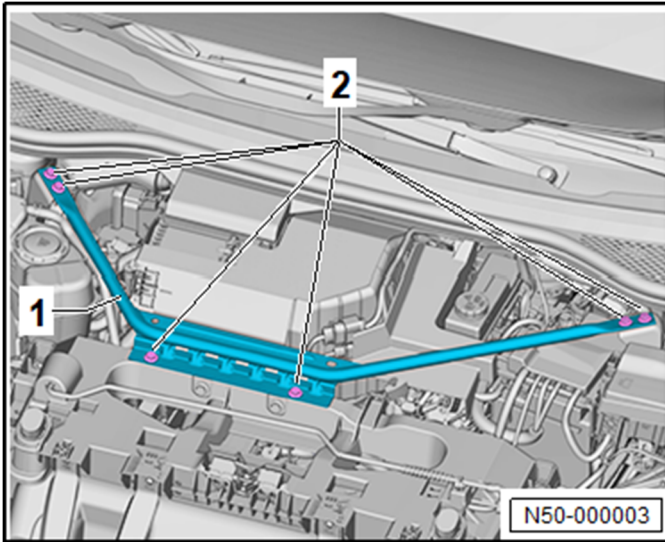
- Remove the bolts <2>.
- Remove the impact member <1>.

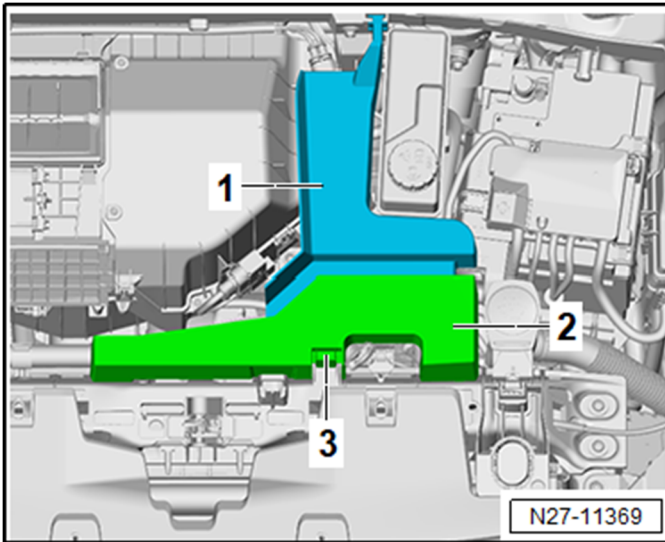
- Release the hook <3>.
- Remove the high-voltage connection cover <2>.

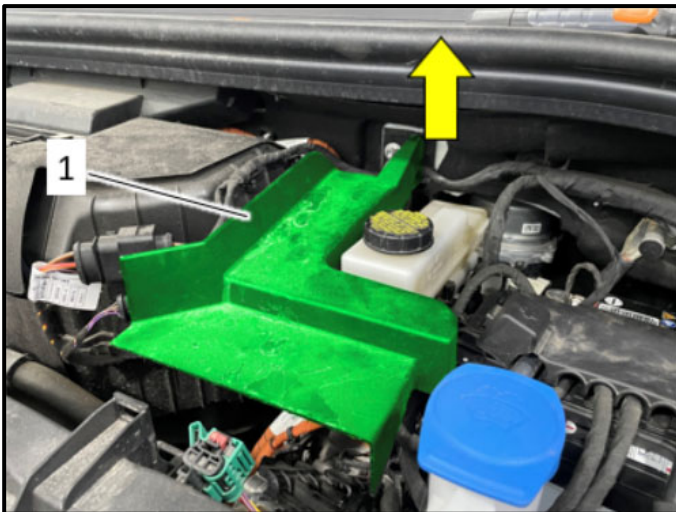
- When removing the high-voltage connection cover <1> the cover has to be lifted up at the connection to the firewall in the <direction of arrow>.

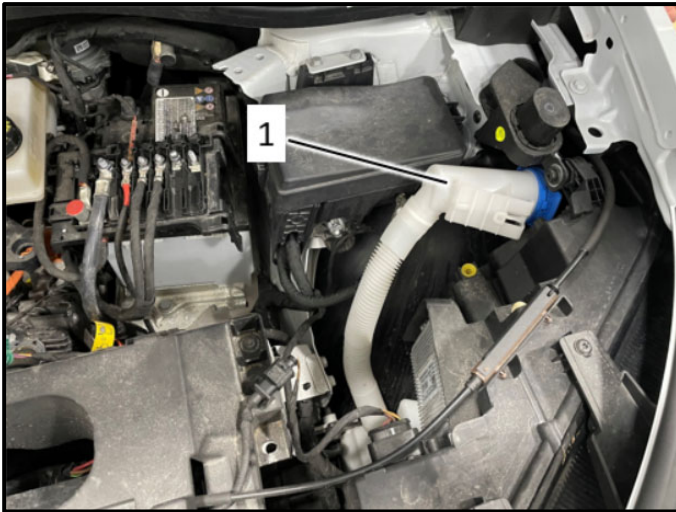
- The washer fluid filler neck will have to be unclipped and moved to the side.

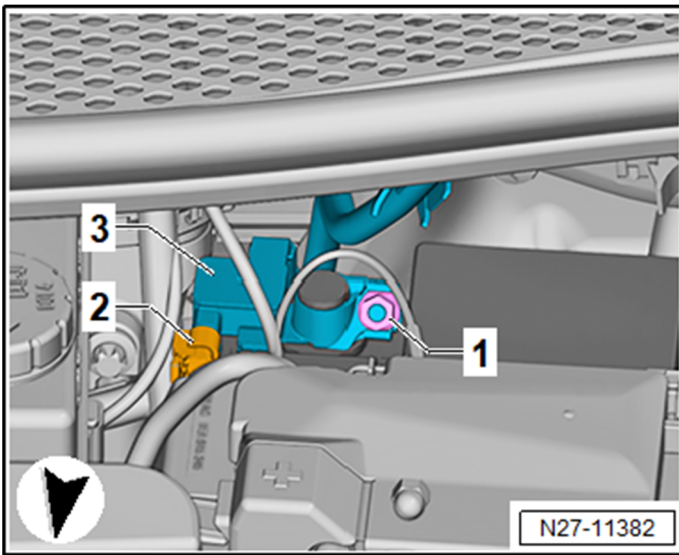
- Open the negative terminal cover above the battery monitoring control module <3>.
- Loosen the nut <1> several turns and remove the battery monitoring control module <3> from the battery negative terminal.
- Disconnect the connector <2> from the Battery Monitoring Control Module -J367-.
- Wait 1 minute.
- Check the voltage of the 12V vehicle electrical system using a commercially available voltmeter.
- The voltage must be 0V.

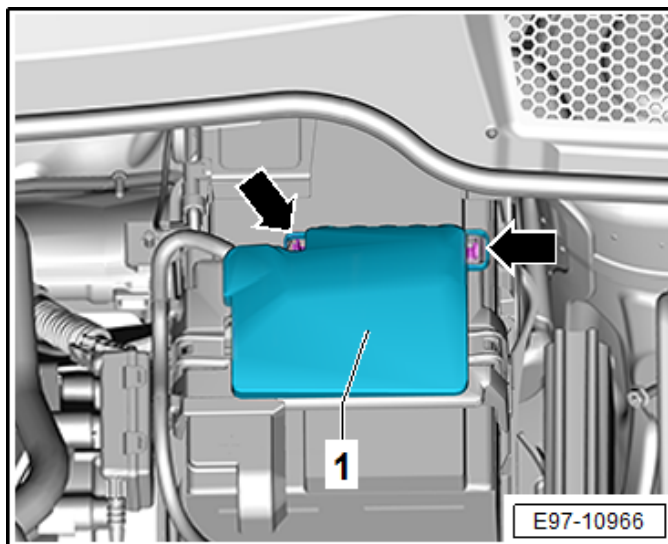
- Release the hooks <arrows>.
- Remove the cover <1>.

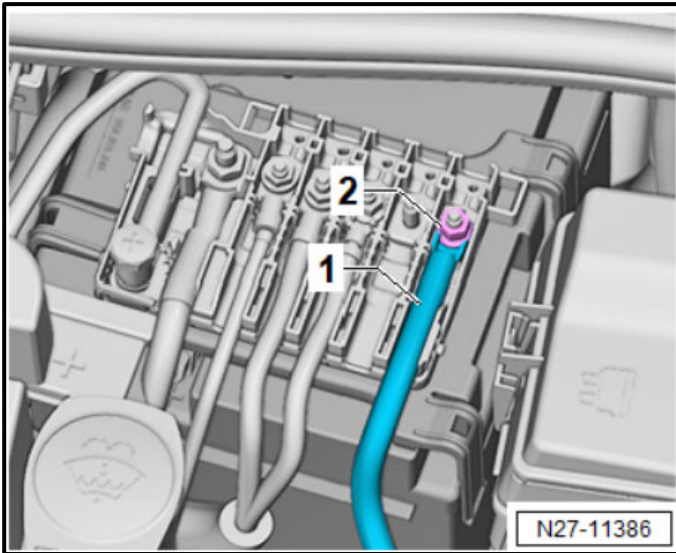
- Loosen the nut <2>.
- Remove the wire <1>.

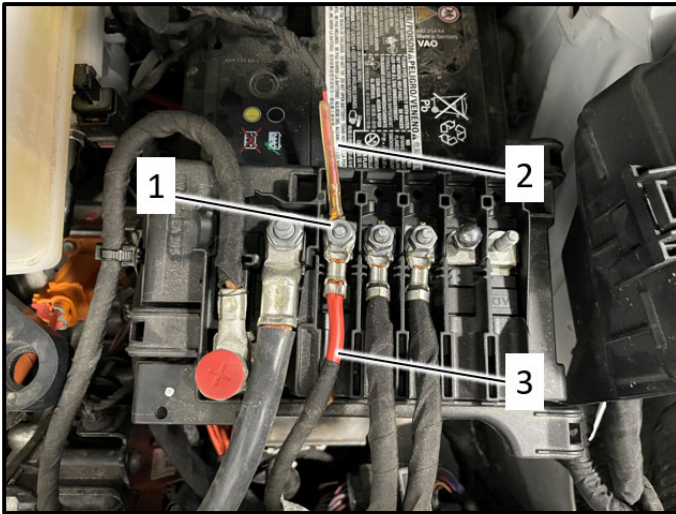
- Loosen the nut <1>.
- Remove wires <2> and <3>.

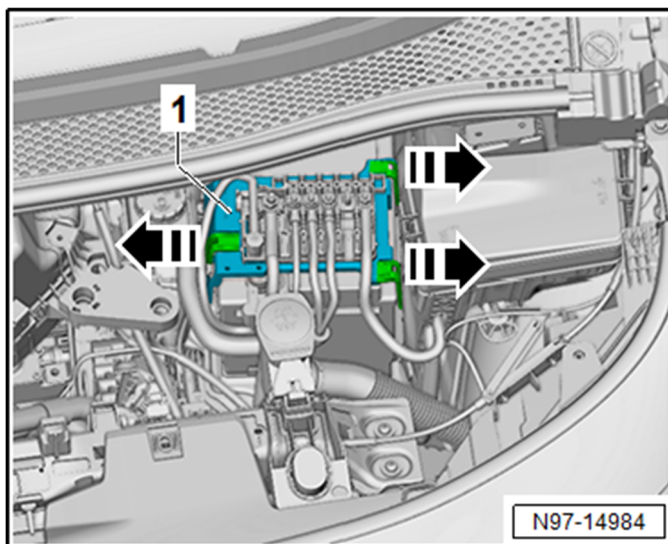
- Release the retaining straps for the bracket for fuse panel A <1> in the direction of <arrow>.
- Remove the bracket for fuse panel A <1> and move it to the side with the wires still connected.

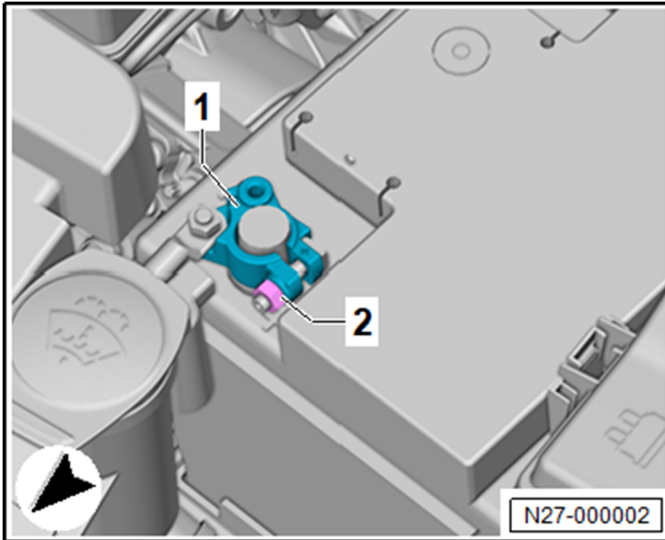
- Loosen the nut <2> several turns and remove the positive terminal battery clamp <1>.

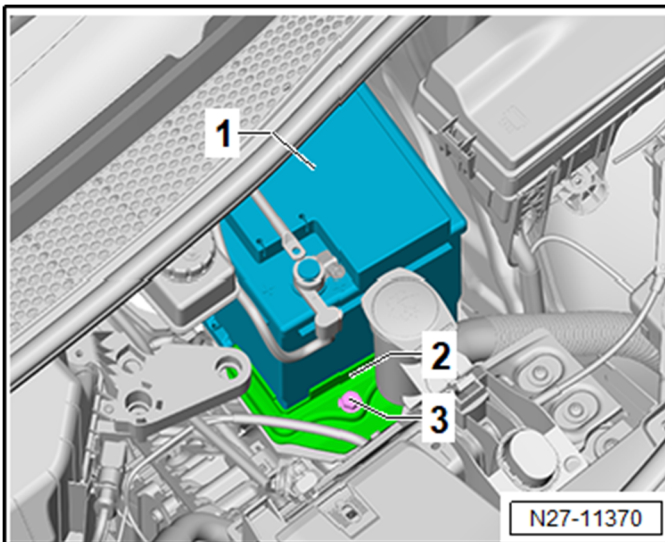
- Remove the bolt <3>.
- Remove the bracket <2>.
- Remove the battery <1> in the direction of travel from the battery tray and lift it upward out of the engine compartment.
- Install the new battery in the reverse order of removal.

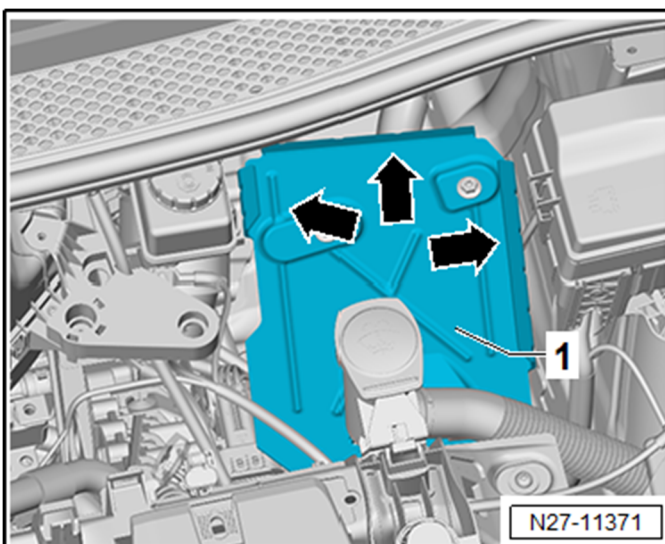
- Insert the battery into the battery tray <1> so that the battery clamping strip touches the rear and side stops <arrows>.

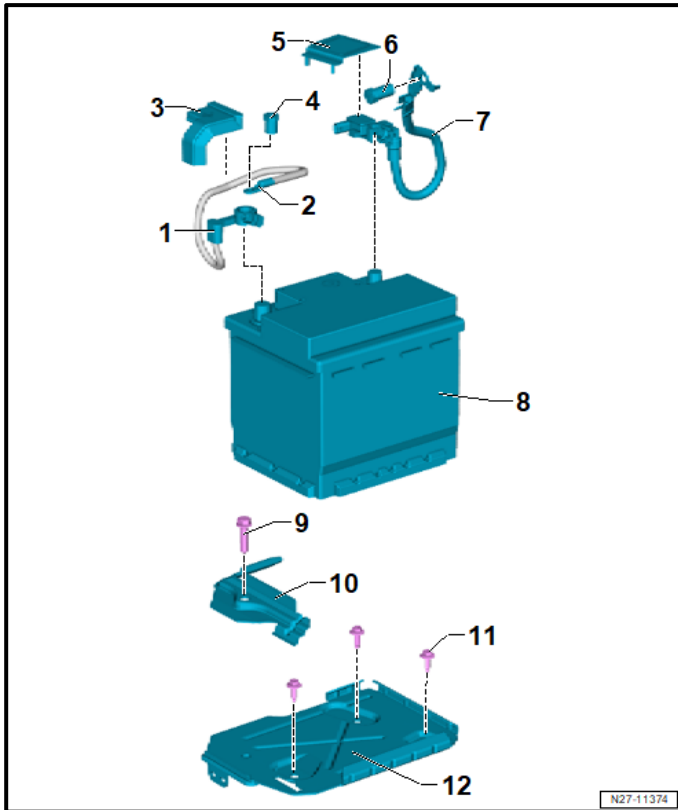
- Torque battery hold-down bolt <9> to 20 Nm.
- Torque battery terminals to 5 Nm.
- Torque power cables on top of battery to 6 Nm.
- Install covers.
- Install impact member and torque bolts to 20 Nm.

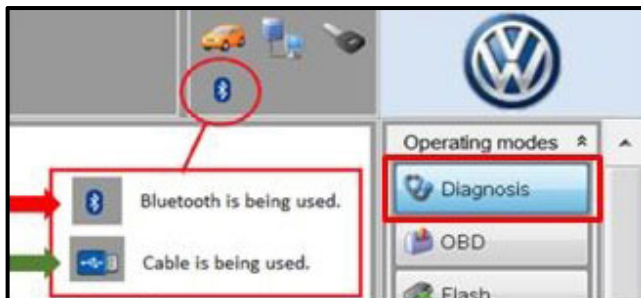
- Turn battery charger OFF, then back ON.
- Connect battery charger.
- **Cycle the ignition OFF, then back ON.**
- Confirm that scan tool is communicating with the diagnostic head by USB <Green Arrow>.
 - If the Bluetooth symbol is shown <Red Arrow> then disconnect the diagnostic head from the vehicle and reconnect the USB cable to the diagnostic head and then reattach to the vehicle.
- Upon ODIS startup, verify the "Diagnosis" operating mode is selected <as shown>.
- Turn the hazards on.

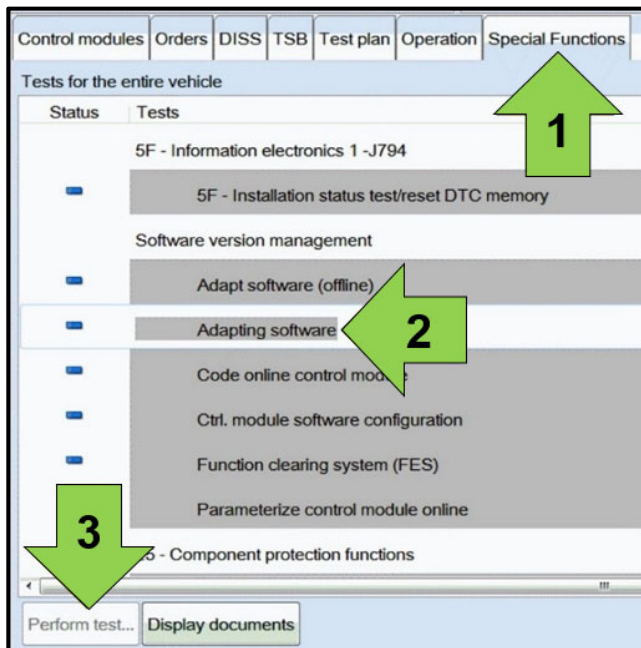
- Once the GFF scan is complete, select “Special functions” <arrow 1>, then “Adapting software” <arrow 2>, then select “Perform test” <arrow 3>.

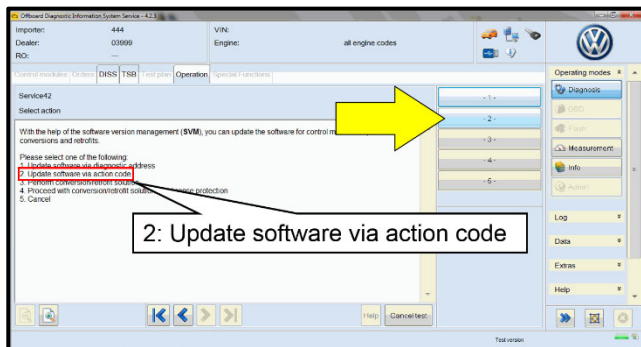
- Select the correct option to “Update software via action code”.

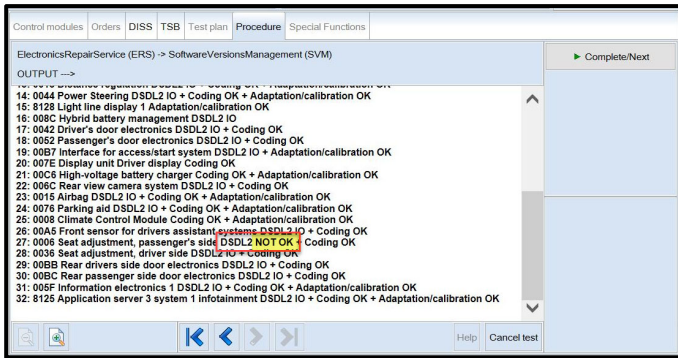
- Pay attention to the status report of the control module updates.
- Any module stating NOT OK will have to be updated again.
- Selecting “Complete/Next” will begin another attempt to update the control module.
- It may take more than one attempt to update every control module.

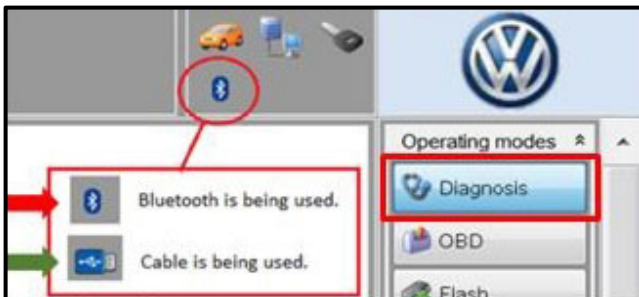
- Turn battery charger OFF, then back ON.
- Connect battery charger.
- Turn the hazards on.
- Confirm that scan tool is communicating with the diagnostic head by USB <Green Arrow>.
 - If the Bluetooth symbol is shown <Red Arrow> then disconnect the diagnostic head from the vehicle and reconnect the USB cable to the diagnostic head and then reattach to the vehicle.
- Upon ODIS startup, verify the “Diagnosis” operating mode is selected <as shown>.
- Once the GFF scan is complete, select “Special functions” <arrow 1>, then “Adapting software” <arrow 2>, then select “Perform test” <arrow 3>.

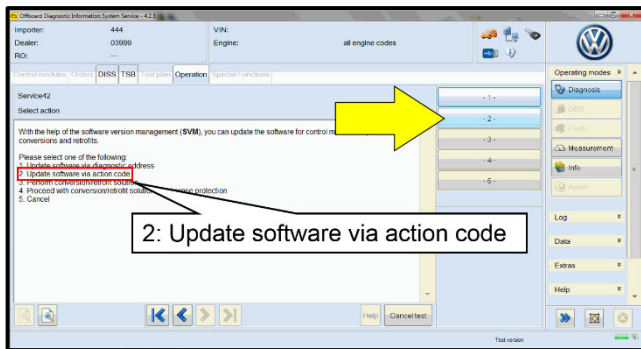
- Select the correct option to “Update software via action code”.

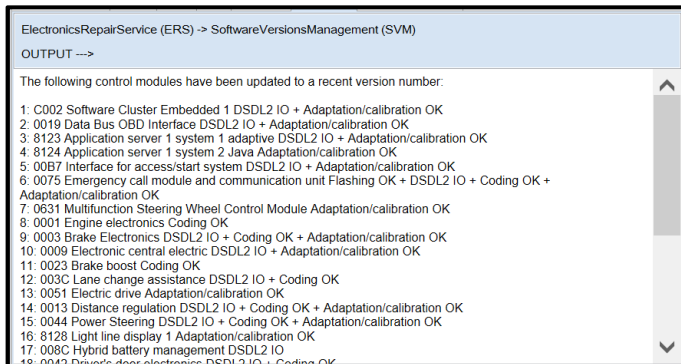
SVM code
US31

- Select “Accept” <arrow> and follow the on screen prompts.
- Pay attention to the status report of the control module updates.
- Any module stating NOT OK will have to be updated again.
- Selecting “Complete/Next” will begin another attempt to update the control module.
- Do not end the diagnostic session.

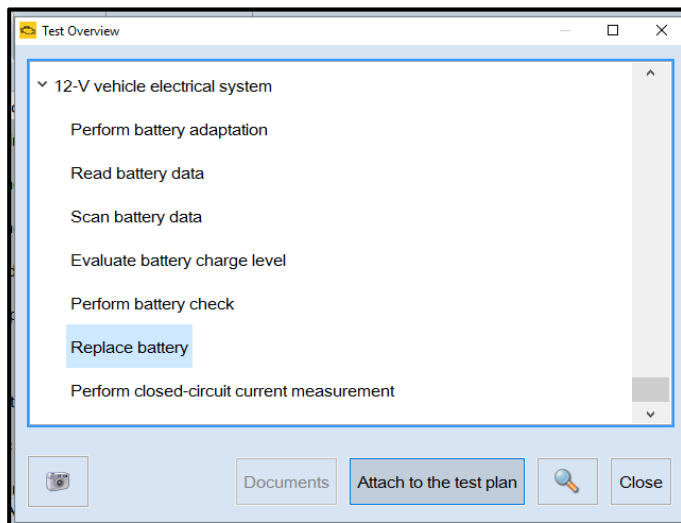
Step 6 – Perform Replace 12V Battery Test Plan

- Perform **“Replace battery”** test plan.
- Follow the on-screen prompts.
- Pay close attention to all steps outlined in the test plan and follow them exactly as described.
- Do not end the diagnostic session.

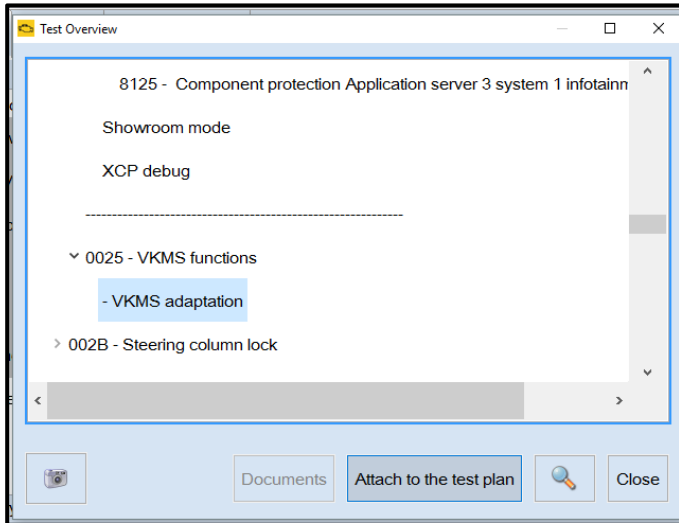
Step 8 – Perform VKMS Adaptation Test Plan

- Perform 0025 Immobilizer “VKMS Adaptation” test plan.

After selecting “Self Test,” use the search function and enter “VKMS” to aid in finding the test plan.

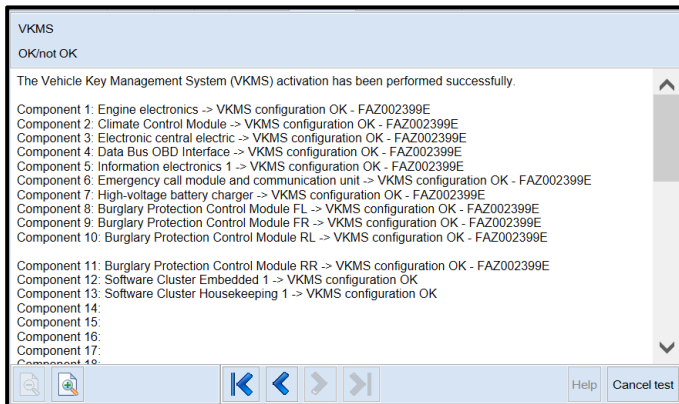
- Follow the on-screen prompts.
- Pay close attention to all steps outlined in the test plan and follow them exactly as described.
- Do not end the diagnostic session.

- Ensure each component shows the VKMS configuration is OK.
- If any component does not complete the VKMS adaptation, repeat the test plan.

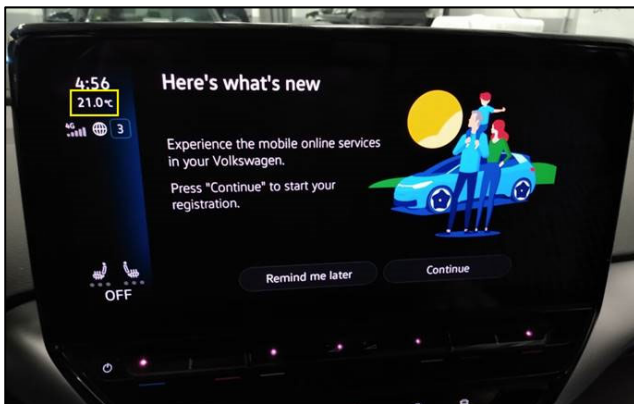
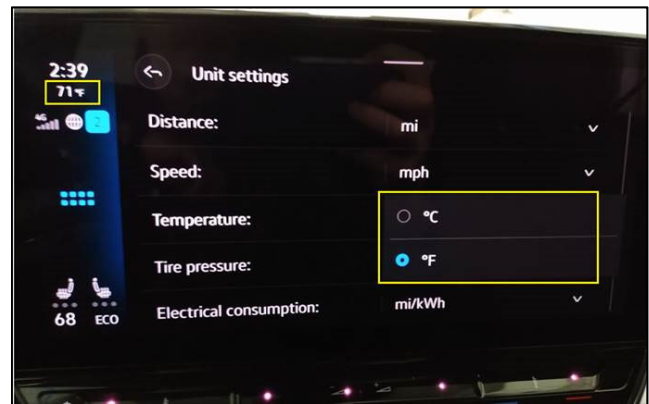
- Adapt end stops (soft stop) of the electric window lifter for all windows:
 - Lower window completely. Release the switch. Hold window switch in the down position, at the second detent for 3 seconds.

- Raise window completely. Release the switch. Hold window switch in the up position, at the second detent for 3 seconds.
- This software update may change the temperature units from Fahrenheit to Celsius. The setting can be changed in the infotainment display by going to *Settings > Unit Settings*. This setting should be adjusted based on customer preference.

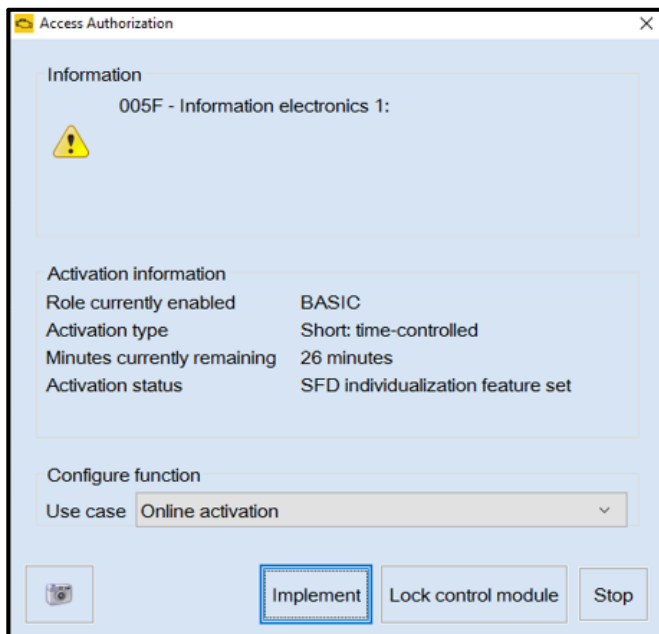
- From the OBD menu, go to: OBD > DA 005F > *Access authorization*.
- Select “Implement” and then enter ODIS login/password if prompted (to unlock SFD).
- Select “stop” to close the window.

- Using Operating mode “OBD”, check 005F adaptation channels \$0548 and \$0549 for the current service interval settings (OBD > DA 005F > Adaptations).
- If the values are the same as the previously recorded values, no change is necessary.
- If the values have changed, enter the correct values as needed.

- The service interval display may be reset by the software configuration. The current service interval should have been read out at the beginning of this repair.
- It is also possible that the service interval could have been reset on a previous service visit if a software configuration was carried out on the vehicle. Therefore, the service interval should be compared to the vehicle's service records. If there is a discrepancy, the service interval values will have to be adjusted accordingly.
- After the software updates are complete, the adaptation channels will also change:
 - Pre-flash:
 - \$0541 (distance driven since the last inspection AND time since the last inspection)
 - Post-flash:
 - \$0548 (distance driven since the last inspection)
 - \$0549 (time since the last inspection)

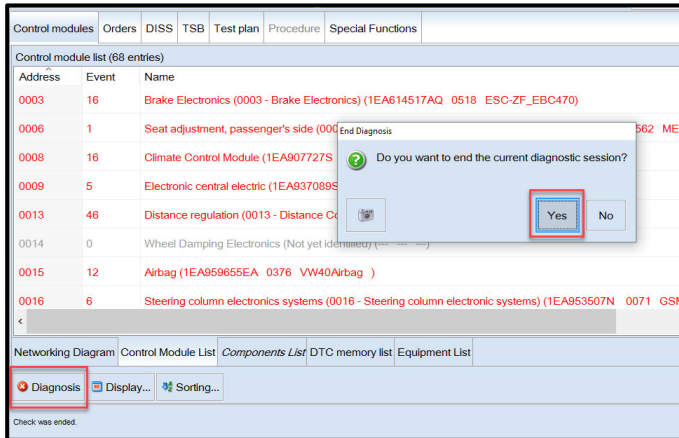
Step 11 – Perform GFF Test Plans For All Faults Created by the Flash Process

- Exit Diagnosis and select “Yes” to end the diagnostic session.

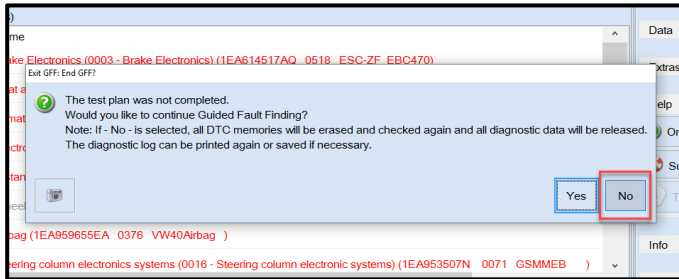
- When prompted to continue Guided Fault Finding, select “NO”.
- GFF will be exited and faults will be erased.

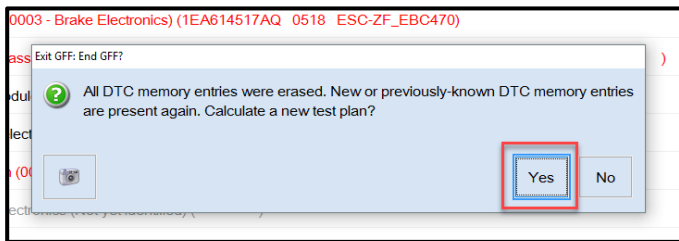
- Static faults created by the flash process will remain.
- When prompted, select “YES” to populate new test plans.

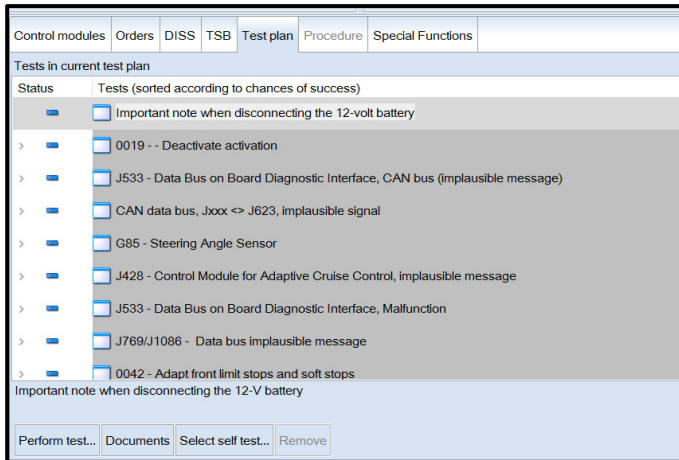
- Work through all test plans for faults created by the flash process.
- Reference any applicable TSBs that address “ghost” faults.
- Pay close attention to all steps outlined in the test plans and follow them exactly as described.
- Exit GFF and send diagnostic protocol online.

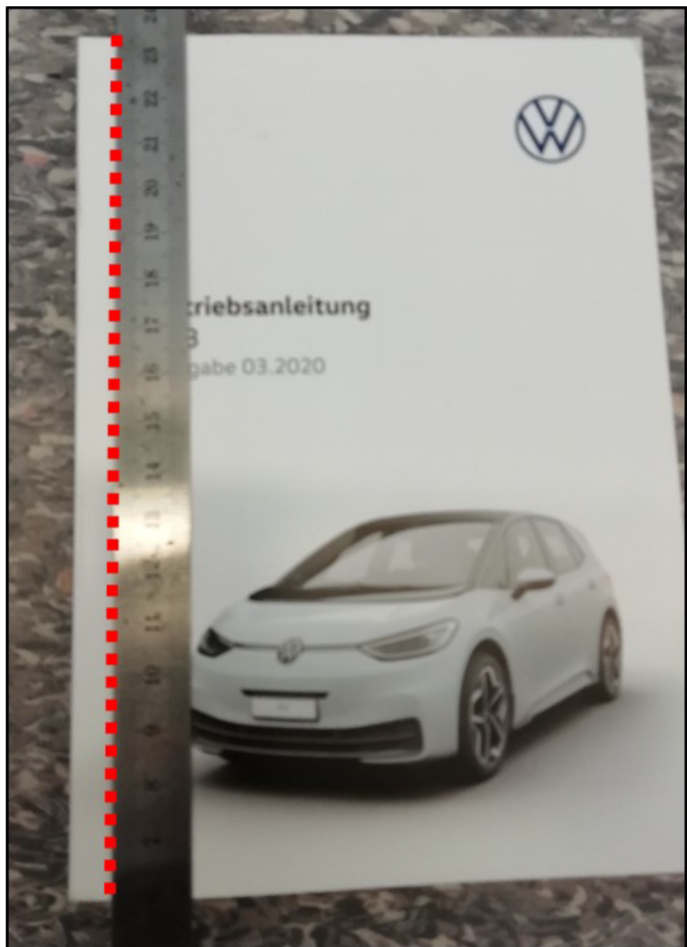
Replace the owner’s manual and provide a tow hook supplement.

- On the first page (inside) of the owner's manual enclosed in the vehicle there is the vehicle data sticker and information on PDI and date of delivery/registration.
- To ensure this information is not lost to the customer, cut out the first page of the owner's manual with a sharp knife, as shown in the illustration <red dotted line>.
- We recommend the use of a steel ruler or another suitable implement to guide the knife and ensure a straight cutting line.
- Include the cut-out page in the new owner's manual.
