# Emissions Recall

## Code: 23EM

**Subject** Engine Control Module (ECM) Software

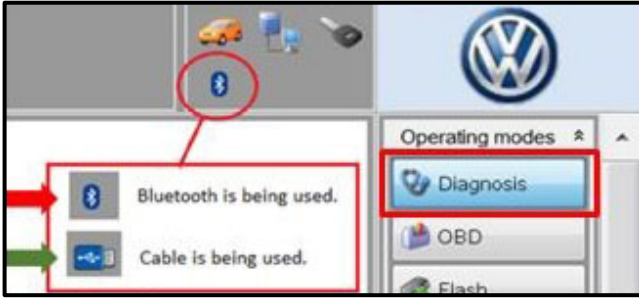
- Confirm that scan tool is communicating with the diagnostic head by USB <Green Arrow>.
  - If the Bluetooth symbol is shown <Red Arrow> then disconnect the diagnostic head from the vehicle and reconnect the USB cable to the diagnostic head and then reattach to the vehicle.
- Upon ODIS startup, verify the “Diagnosis” operating mode is selected <as shown>.
