# Technical Service Bulletin

<b>SUBJECT:</b>  <b>WIRELESS CHARGER STOPS CHARGING WHEN USING iPhone 12 OR LATER</b>			No: <b>TSB-22-13-004</b>
			DATE: <b>December 2022</b>
			MODEL: <b>2022-23 Outlander 2023 Outlander PHEV</b>
<b>CIRCULATE TO:</b>	<input type="checkbox"/> GENERAL MANAGER	<input checked="" type="checkbox"/> PARTS MANAGER	<input checked="" type="checkbox"/> TECHNICIAN
<input checked="" type="checkbox"/> SERVICE ADVISOR	<input checked="" type="checkbox"/> SERVICE MANAGER	<input checked="" type="checkbox"/> WARRANTY PROCESSOR	<input type="checkbox"/> SALES MANAGER

This Campaign Bulletin provides instructions to reprogram the wireless charger with the latest software.

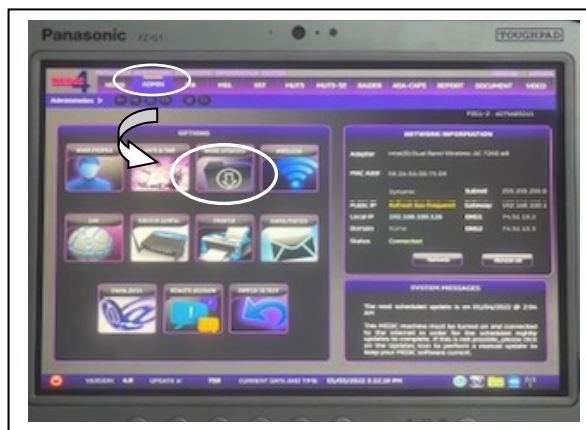
3. Select the MEDIC 3.5/4 Admin tab and click on "Updates".

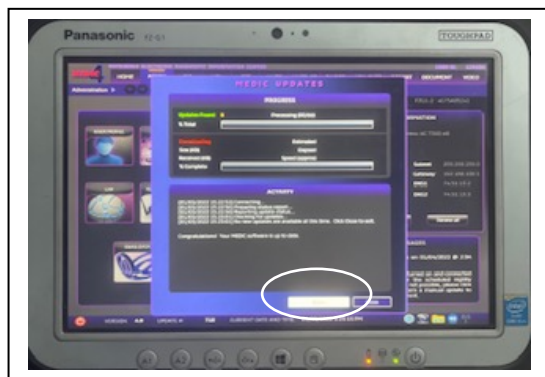
4. If the MEDIC update screen advises updates are available, click the "Begin" button. After all updates are complete, **GO TO THE REPROGRAMMING PROCEDURE.**

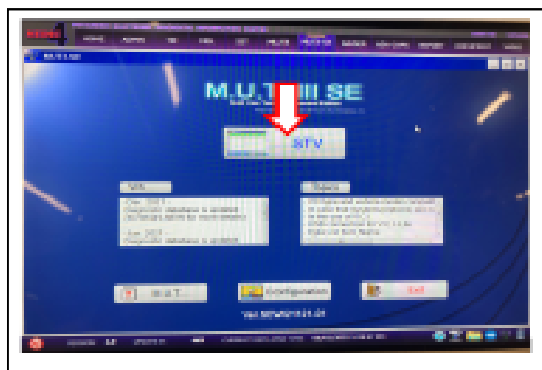
- a. Press the MUT-III SE STV icon.

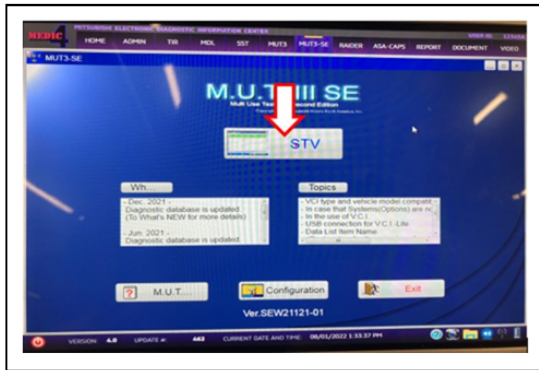
- a. Press MUT-III SE STV icon.
