Technical Service Bulletin

SUBJECT:		No: TSB-22-54-006	
IGNITION SWITCH ACCESSORY (ACC) POSITION MALFUNCTION OF AUTO POWER OFF		DATE: December 2022	
		MODEL: 2020-21 Outlander Sport	
CIRCULATE TO:	<input type="checkbox"/> GENERAL MANAGER	<input checked="" type="checkbox"/> PARTS MANAGER	<input checked="" type="checkbox"/> TECHNICIAN
<input checked="" type="checkbox"/> SERVICE ADVISOR	<input checked="" type="checkbox"/> SERVICE MANAGER	<input checked="" type="checkbox"/> WARRANTY PROCESSOR	<input type="checkbox"/> SALES MANAGER

This Service Bulletin provides instructions to reprogram the ETACS-ECU with the latest software.

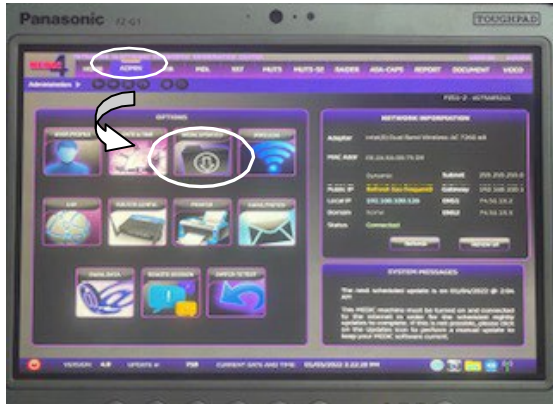
3. Select the MEDIC 3.5/4 Admin tab and click on "Updates".

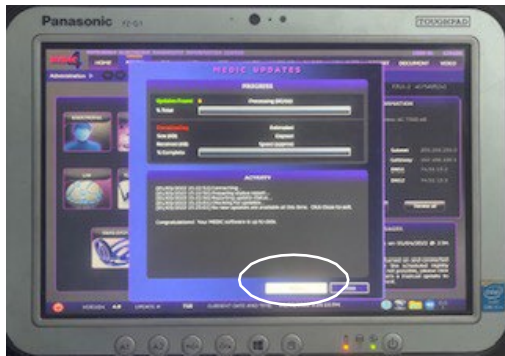
4. If the MEDIC update screen advises updates are available, click the "Begin" button. After all updates are complete, GO TO THE REPROGRAMMING PROCEDURE.

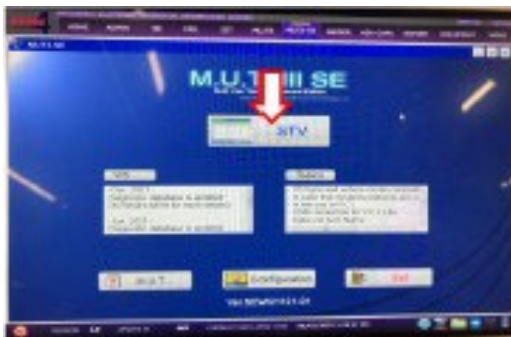
- a. Press the MUT-III SE STV icon.

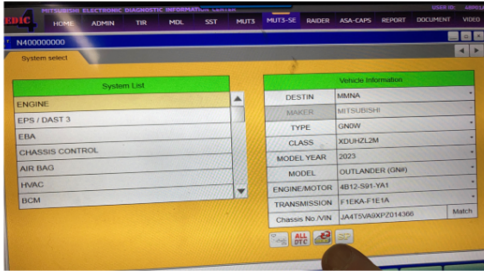
b. Press the Reprogramming button once the vehicle information is entered.

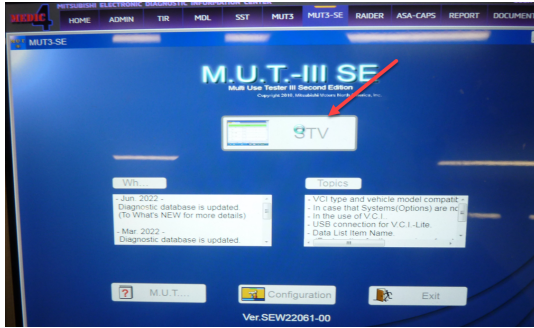
a. Press the MUT-III SE STV icon.

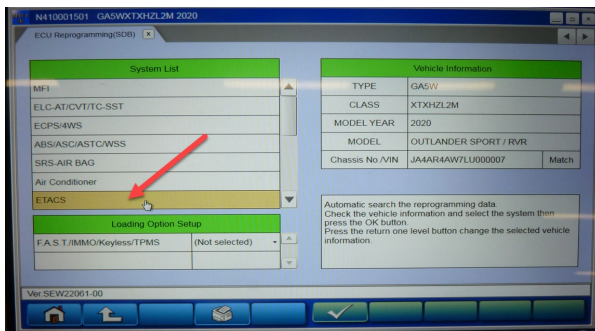
d. Select "ETACS" from the System List and press the OK button.

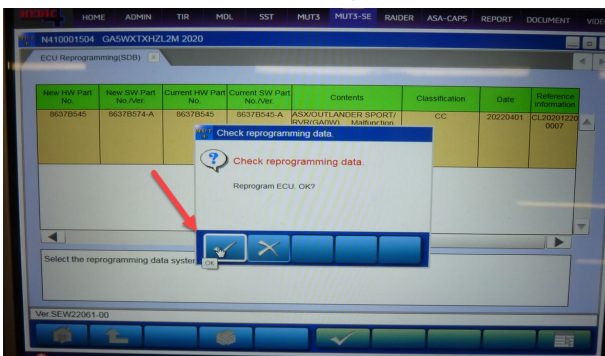
- f. Press the OK button and type in the AS2 account information to start the reprogramming.

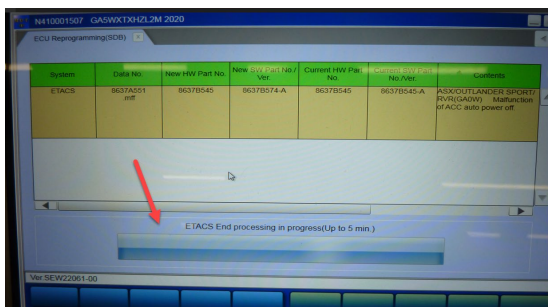
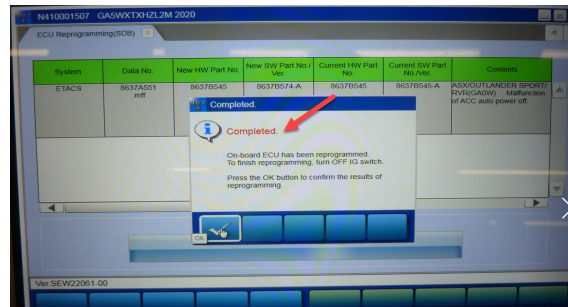
- g. Once the reprogramming is initiated the screens shown below will appear and indicate the reprogramming progress. It may take up to 5 minutes to complete.

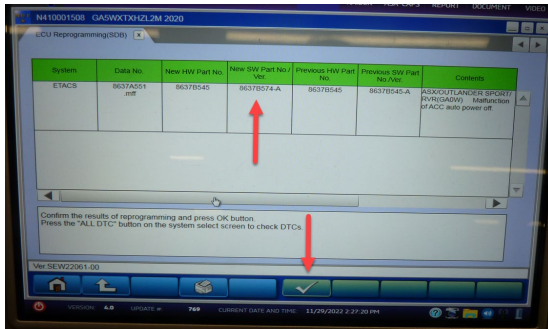
h. Verify that the software version has been updated to **"8637B574A"** and press OK button.
