NUMBER: 08-160-22 REV. C

GROUP: 08 - Electrical

Radio Over The Air R141.01.12, 139.01.53, 136.10.04 to R145.00.15 Software Version Updates

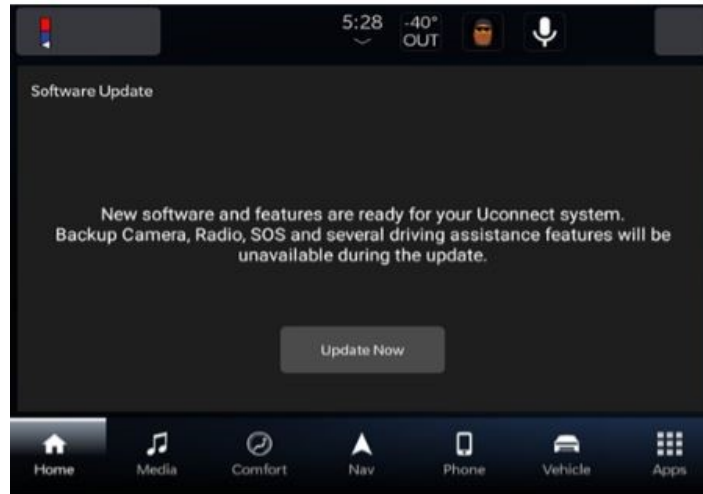
Fig. 1
Software Acceptance Screen

1. The vehicle needs to be in 'park'. The ignition needs to be in the off position.
2. If the customer selects "Update Now" they can shut off the vehicle and leave. The update will be completed automatically.
