**TECHNICAL INSTRUCTIONS**  
**FOR**  
**LIMITED SERVICE CAMPAIGN KLG**  
**CUSTOMER SUPPORT PROGRAM 19LE05**

**SAFETY CONNECT SYSTEM – VEHICLE LOCATION INACCURATE**  
**CERTAIN**

**Updated 08/24/2020**

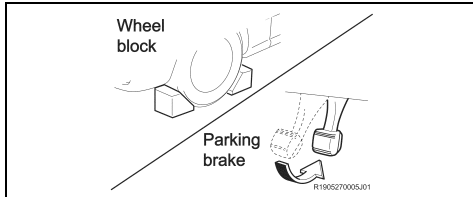
<<APPLY WHEEL BLOCKS AND PARKING BRAKE>>

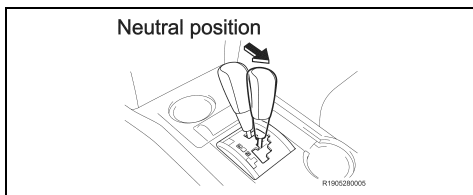
<<MOVE THE SHIFT LEVER TO N POSITION>>

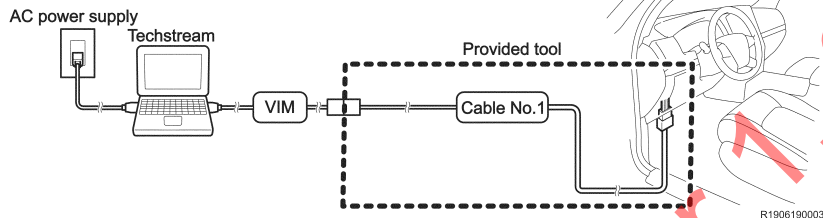
- Turn the IG OFF.
- Using a Cable No.1 (provided tool), connect the Techstream to the vehicle.

- Turn off the screen saver and power saving mode of the PC.
- Use the external power supply for the PC. (**DO NOT** use the PC's internal battery or vehicle's battery.)
- Ensure that the communication cable connectors are securely connected, the cable is in good condition, and the connection is stable.

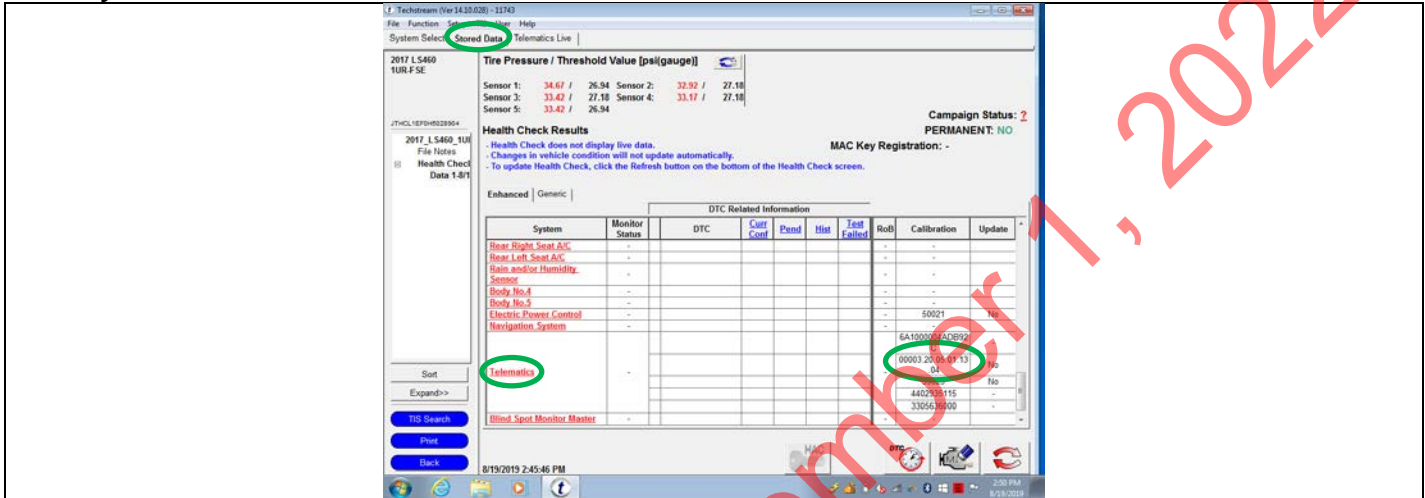
a) Determine the status of an available update; indicated by the calibration ID.

**Note:** Do not use the update column and an indicator if an update is required as it will always say No. Only use calibration ID

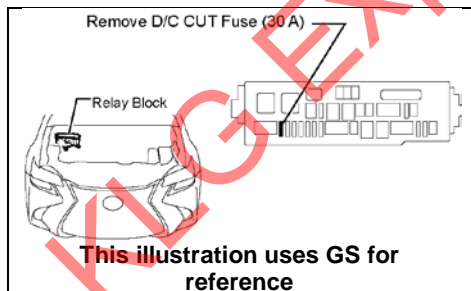
This illustration uses GS for reference

- c) DISCONNECT "D/C CUT " OR "SHORT PIN"

- The reprogramming may fail if you perform it without disconnecting the "D/C CUT" or "SHORT PIN". Please make sure to disconnect the "D/C CUT" or "SHORT PIN" before performing the reprogramming.
- Refer to Section XIV for the location of "D/C CUT" and "SHORT PIN" of each vehicle model.

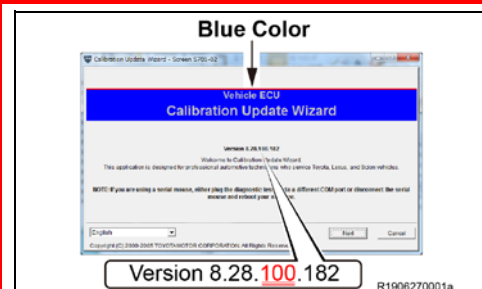
- a) Check if the Special CUW (only for DCM) is downloaded.  
**NOTE:**  
**If Special CUW (only for DCM) has not been downloaded, follow the instructions of section VII.**

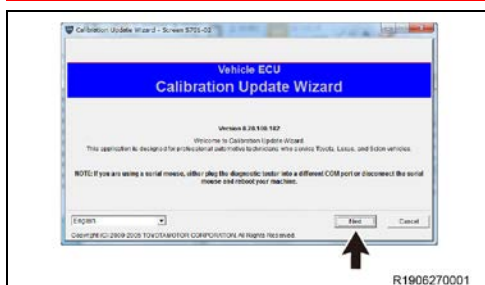
- b) When Calibration Update Wizard is launched, click on “Next”.

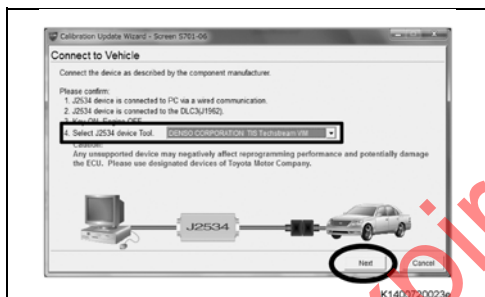
- c) Select a device tool, and then click on "Next".

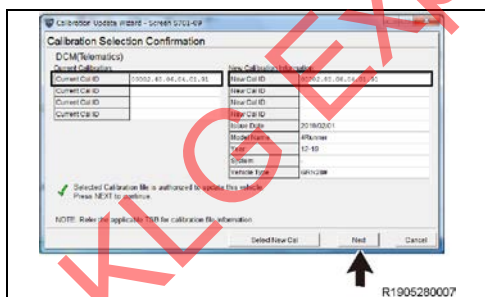
- d) Confirm that "Current Cal ID" and "New Cal ID" are correct, and then click on "Next".

**NOTE: The calibration IDs will be displayed as shown on the left. Please make sure you *DO NOT* mistake where to check to confirm the IDs.**

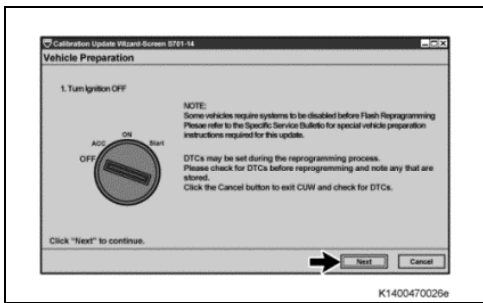
- e) Follow the on-screen instructions and turn the IG off, and then click on "Next".

**NOTE:** After "Next" is clicked, a bar showing the progress is displayed. **DO NOT** turn the IG on while the bar is shown.

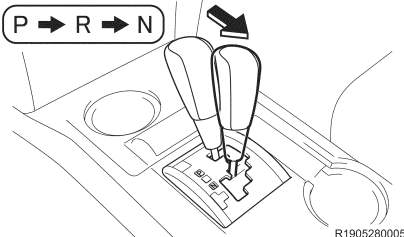
Neutral position

- f) Turn the IG to the ON position (engine off).

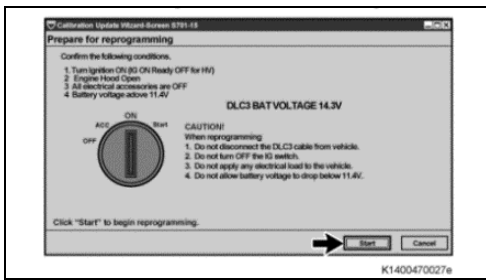
h) Click on "Start".

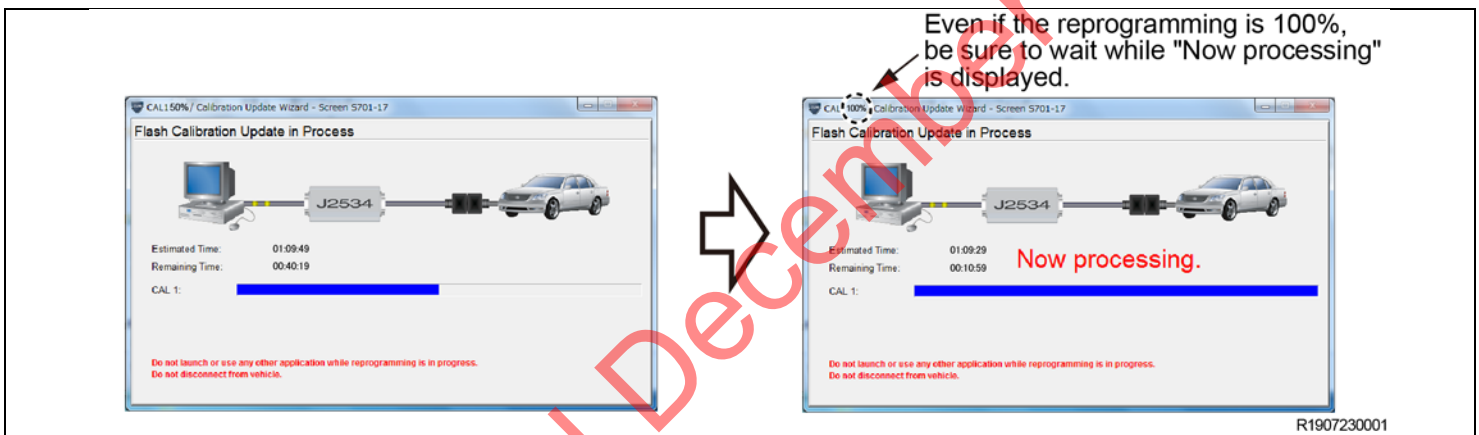
i) While reprogramming, the screen shown on the below is displayed.

- As reprogramming completes within approximately 75 minutes, stay near the vehicle and **DO NOT** allow any third parties to operate the vehicle or Techstream in order to prevent issues from occurring. The following phenomena may be observed while reprogramming due to interrupted communication. However, there is no problem.
  - Vehicle proximity alarming sound.
  - Blackout navigation screen (black).
  - Indication of a warning lamp or error message in the meter.
- "Now processing" is displayed for about 10 minutes. **DO NOT** finish reprogramming until the screen changes.

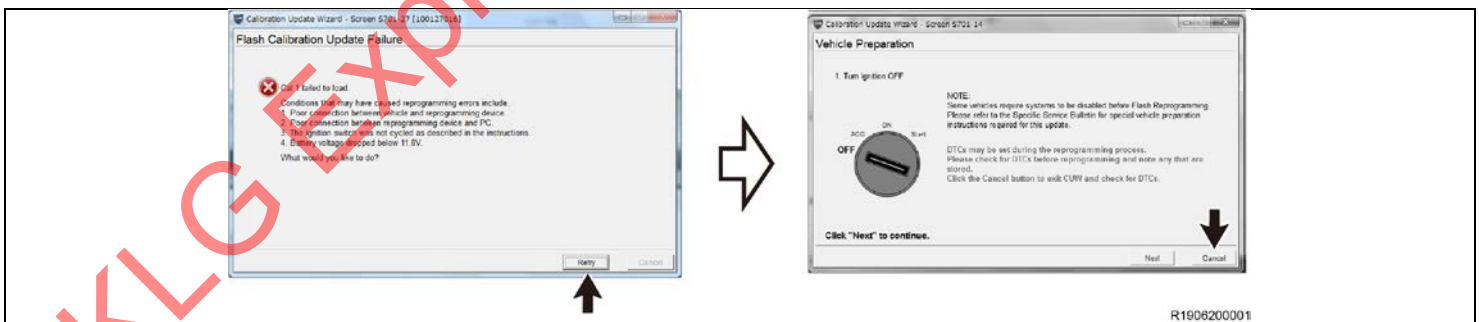
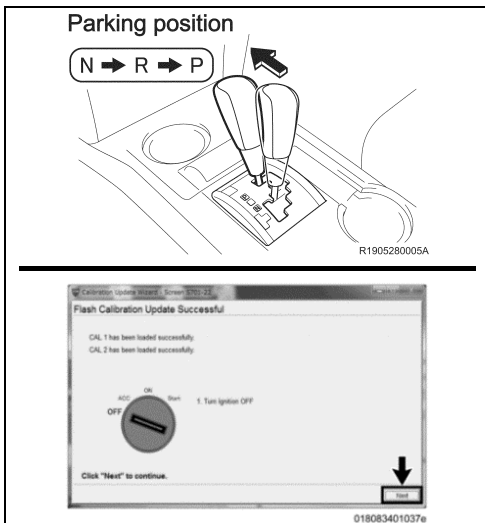
If the following window is displayed and the reprogramming has failed, click on "Retry" and then "Cancel" to finish the reprogramming process. Remove the DCM (telematics transceiver) from the vehicle and perform the reprogramming procedure again only to the DCM (telematics transceiver). Refer to Section XIII

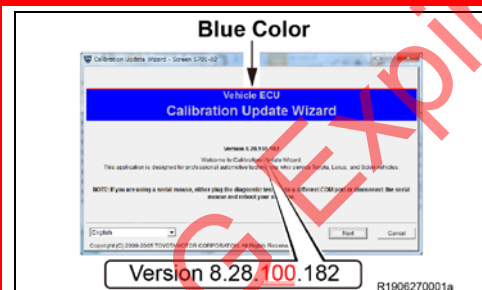
d) Check if the Special CUW (only for DCM)” is downloaded.

If Special CUW (only for DCM) has not been downloaded, follow the instructions of section VII.

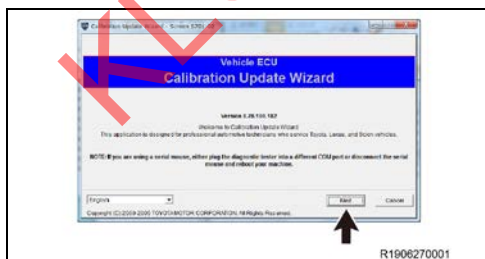
e) When Calibration Update Wizard is launched, click on “Next”.

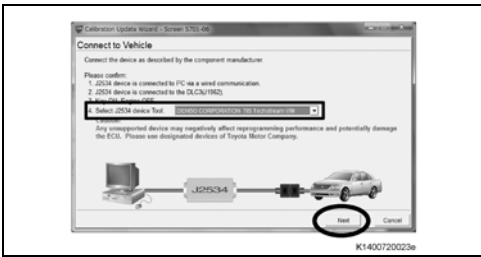
f) Select a device tool, and then click on "Next".

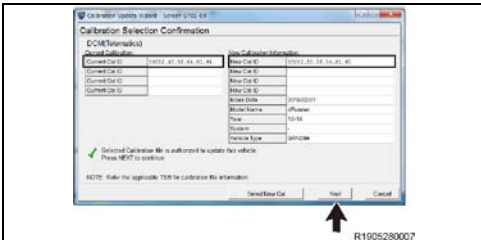
g) Confirm that "Current Cal ID" and "New Cal ID" are correct, and then click on "Next".

**NOTE:** The calibration IDs will be displayed as shown on the left. Please make sure you **DO NOT** mistake where to check to confirm the IDs.

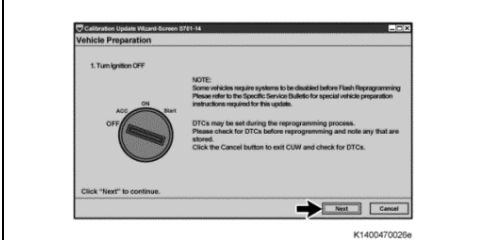
h) Follow the on-screen instructions and turn the IG off, and then click on "Next".

**NOTE:** After "Next" is clicked, a bar showing the progress is displayed. **DO NOT** turn the IG on while the bar is shown.

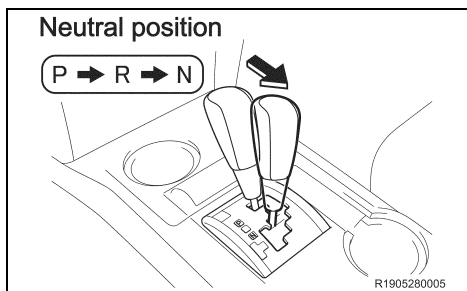
**Vehicle condition before reprogramming  
DO NOT start the engine.**

i) Turn the IG to the ON position (engine off).

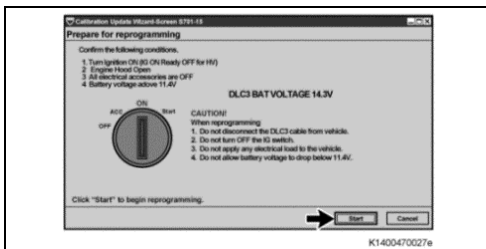
k) Click on "Start".

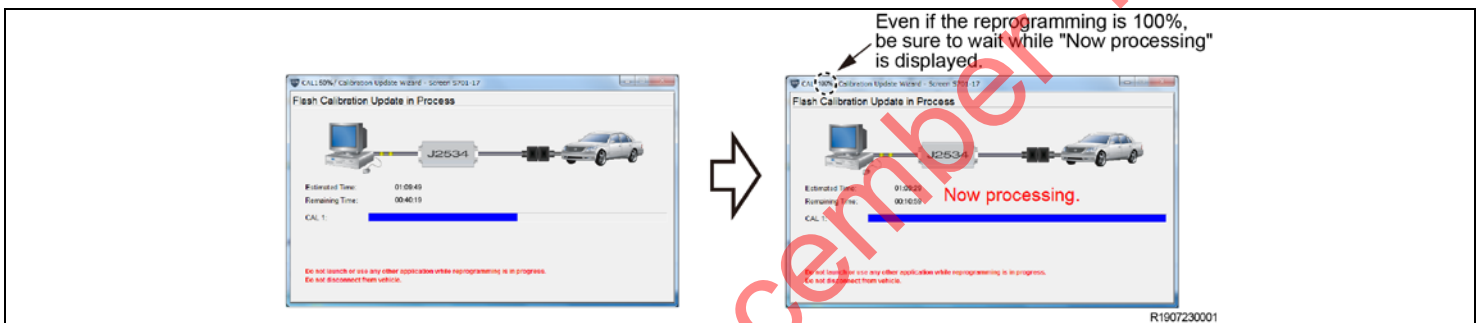
l) While reprogramming, the screen shown on the below is displayed.

- As reprogramming completes within approximately 85 minutes, stay near the vehicle and **DO NOT** allow any third parties to operate the vehicle or Techstream in order to prevent issues from occurring. The following phenomena may be observed while reprogramming due to interrupted communication. However, there is no problem.
  - Vehicle proximity alarming sound.
  - Blackout navigation screen (black).
  - Indication of a warning lamp or error message in the meter.
- "Now processing" is displayed for about 10 minutes. **DO NOT** finish reprogramming until the screen changes.

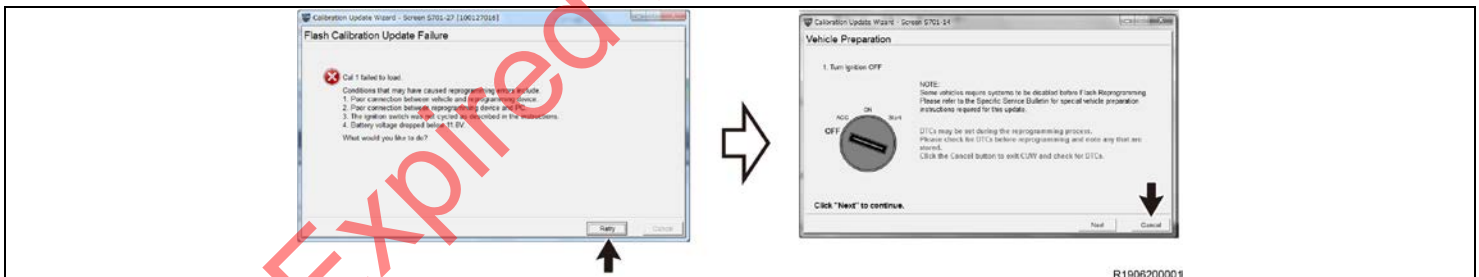
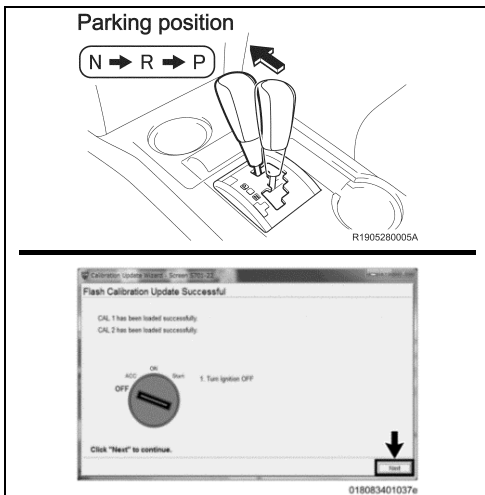
If the following window is displayed and the reprogramming has failed, click on "Retry" and then "Cancel" to finish the reprogramming process. Remove the DCM (telematics transceiver) from the vehicle and perform the reprogramming procedure again only to the DCM (telematics transceiver). Refer to Section XIII

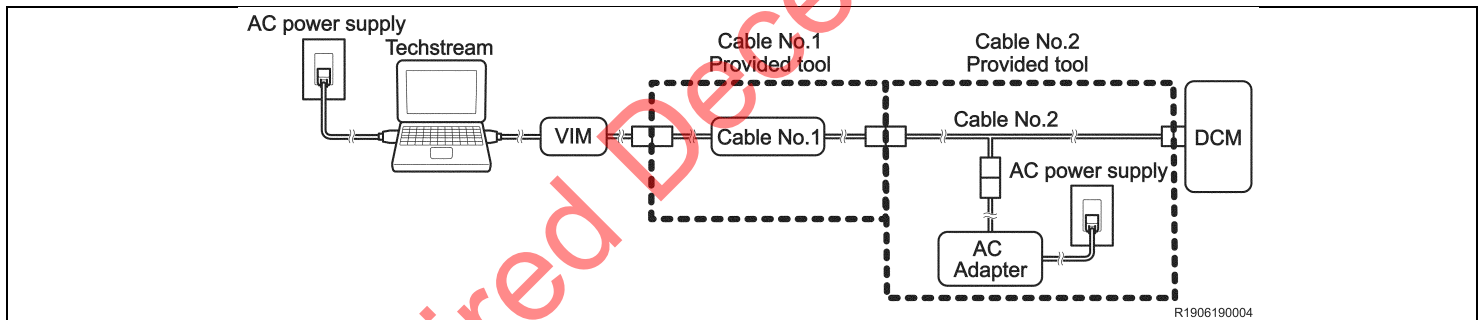
Follow the instructions below. Otherwise, the battery voltage will decrease or communication will become disabled, and this may require the replacement of the DCM.

- Turn off the screen saver and power saving mode of the PC.
- Use the external power supply for the PC. (**DO NOT** use the PC's internal battery or vehicle's battery.)
- Ensure that the communication cable connectors are securely connected, the cable is in good condition, and the connection is stable.

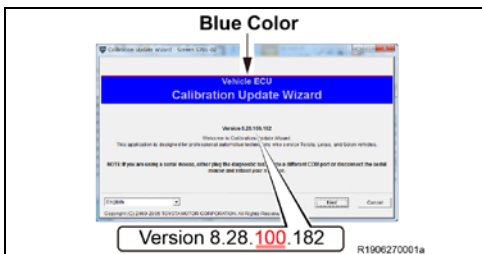
b) When Calibration Update Wizard is launched, click on "Next".

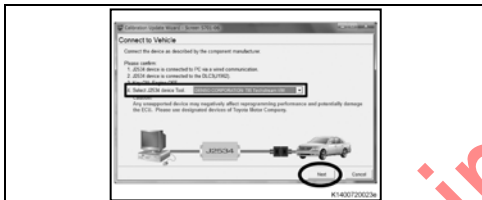
c) Select a device tool, and then click on "Next".

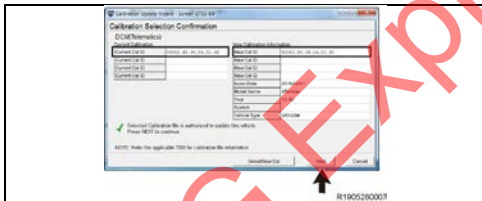
d) Confirm that "Current Cal ID" and "New Cal ID" are correct, and then click on "Next".

**NOTE:** The calibration IDs will be displayed as shown on the left. Please make sure you **DO NOT** mistake where to check to confirm the IDs.

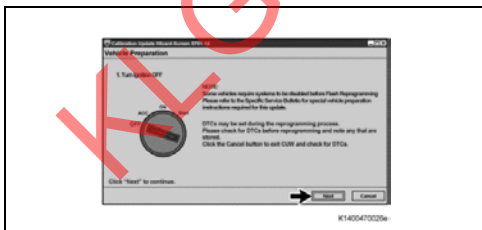
e) Click on "Next".

**NOTE:** It is **NOT** necessary to follow the instructions on the screen of Techstream.

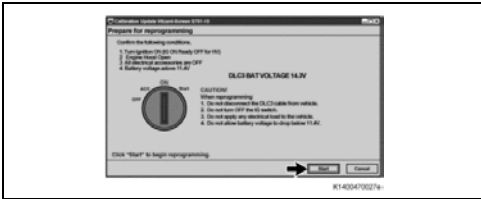
f) Click on "Start".

**NOTE:** It is **NOT** necessary to follow the instructions on the screen of Techstream.
