## Rapid Update 580 M182 - R1 Software Update to S24.31

Certain Maserati Grecale MY23 (M182) vehicles listed in MODISCS+ are involved in a Rapid Update for the software update of the Entertainment Module (ETM) R1 to the latest S24.31 version.

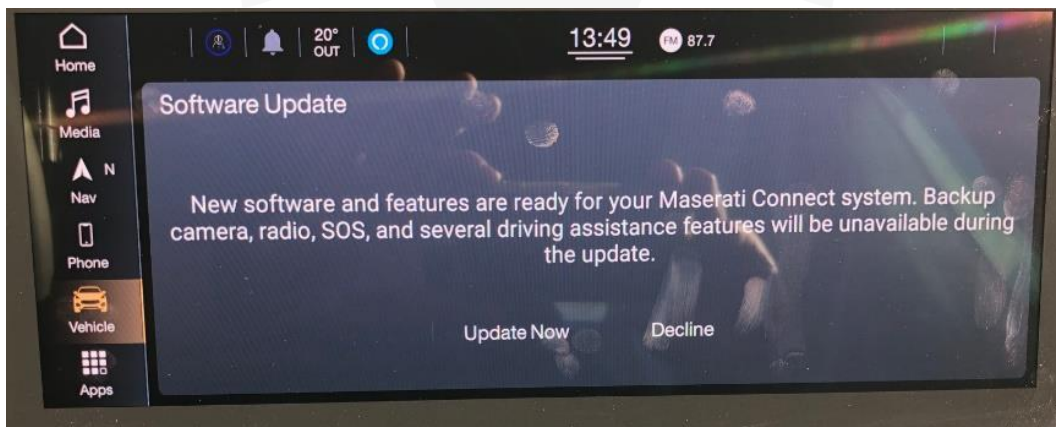
6. This procedure must be performed with the **engine running**.
7. Insert the USB Flash Drive into the USB socket.
8. The following prompt will appear and press "Update Now".

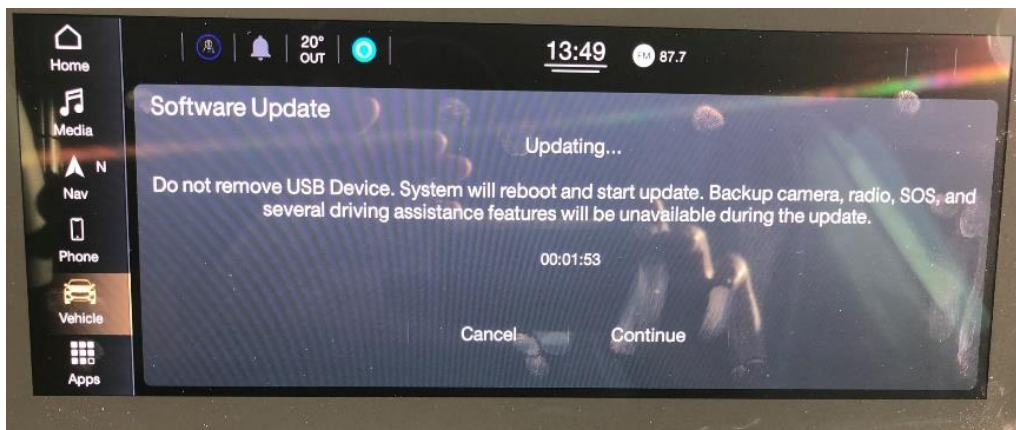
9. The following prompt will appear, and then press "Continue" and wait for the software download.

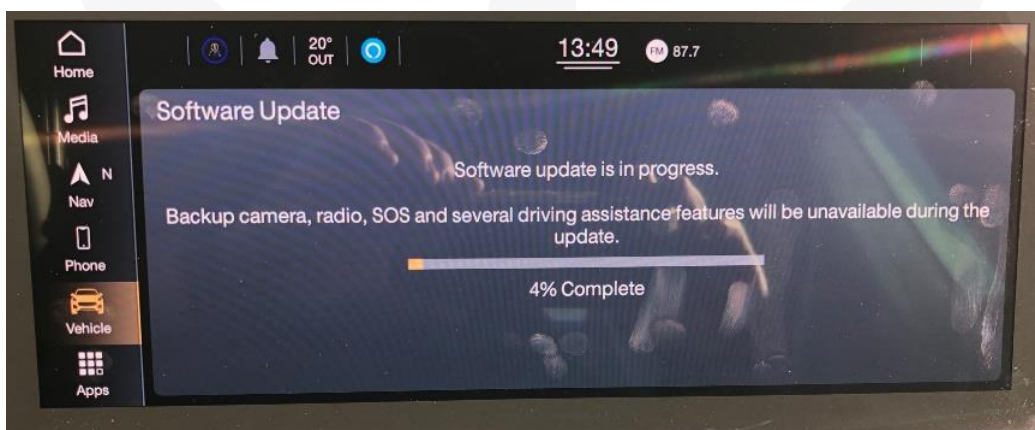
10. This step will take **approx. 25 minutes** (without any action to be done by the operator).

**Note:** During the update, the ETM could show a black screen. In this case, wait for systems to restart without removing the USB Flash Drive from the USB socket.

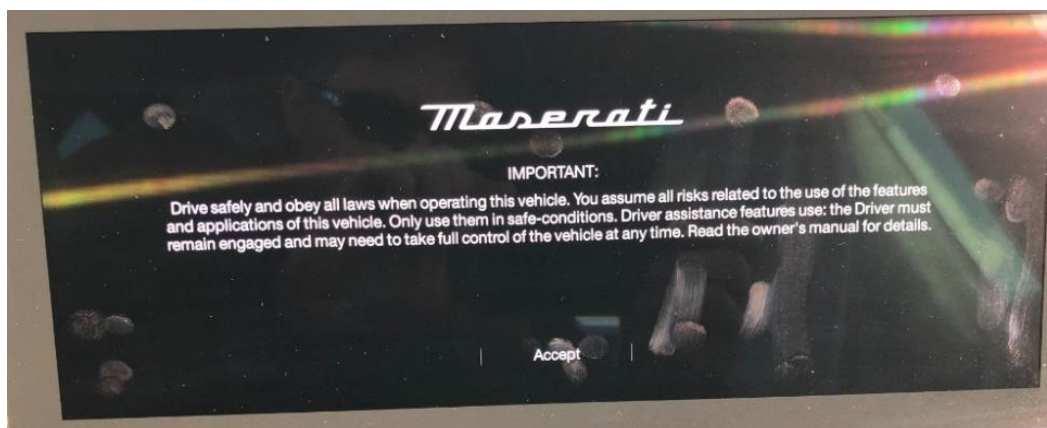
11. Wait for the reboot of the system, then press "Accept".

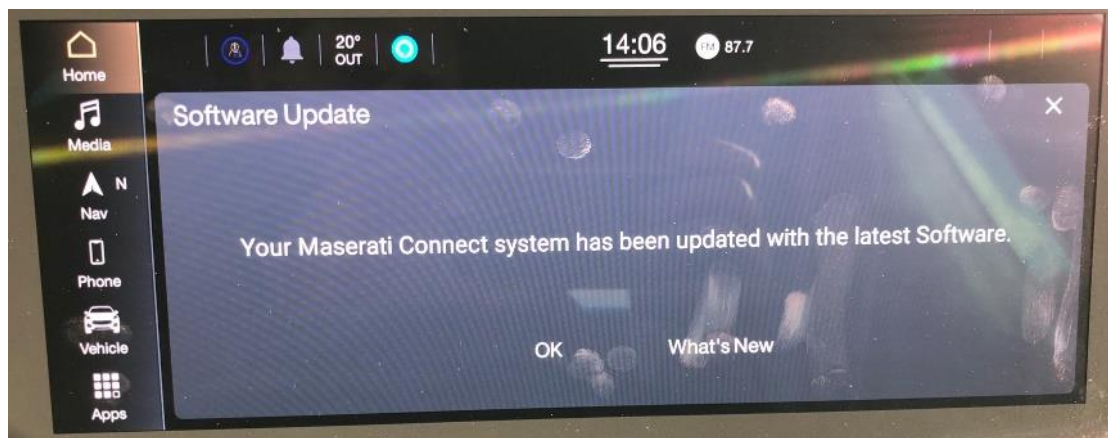
13. The following Prompt will appear and press "OK".

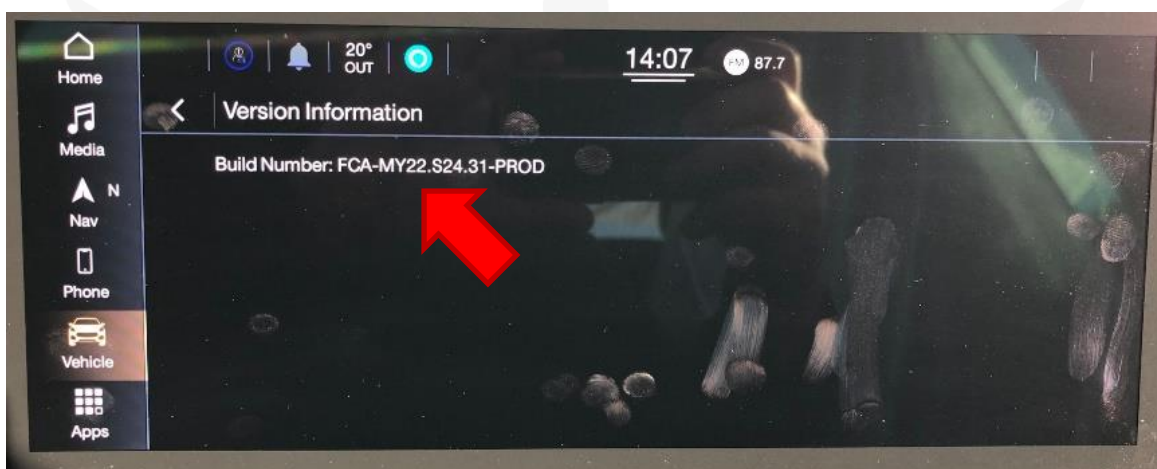
14. Before proceeding with the factory reset, verify that the new software has been installed:

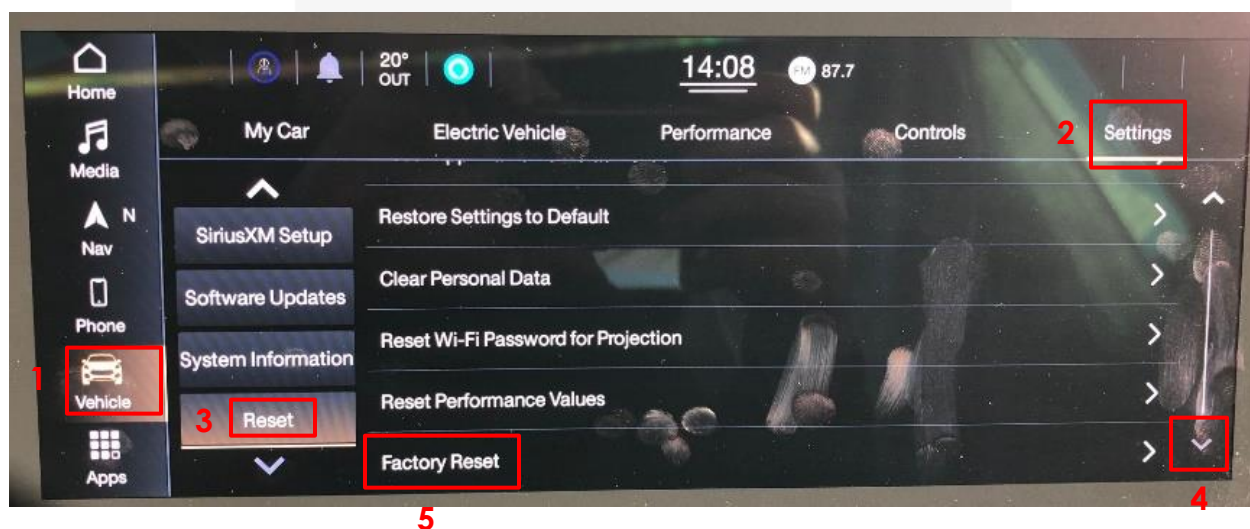
15. Select ►Vehicle ► Settings ►Reset menu and scroll down to view the "Factory Reset" Option:

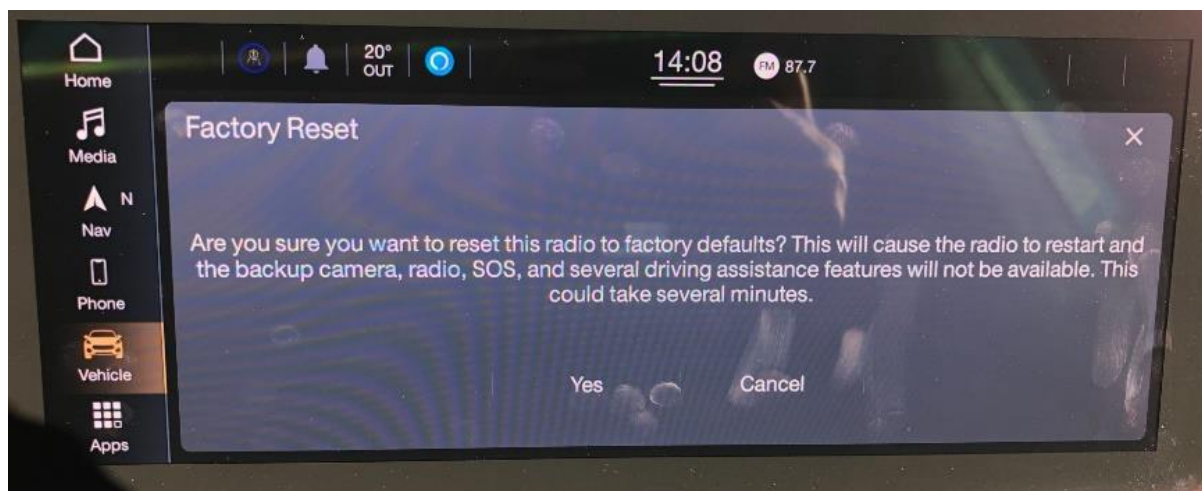
16. Select "Factory reset" and press "Yes".

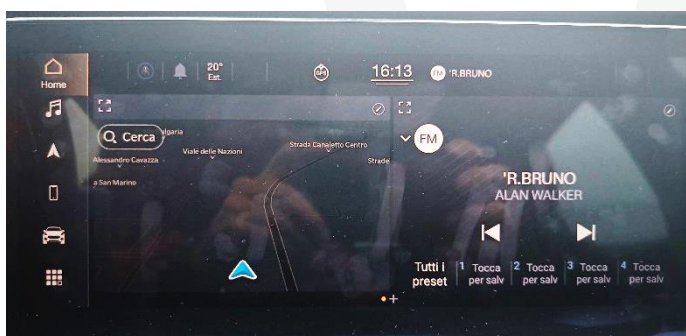
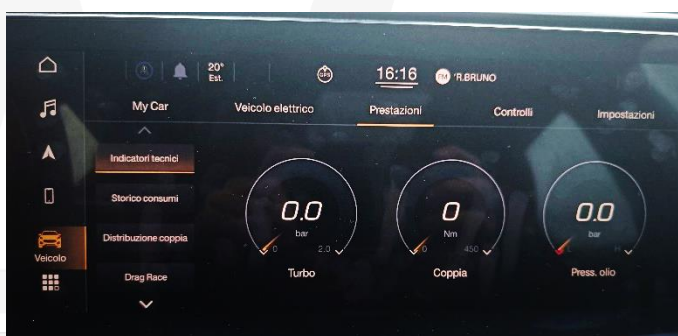
19. Check configuration and ensure that all widgets and screens have the right theme according to the following slides (No Blue theming should be visible):
