NUMBER: 08-204-22

GROUP: 08 - Electrical

Front Passenger Display Module (FPDM) Update to S23

2022	(WL)	Jeep Grand Cherokee
2022	(WS)	Wagoneer / Grand Wagoneer

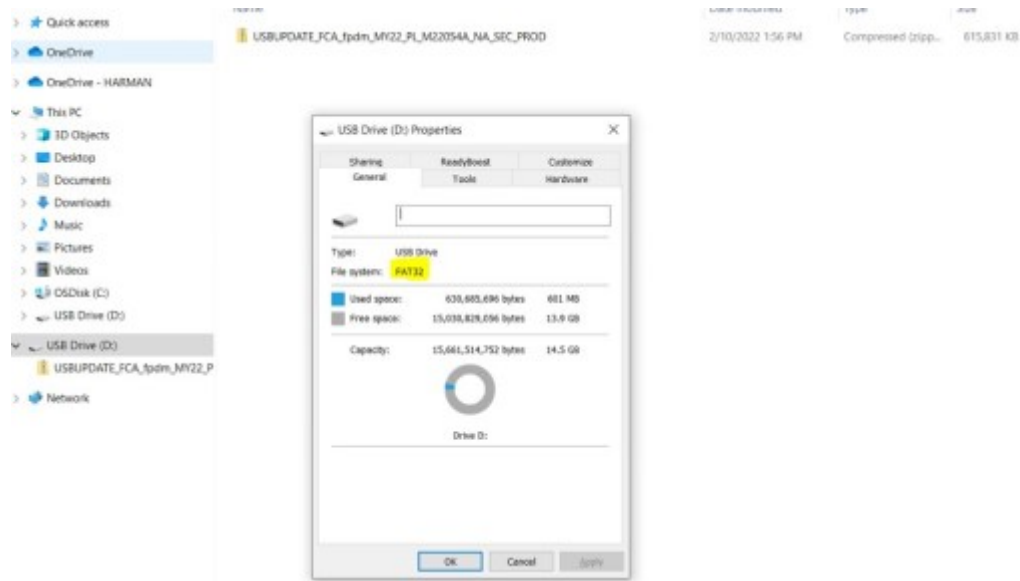
- 7. Copy the update zip file to the root of a USB flash drive. (DON'T RENAME OR UNZIP) (Fig. 2) .

Fig. 2
Software File

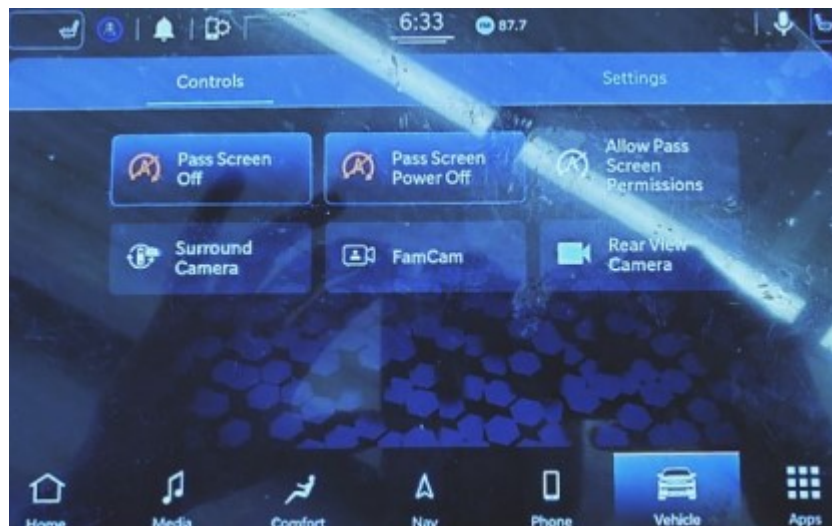
- 8. **Do not unzip** the software when attaching it to the USB flash drive.
NOTE: Only copy the USB UPDATE file to the USB flash drive.
- 9. Once the file is attached to the USB flash drive, it is recommended to label the USB flash drive with the bulletin number.
- 10. Power on the radio and FPDM and turn on the FPDM using the "Passenger Screen Power" controls soft key (Fig. 3) .

Fig. 3
R1 Radio Screen

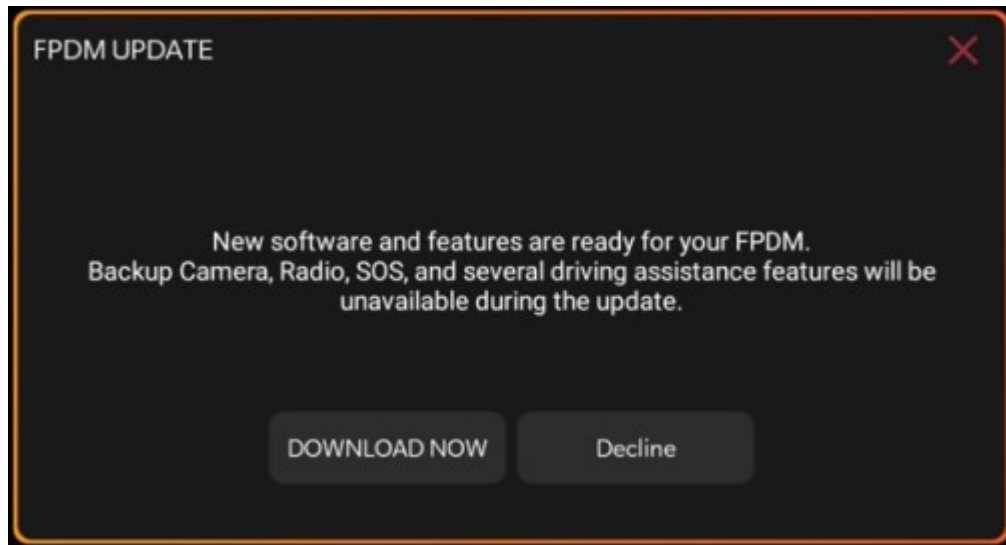
12. Accept the pop-up to download on the radio (Fig. 4) .

Fig. 4
FPDM Update Pop Up

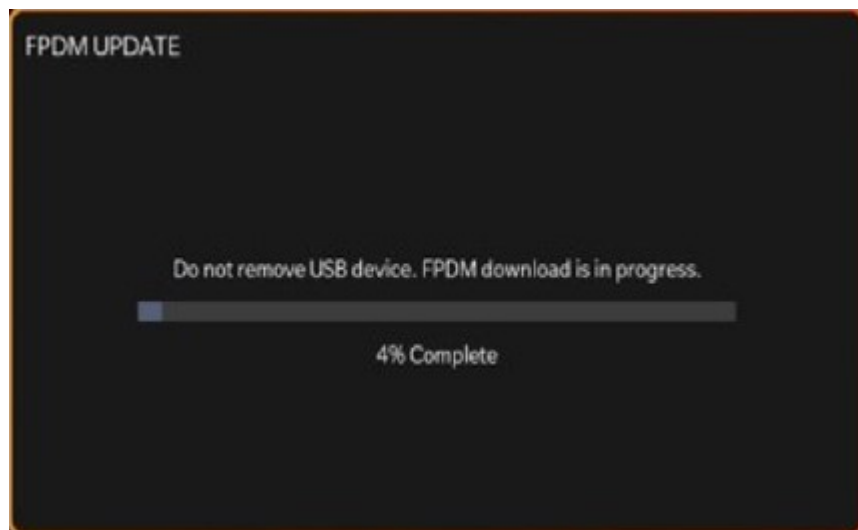
13. The FPDM screen will turn off and begin software download (Fig. 5) , (Fig. 6) .

Fig. 5
Download Screen

Fig. 6
Download Complete Screen

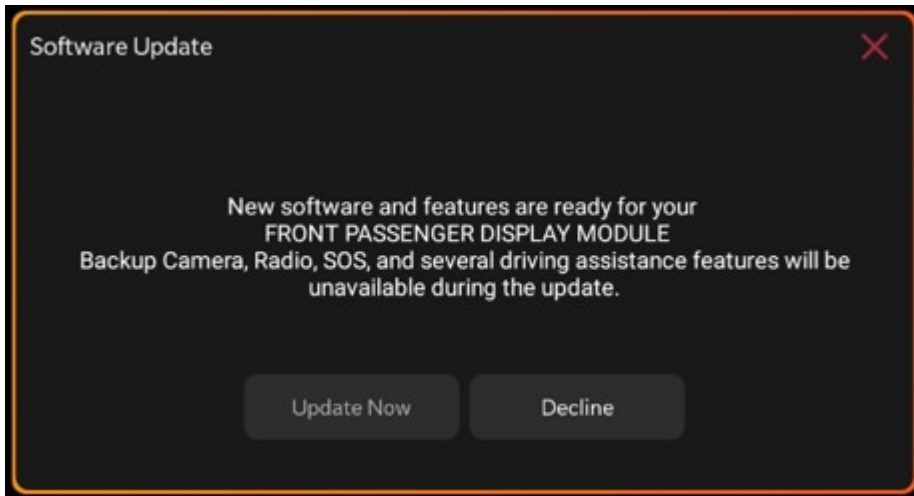
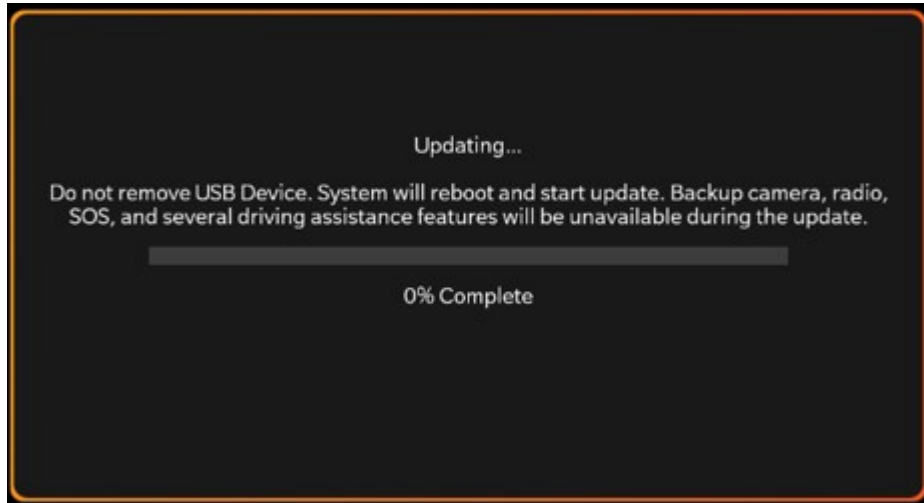
- 14. After the download completes, dismiss the pop-up by pressing the X button on the top right corner.
- 15. Accept the software update by pressing the "Update Now" soft key (Fig. 7) , (Fig. 8) .

Fig. 7
Update Screen

Fig. 8
Updating Screen

16. The FPDM will go through multiple resets during the update.

NOTE: The progress bar will stay at 99% for approximately five minutes. This is not an issue. Please wait and do not power off FPDM.

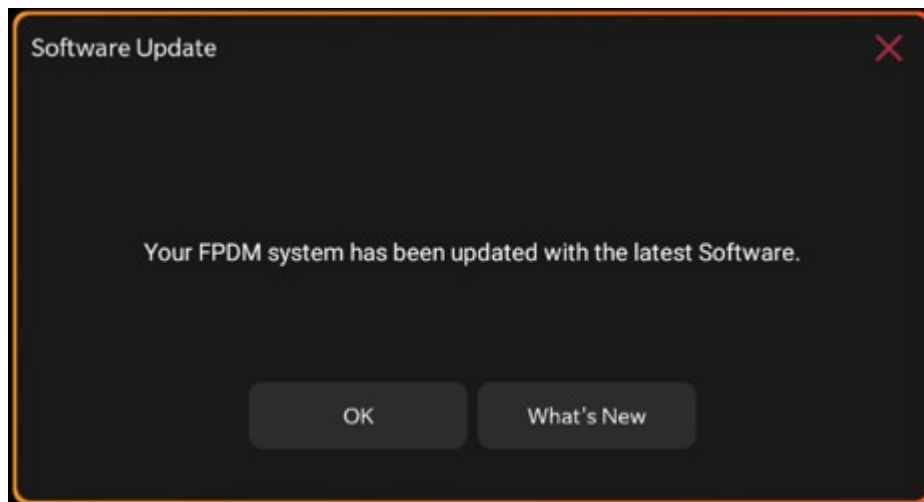
17. When the update is complete, you will see the following popup. Press OK of What's New. Then the system is ready to use (Fig. 9) .

Fig. 9
Update Complete
