**NUMBER:** 08-209-22

Radio Over The Air 24.18 to S26.18 Software Version Updates

This bulletin provides information regarding the latest Firmware Over The Air (FOTA) update and provides the service technician an overview of the steps a customer will need to take to complete the update. The radio software will be updated from S24.18 to to S26.18.

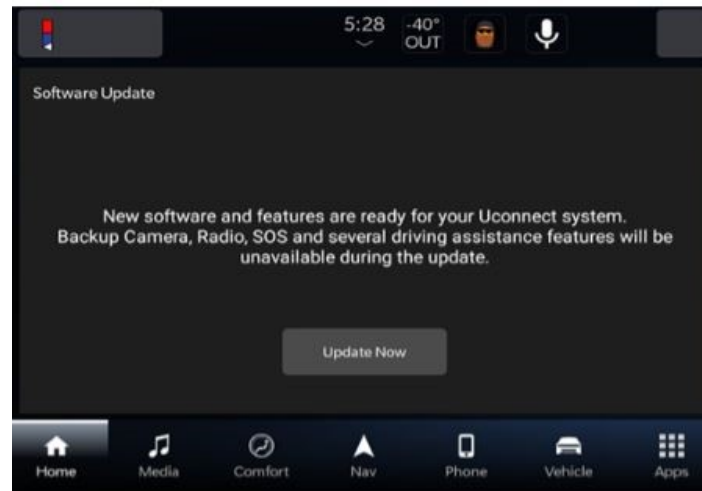
**Fig. 1**  
**Software Acceptance Screen**

1. The vehicle needs to be in 'park'. The ignition needs to be in the off position.
2. If the customer selects “Update Now” they can shut off the vehicle and leave. The update will be completed automatically.
