GLOBAL SAFETY FIELD INVESTIGATIONS
DCS6394
URGENT - DISTRIBUTE IMMEDIATELY

Subject: REVISION: N222372591-01 - Service Update
Charge Air Cooler Icing
Revised Attention Box and Dealer Responsibility Section

Models: 2020 – 2022 Buick Encore GX
2021 – 2022 Chevrolet Trailblazer

N222372591 Charge Air Cooler Icing

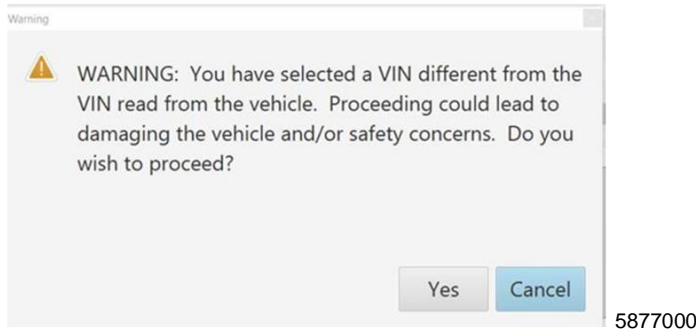
Important: If the vehicle VIN DOES NOT match, the message below will be shown.

Important: Techline Connect screens shown above.
