Service Bulletin

23-008

Product Update: PGM-FI Idle Stop Software Update

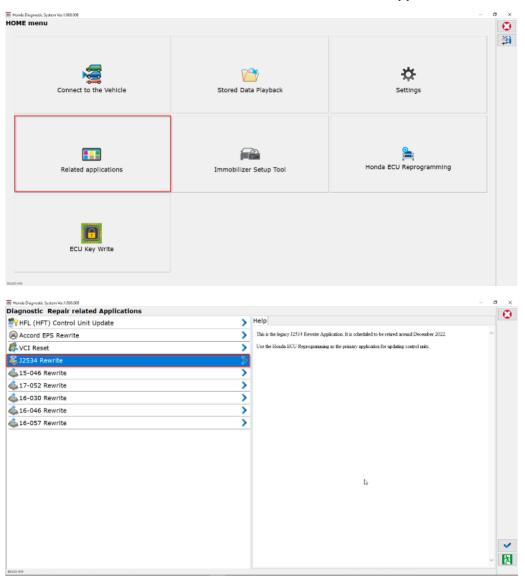
2. From the HOME menu, select the **J2534 Rewrite** under **Related applications**.

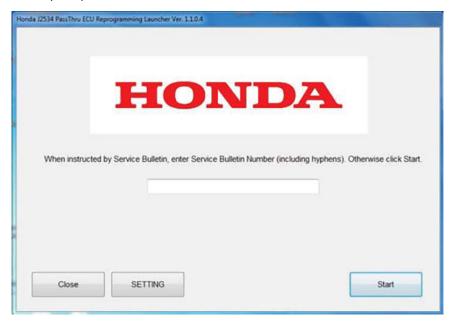
3. When prompted select **Start**, do not enter a service bulletin number.

NOTE: Under certain conditions the **HOME menu** screen may come up. If it does, just minimize it to show the screen under it.

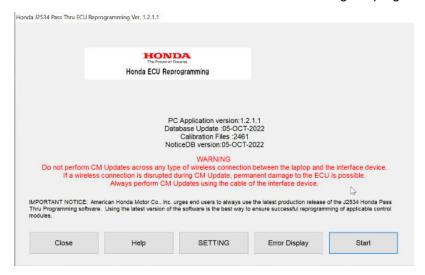
4. Connect the i-HDS to the vehicle and select **Start** to begin reprogramming.

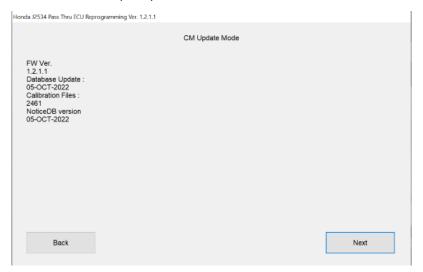
5. Follow the screen prompts, then select **Next.**

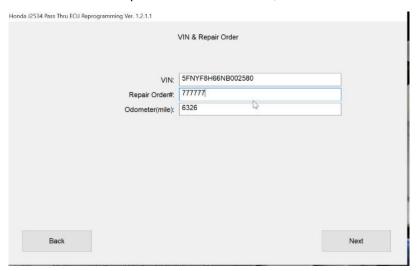
6. Enter the VIN and repair order number. Then, select Next.

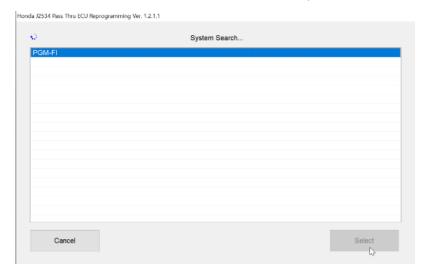
7. Select the **PGM-FI**, and then **Select**.

NOTE: Wait until vehicle communication has completed.

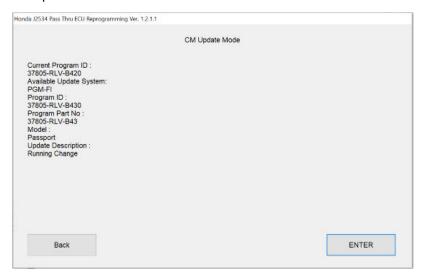
Passport

8. Confirm the update information, then select **ENTER** to proceed.

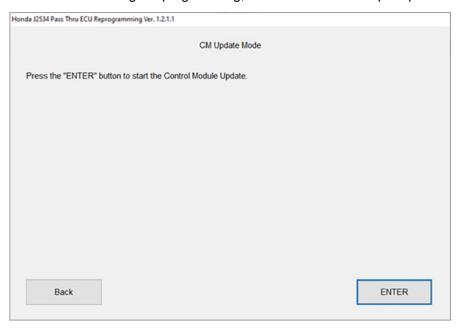
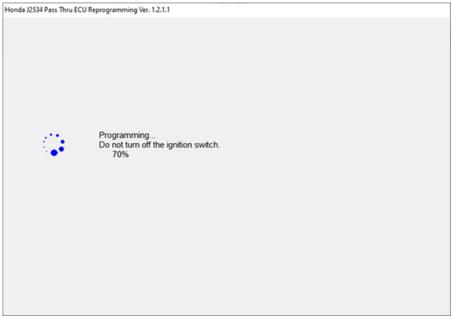
9. Select **ENTER** to begin reprogramming, and follow the screen prompts.

Honda J2534 Pass Thru ECU Reprogramming Ver. 1.2.1.1	
	CM Update Mode
Honda J2534 Pass Thru ECU Reprogramming Ver. 1.2.1.1	
Turn the ignition switch ON within 60 seconds.	CM Update Mode
	58 secs to go

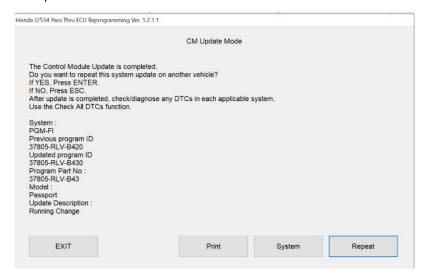
Passport

10. Once the module is updated, the following screen appears, then select **EXIT.**
