# Service Bulletin

23-001

# Product Update: 2016–20 MDX PGM-FI Idle Stop Software Update

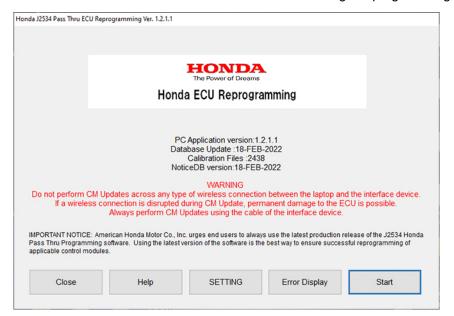
4. Connect the i-HDS to the vehicle and select **Start** to begin reprogramming.

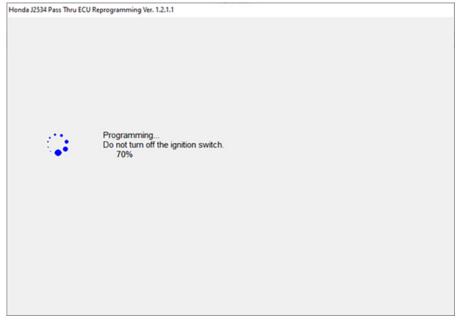
9. Select **ENTER** to begin reprogramming, and follow the screen prompts.

onda J2534 Pass Thru ECU Reprogramming Ver. 1.2.1.1
CM Update Mode
PGM-FI Completed. Turn the ignition switch OFF.
onda J2S34 Pass Thru ECU Reprogramming Ver. 1.2.1.1
wine reserve as the east reprogramming terminal
CM Update Mode
