# Customer Satisfaction Program

## N222378271 Vehicle Software Configuration Management Update

<b>Condition</b>	Certain 2023 model year Cadillac LYRIQ vehicles may have multiple software issues such as no audio, flashing cornering lamps, or lighting concerns.
<b>Correction</b>	Dealers will confirm the over-the-air updates are installed. Various modules will be manually updated by the dealer with the latest software.

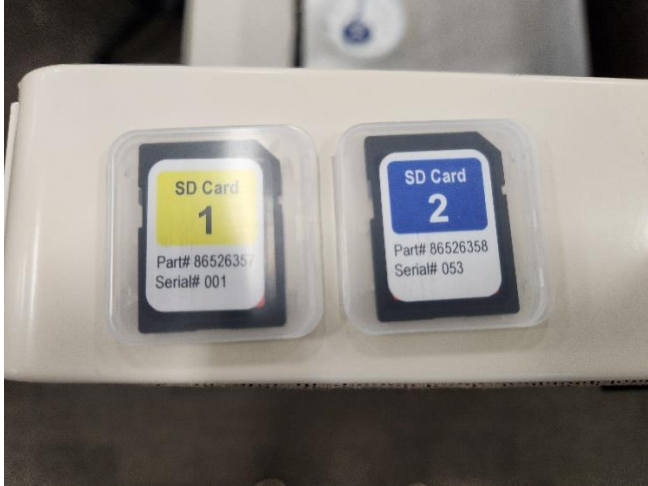
6205333

Service Programming System (SPS) - Special Function

ADAS Compute Platform 3 - SD Card Software Update

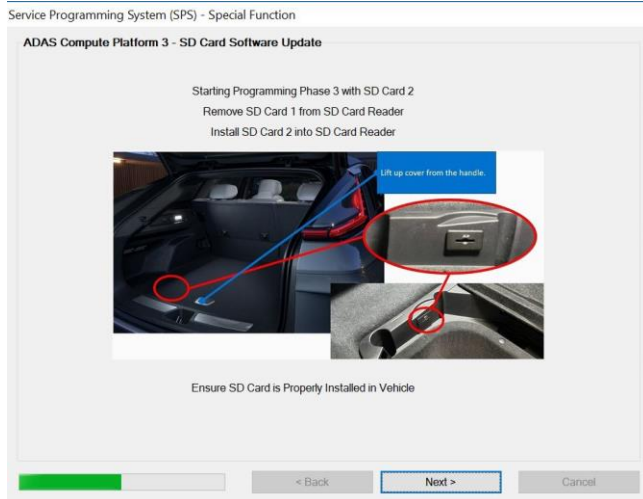
6205343

6. Select Image Processing Module 1 Processor 2 and select “Programming” in Techline connect. Insert SD card 1 located at the rear of the vehicle and follow on-screen instructions. There are 2 cards and they must be used in order.
7. Record SPS Warranty Claim Codes on job card for warranty transaction submission. Submit the last warranty claim code after all programming has been completed.
