GROUP	MODEL
ELE	2022MY Carnival (KA4) w/AVN 5.0W
NUMBER	DATE
258 (Rev 1, 01/18/2023)	August 2022

TECHNICAL SERVICE BULLETIN

SERVICE ACTION: AVN 5.0W SOFTWARE UPDATE FOR Wi-Fi FUNCTIONALITY (SA504)

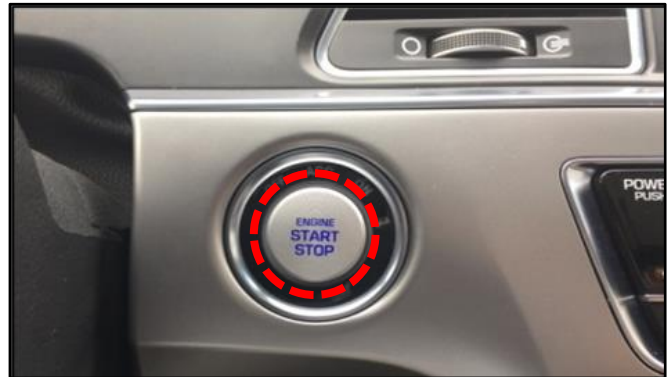
1. Press the 'START' button to turn ignition 'ON'. (DO NOT start the engine)

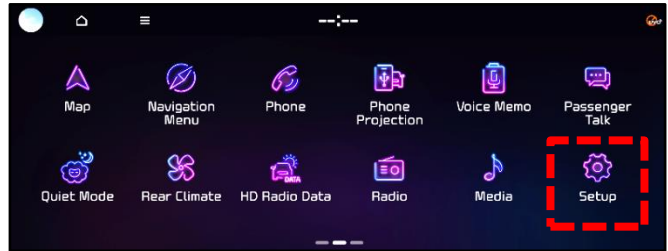
2. Select 'Setup' on the head unit.

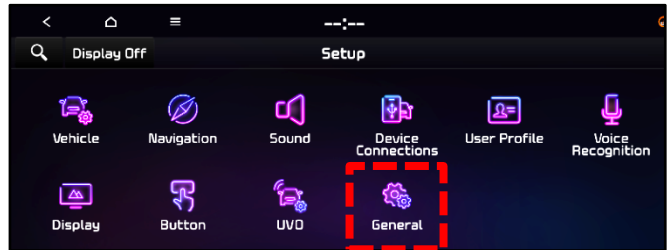
3. Select 'General'.

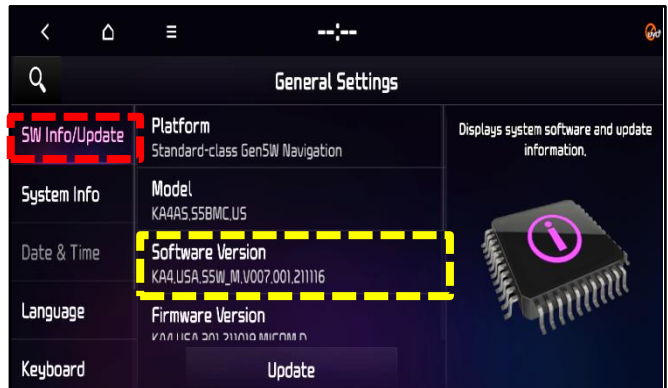
4a. Select 'SW Info/Update'.

4b. Verify that an earlier software version is currently installed. Refer to the "Software Version" table on page 4.

If the SW version is older than the "New Version" in the table, proceed with the update.

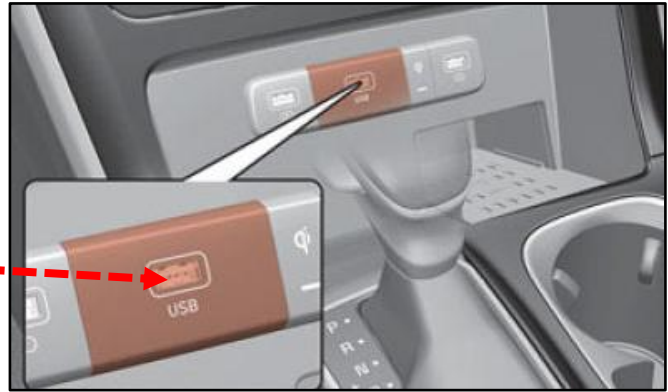
5. Insert the supplied USB flash drive containing the downloaded files into the vehicle's USB port.

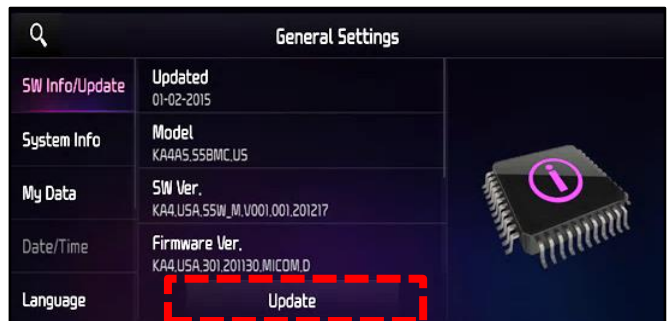
6. Select 'Update'.

Do Not remove the USB drive or turn off the ignition during the update.

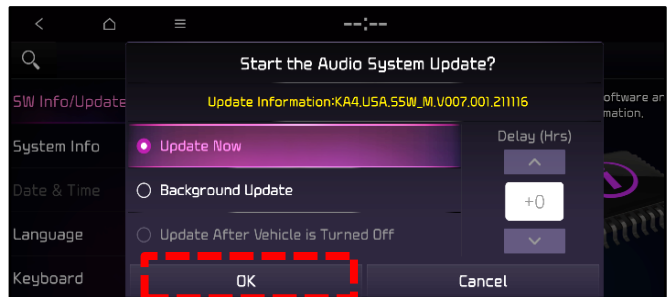
7. Select 'OK' on the pop-up message.

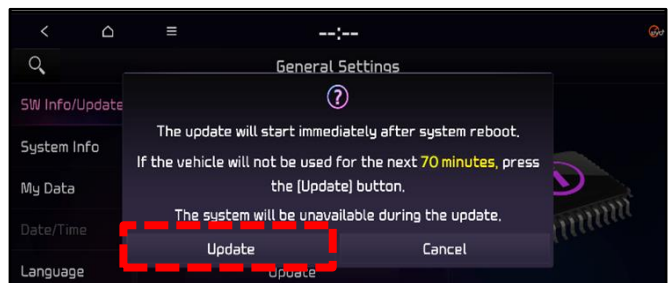
8. Select 'Update'.

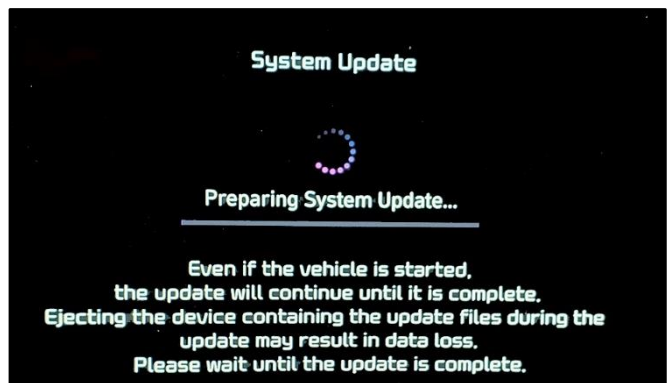
9. The software update will begin.

- Update may take 70 minutes or more.
- Do **NOT** turn off power or remove the USB drive. Removing it during the update may cause data loss or system failure.
- There will be multiple occurrences where the Kia logo will appear, or the display will be black during the update process. This is normal.

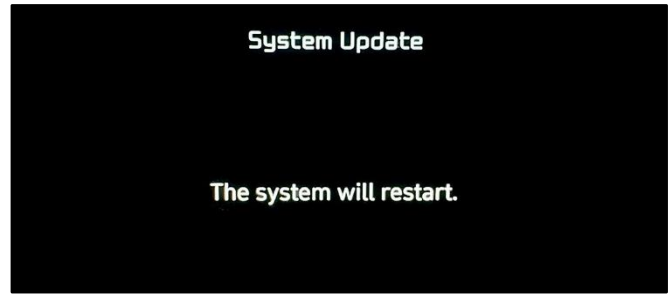
The image shown on the right will appear when the installation is complete. Wait for the system to restart.

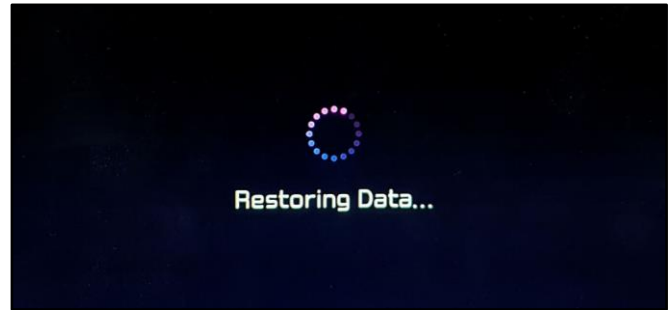
After the system reboots once, the 'Restoring Data' message will be displayed. The system will automatically reboot once again.

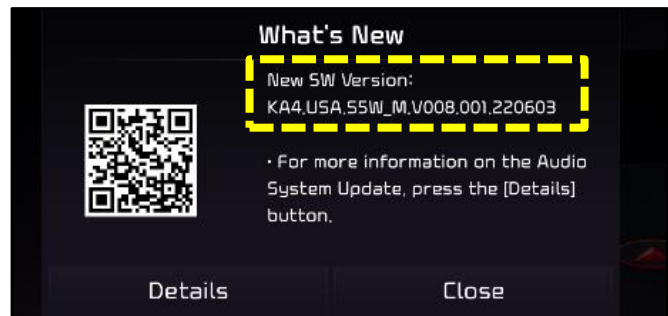
10. After the update is completed, the screen shown on the right will display with the new software version.

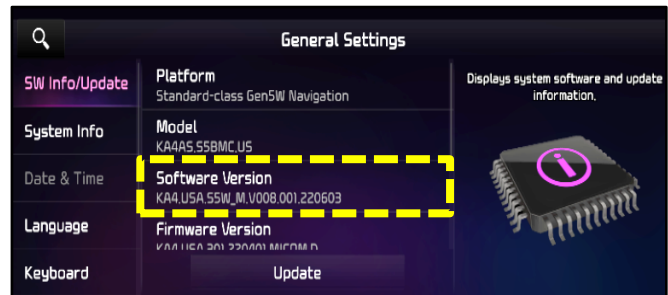
11. Confirm the new Software Version was installed correctly. Updated software version should be:
KA4.USA.S5W_M.V008.001.220603
 (or later)

Note: Refer to the Software Version table below.
