MODEL  
2017-2019MY  
Optima (JF P/HEV)

## TECHNICAL SERVICE BULLETIN

**SERVICE ACTION: BMS/OPU/MCU  
LOGIC IMPROVEMENT (SA411)**

This bulletin provides the procedure to improve the logic of the Battery Management System (BMS), Oil Pump Control Unit (OPU) and Motor Control Unit (MCU) on some 2017-2019MY Optima (JF P/HEV) vehicles, produced from August 25, 2016 through September 13, 2018 (refer to page 8) in order to improve the BMS diagnosis logic, OPU judgment logic for DTC P1B77 (High Voltage Battery Pre-Charging fault) and MCU communication logic. To correct this concern, apply the improved logic to the following three (3) systems: BMS, OPU and MCU using the KDS ECU Upgrade function as described in this bulletin. For confirmation that the latest reflash has been applied to a vehicle you are working on, verify the ROM ID using the table on page 3 of this bulletin. Before conducting the procedure, verify that the vehicle is included in the list of affected VINs.

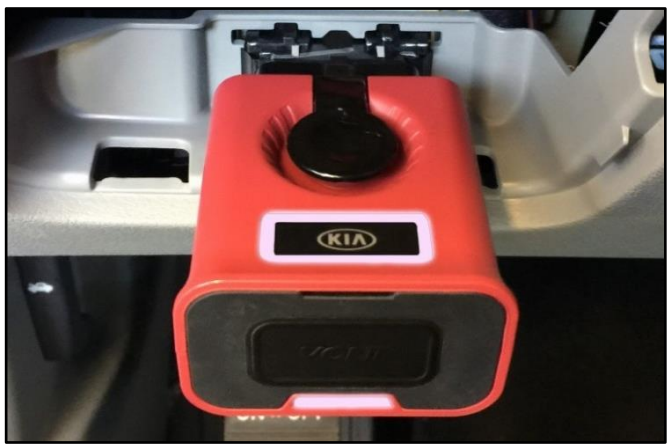
- 1. Connect the VCI-II to the OBD-II connector, located under the driver's side of the instrument panel.

**\* NOTICE**  
The ECU upgrade function on KDS operates wirelessly. It is not necessary to perform the upgrade via USB cable.

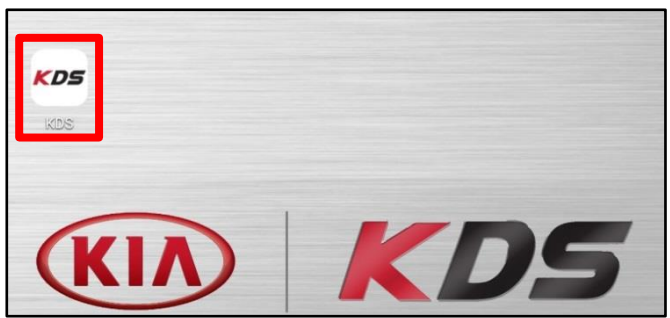
- 2. With the ignition ON, turn ON the KDS tablet. Select **KDS** from the home screen.

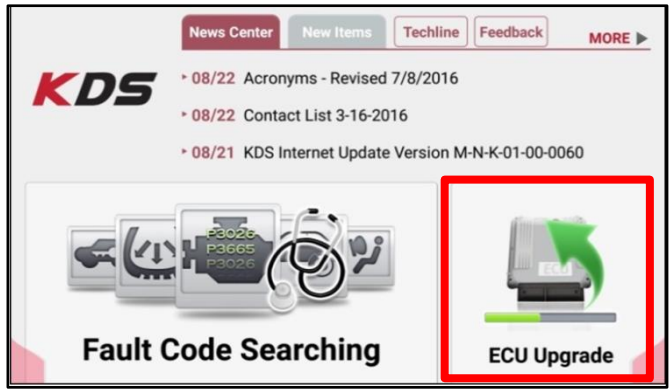
- 4. Select **ECU Upgrade**.

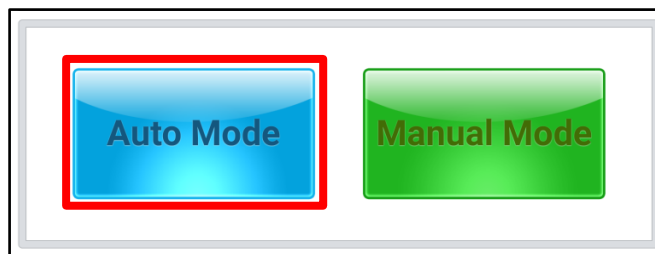
- Select **Auto Mode**.

Do NOT attempt to perform a Manual Mode upgrade UNLESS Auto Mode fails. Always follow the instructions given on the KDS in either Auto or Manual mode.

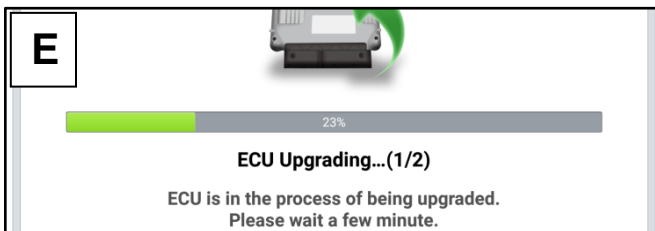
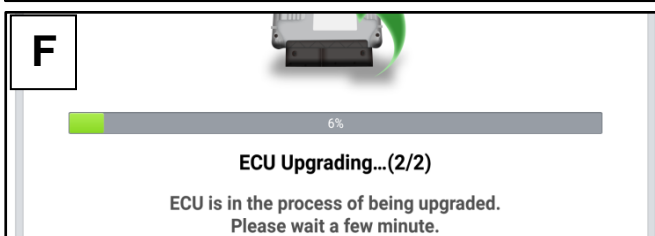
- The ECU upgrade will begin and the progress of the upgrade will appear on the bar graph. Upgrade part (1/2) (E) will download the upgrade event to the VCI-II. Upgrade part (2/2) (F) will upgrade the ECU.

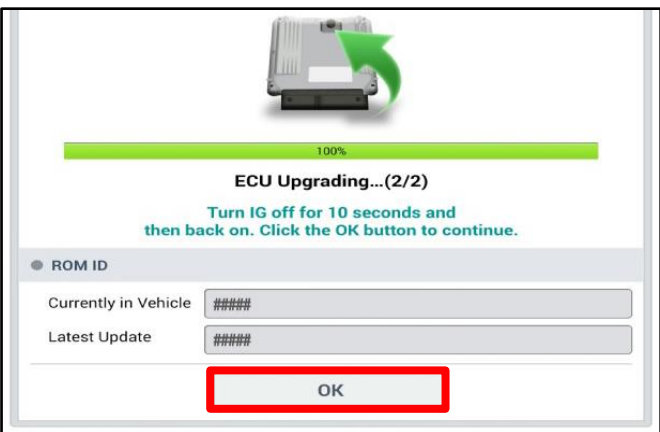
- When instructed on the KDS, turn the ignition **OFF** for ten (10) seconds then back on. Touch **OK** to continue.

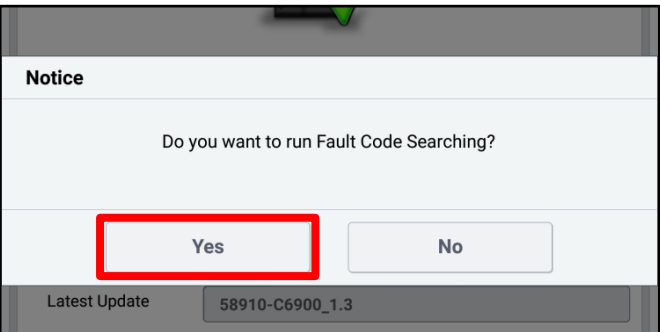
- When prompted, select **YES** to check for Diagnostic Trouble Codes (DTC) and erase any DTCs stored such as EPS, ESC, and TPMS that may have been set during the upgrade.
