SUBJECT: **SERVICE ACTION: CLUSTER LOGIC IMPROVEMENT  
FOR ADAS ALERT VOLUME CHANGE (SA517)**

This bulletin provides the procedure to update the software logic of the Cluster (CLU) system on some 2023MY vehicles to allow the Advanced Driver Assistance System (ADAS) default alert volume to be changed. Kia is requesting the completion of this Service Action on all affected vehicles in dealer stock, prior to delivery. Follow the procedure outlined in this publication to apply the improved logic to the 'CLU' system using the KDS ECU Upgrade function as described in this bulletin. For confirmation that the latest reflash has been applied to a vehicle you are working on, verify the ROM ID using the table on pages 3-5 of this bulletin. Before conducting the procedure, verify that the vehicle is included in the list of affected VINs.

**This issue number is SA517.**

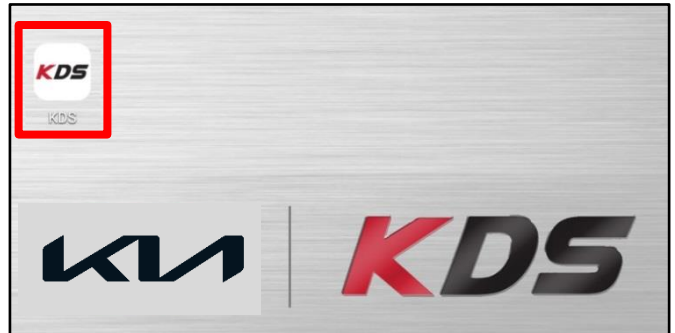
2. With the ignition ON, turn ON the KDS tablet. Select 'KDS' from the home screen.

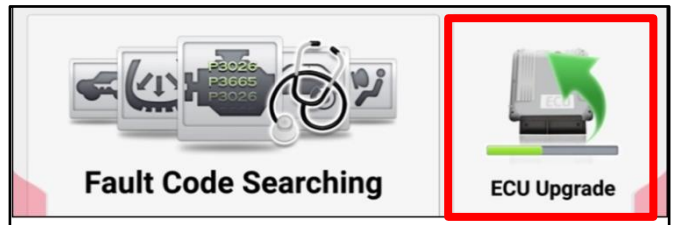
4. Select 'ECU Upgrade'.

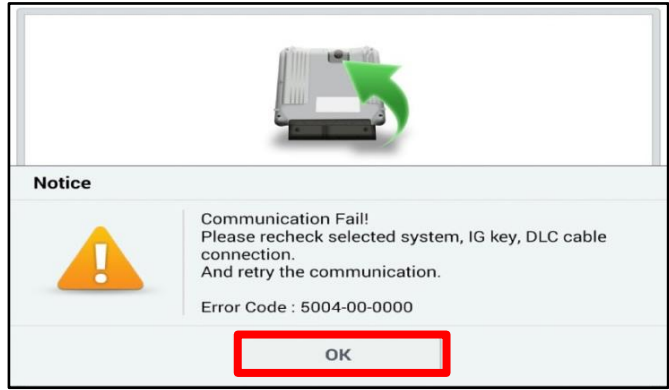
- If a "Communication Fail" screen appears, verify that the VCI-II and KDS are communicating properly. Select 'OK' and restart the from step 4.

**NOTICE**  
**If an error notice continues to appear or if the upgrade cannot be performed, DO NOT disconnect the KDS/VCI-II. Contact GIT America Help Desk at (888) 542-4371 or Techline.**

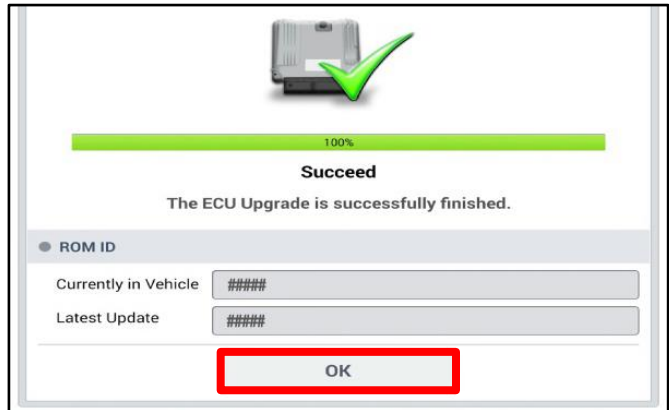
- Once the upgrade is complete, select 'OK' to finalize the procedure.

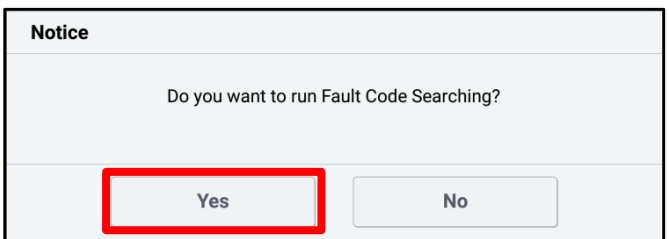
- When prompted, select 'YES' to check for Diagnostic Trouble Codes (DTC) and erase any DTCs stored such as EPS, ESC, and TPMS that may have been set during the upgrade.
