<b>Subject:</b>  09-001/23- DTC U3000:04 STORED AFTER CONNECTED VEHICLE SERVICE CONTRACT HAS BEEN DISCONTINUED	<b>Bulletin No.:</b> 09-001/23
	<b>Last Issued :</b> 01/03/2023

2021-2023 Mazda3  
2021-2023 CX-30  
2021-2023 CX-5  
2021-2023 CX-9  
2022 MX-30  
2023 CX-50

## DESCRIPTION

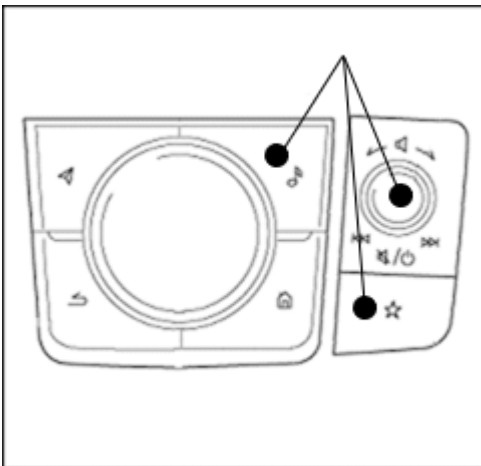
[Mazda3, CX-30, MX-30, CX-50]

g. Press and hold the Volume knob, then press and hold the Entertainment and Favorites buttons at the same time for 3-5 seconds and the Factory/Service Inspection screen will appear.

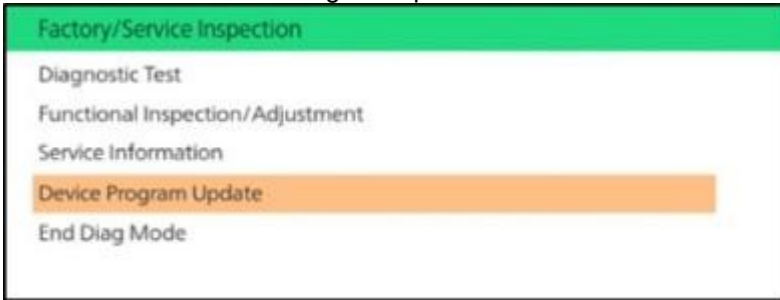
h. Select "Device Program Update" on the screen below.

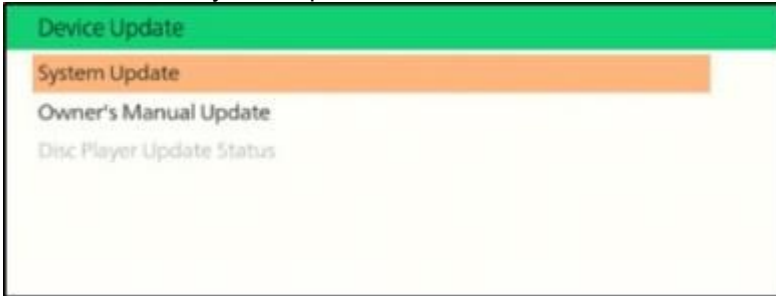
i. Select "System Update" on the screen below

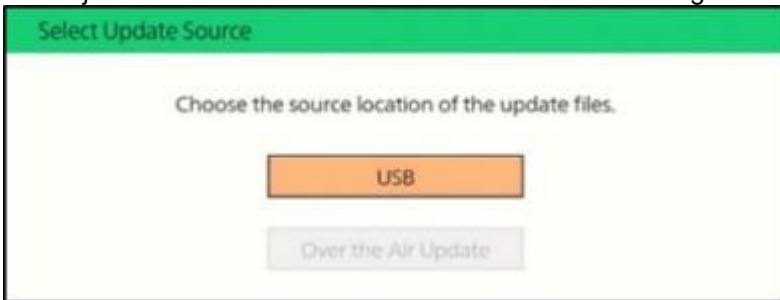
j. Select "USB" on the screen below to start checking for the update file.

**NOTE:** If "Update file(s) not found" message appears, the wrong file may be stored in the USB memory or the vehicle has already been updated.

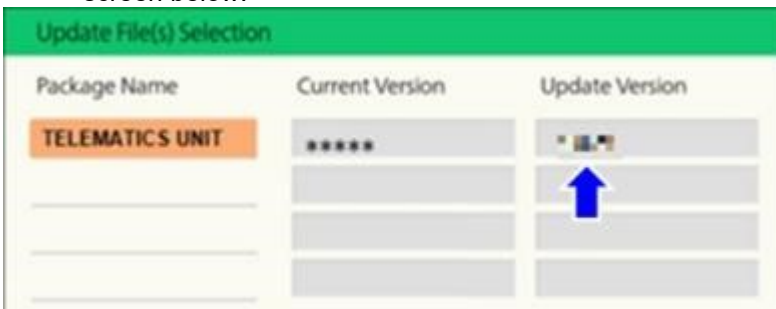
k. Confirm the correct software version is shown under "Update Version" and select "TELEMATICS UNIT" on the screen below.

Model	Update Version
MAZDA3 (BP)	10007
CX-30 (DM)	10007
MX-30 (DR)	10020
CX-5 (KF)	10024
CX-50 (VA)	10004
CX-9 (TC)	10024

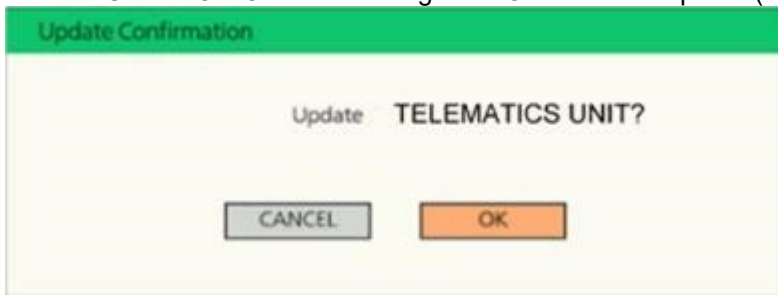
l. Select "OK" on the screen below and wait until the update (loading) is completed.

**NOTE:** DO NOT switch the ignition OFF until the update (loading) is completed.

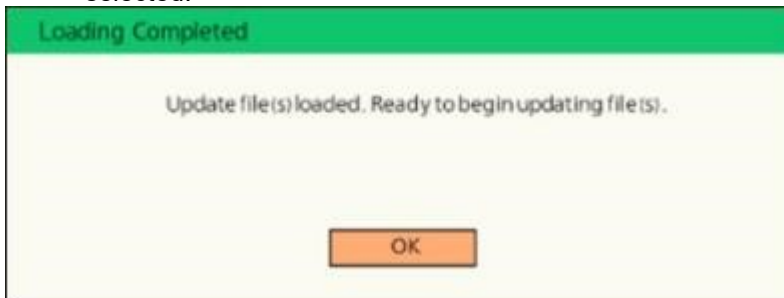
m. Select "OK" on the screen below. The data update will start automatically after 10 seconds if "OK" is not selected.

**NOTE:** After selecting "OK", the system will reboot and the display will turn black, followed by these screens:

- Sending update file(s)
- Checking update file(s)
- Installing update file(s)
- Completed

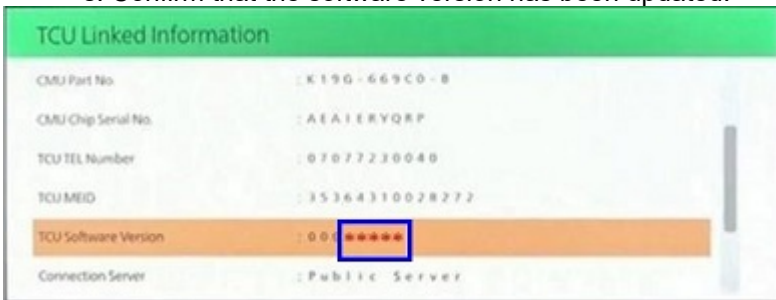
r. Select TCU Linked Information, then scroll down to TCU Software Version.

s. Confirm that the software version has been updated.

Model	Update Version
MAZDA3 (BP)	10007
CX-30 (DM)	10007
MX-30 (DR)	10020
CX-5 (KF)	10024
CX-50 (VA)	10004
CX-9 (TC)	10024
