<b>HYUNDAI</b> <b>Technical Service Bulletin</b>	GROUP <b>CAMPAIGN</b>	NUMBER <b>23-01-002H</b>
	DATE <b>JANUARY, 2023</b>	MODEL(S) <b>Sonata (DN8, DN8a)</b>
<b>SUBJECT:</b> ICU (INTEGRATED CENTRAL CONTROL UNIT) SOFTWARE UPDATE (SERVICE CAMPAIGN T9O)

**Description:** Some 2021 ~ 2022MY Sonata (DN8/DN8a) vehicles with N-Line trim may not engage Forward Collision Avoidance Assist – Junction Turning (FCA-JT) due to omitted logic.

This bulletin provides the service procedure to update the ICU (Integrated Central Control Unit) software to resolve the condition stated above.

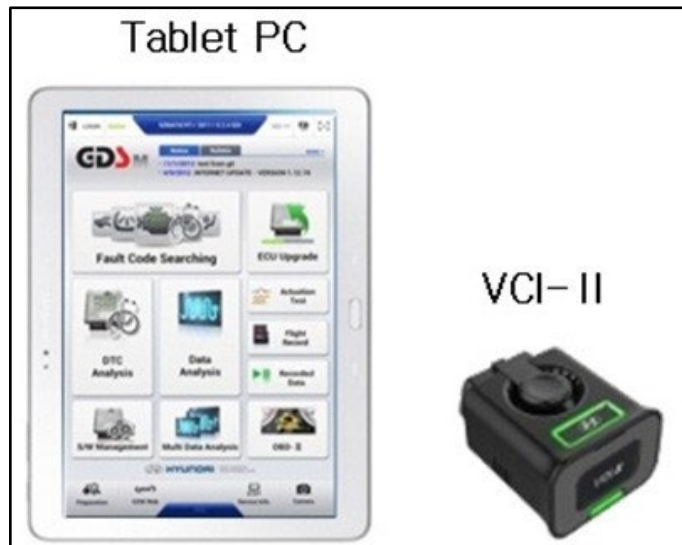
ECU upgrade function on GDS-Mobile is basically operating in wireless communication and Wi-Fi direct. Also, it is possible to be performing via USB cable between Tablet PC and VCI-II.

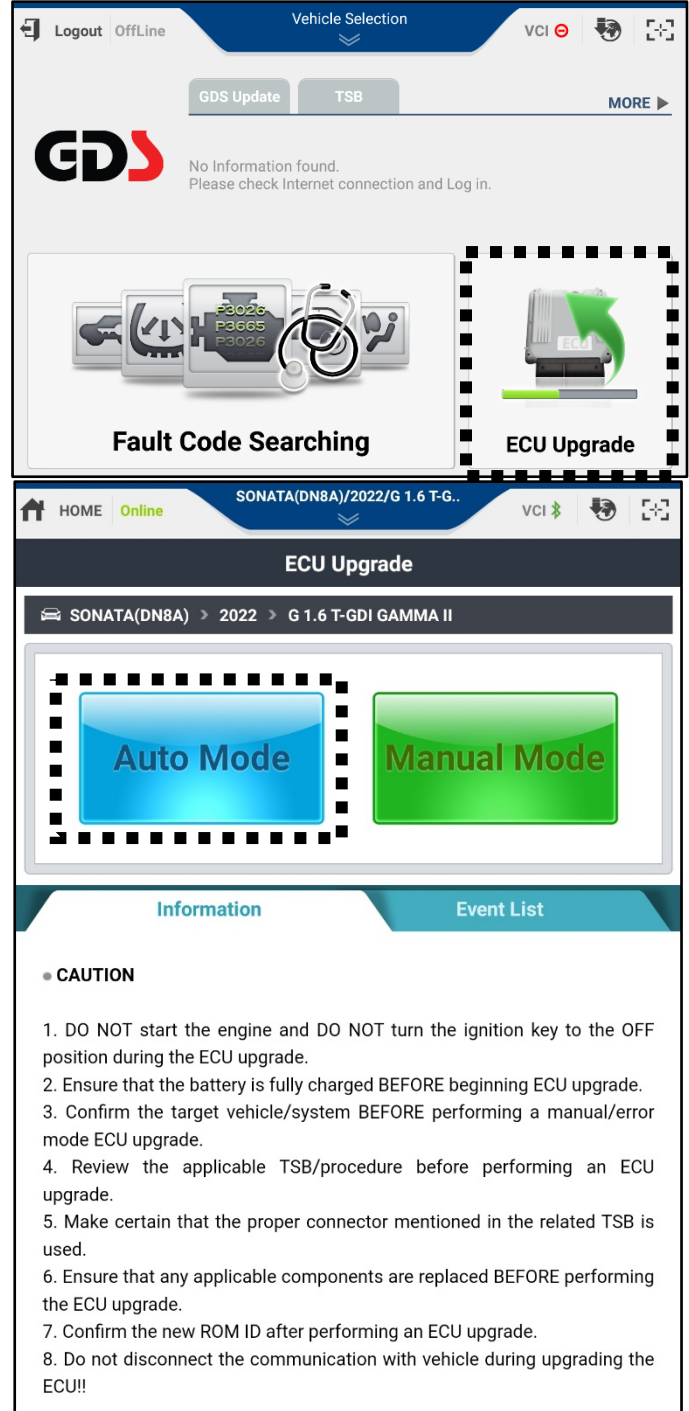
2. Select ECU Upgrade on the initial screen after entering the vehicle information and select Auto Mode.

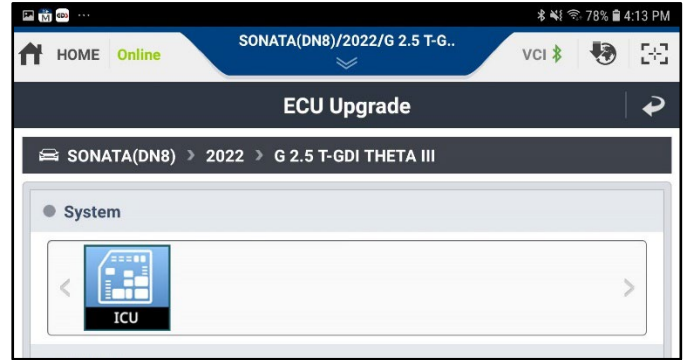
3. Select ICU system.

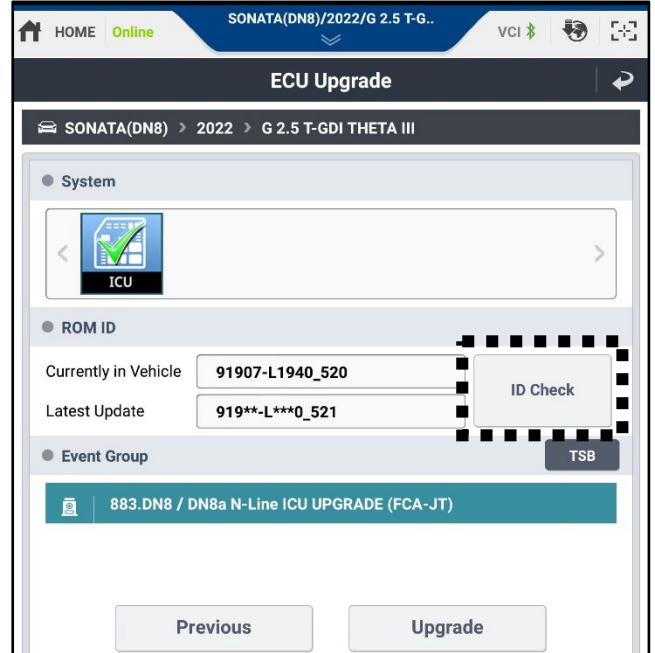
4. Select **ID Check** and GDS will read the current ROM ID in vehicle and check the newest upgrade event.

Check the current version of the ICU ROM ID and compare it to the ROM ID Information Table before attempting to perform the software update.

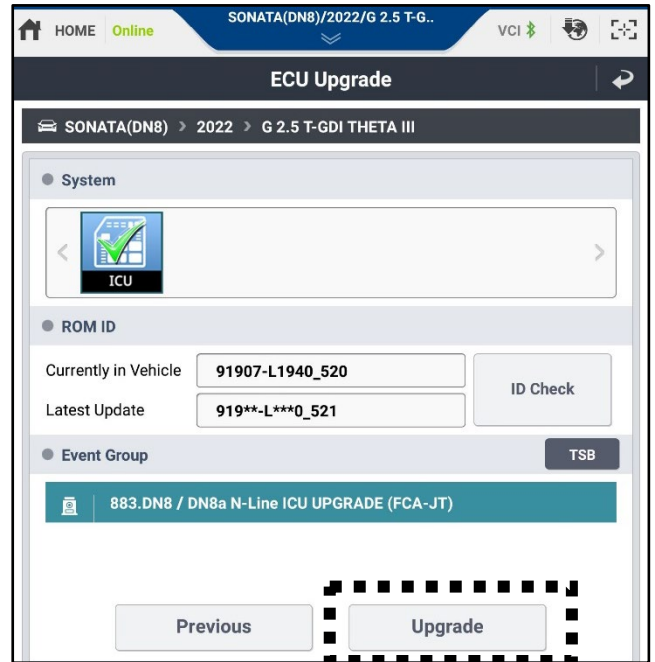
5. Select **Upgrade** after confirming correct Event is selected.

**"883.DN8 / DN8a N-Line ICU UPGRADE (FCA-JT)"**

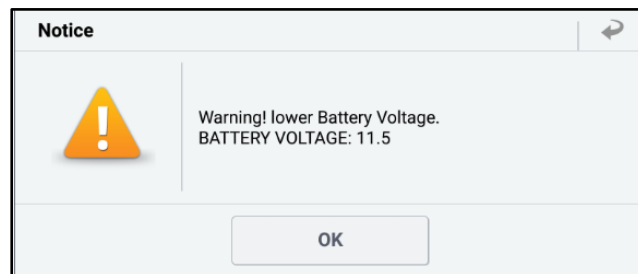
6. The vehicle battery voltage is checked to make sure it is at least 12 voltages to assure reliable upgrade results. Click OK if the results indicate voltage is ok.

If battery voltage is below 12 voltages as below, click BACK and then run the engine to assure an adequate battery charge state for reliable upgrade results.

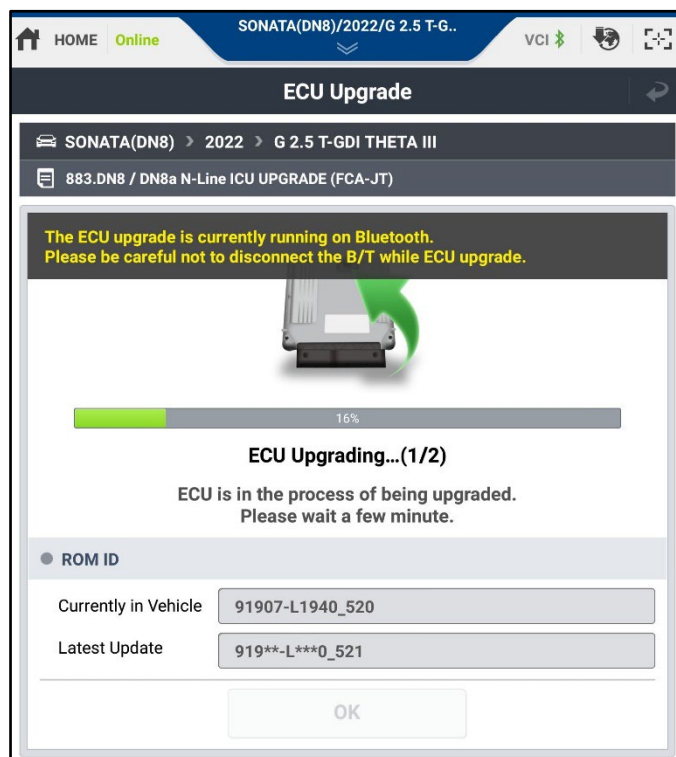
7. Upgrade (1/2) will begin, and the progress of the upgrade will appear on the bar graph.

Upgrade (1/2) will occur until 100% is reached on the bar graph.

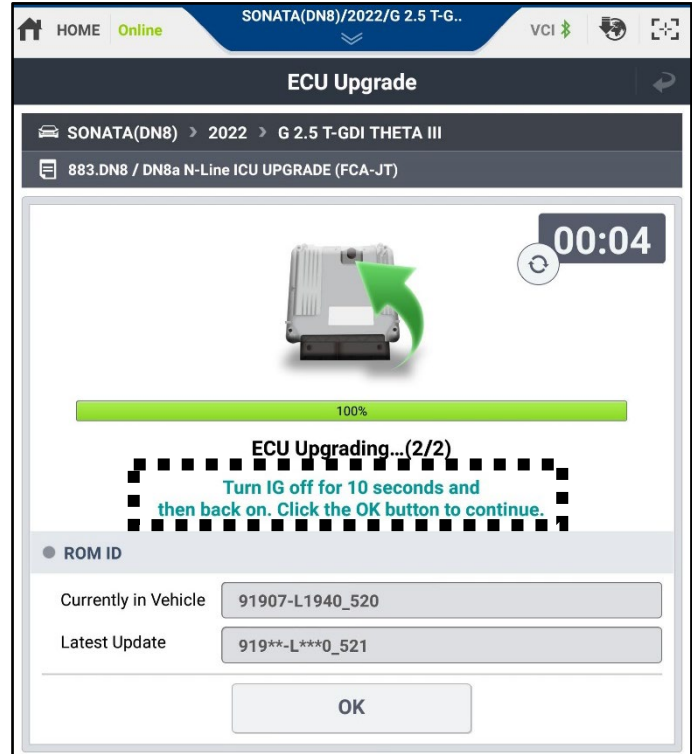
8. Upgrade (2/2) will begin, and the progress of the upgrade will appear in the bar graph.

Upgrade (2/2) will occur until 100% is reached on the bar graph.

When upgrade reaches 100%, follow GDS instructions to “Turn IG off for 10 seconds and then back on. Click the OK button to continue.”

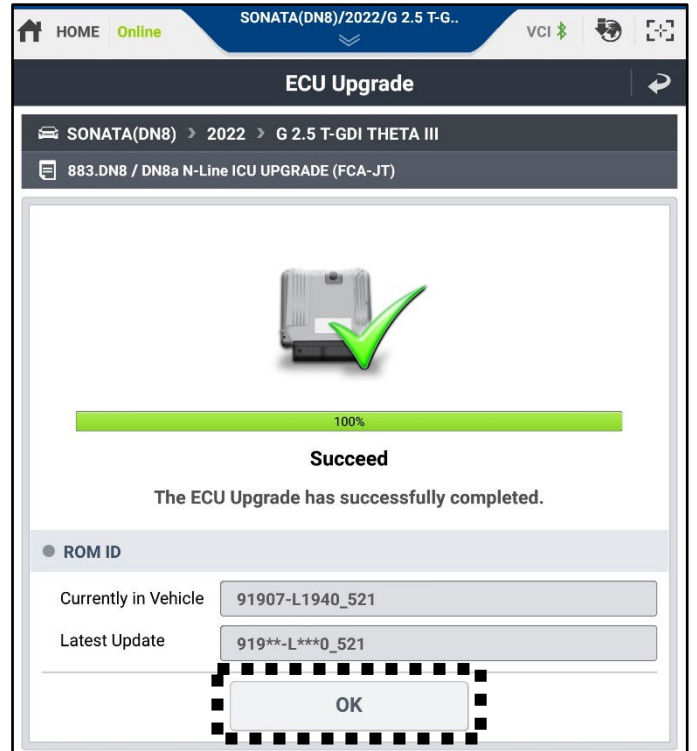
9. Click **OK** on the final screen, which indicates upgrade is complete.

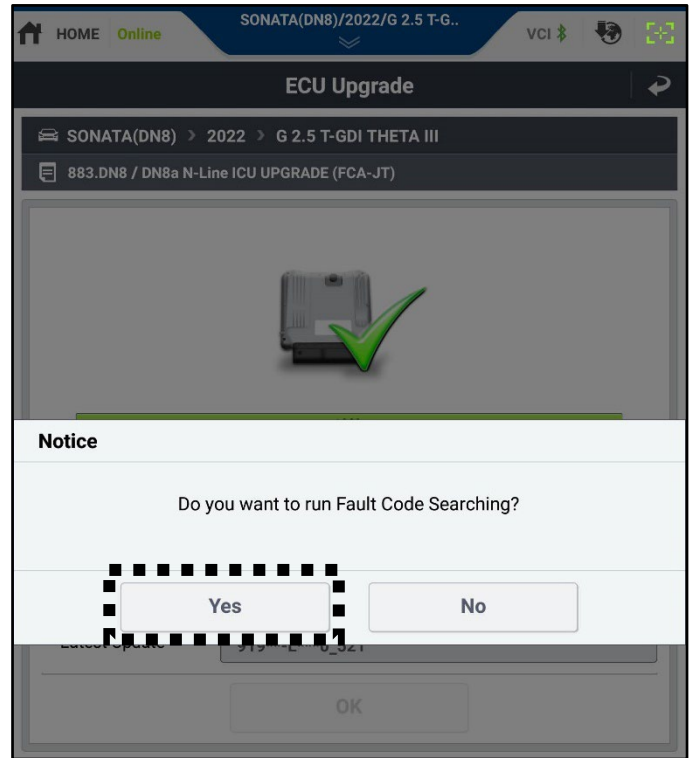
10. Check if any incidental Diagnostic Trouble Codes (DTC) have been created by the upgrade and clear the DTC(s) present.

Start the engine to confirm proper operation of the vehicle.

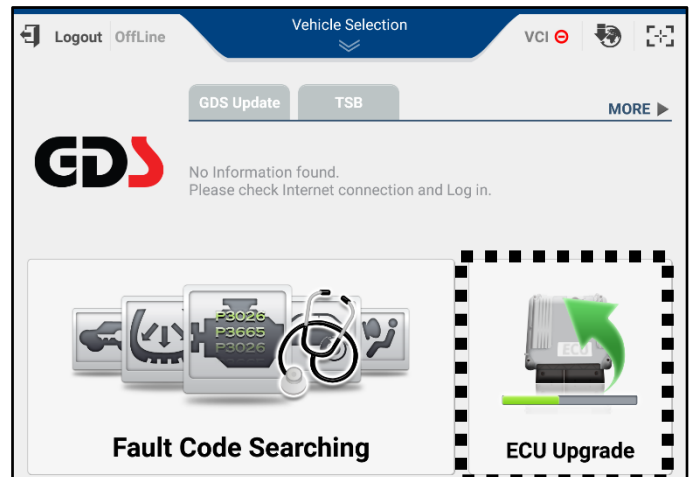
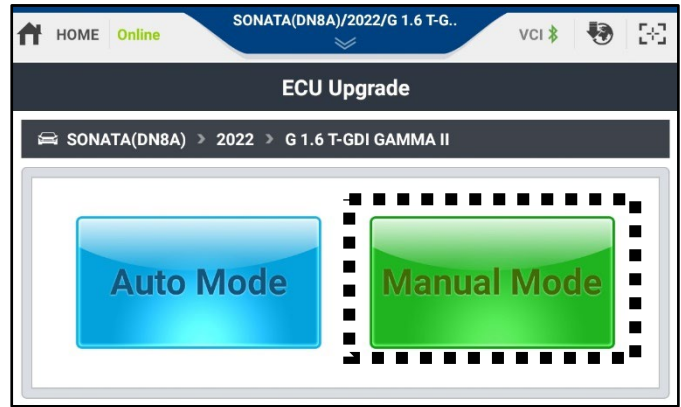
11. Select ECU Upgrade on the initial screen after entering the vehicle information and select Manual Mode.

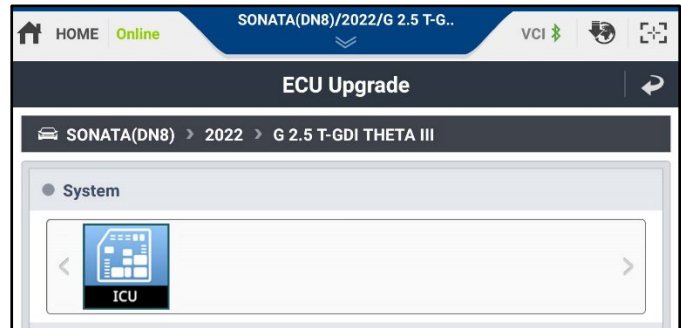
12. Select ICU system.

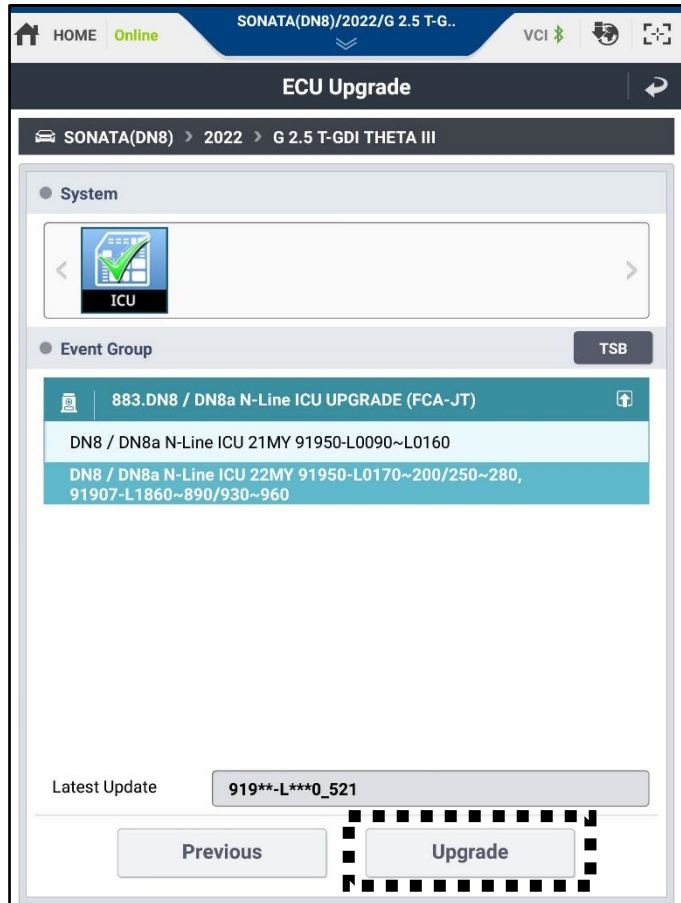
13. Check that the newest event with reference to the above ROM ID Information Table is selected and select **Upgrade**.

**“883. DN8 / DN8a N-Line ICU Upgrade (FCA-JT)”**

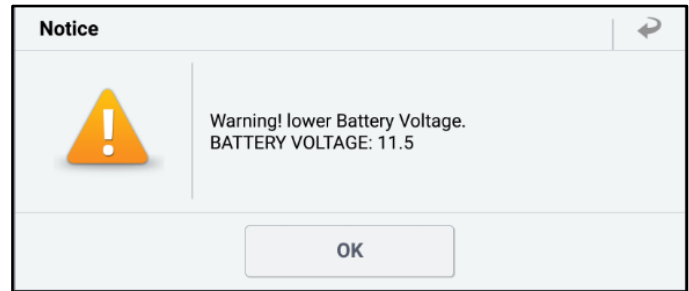
15. The vehicle battery voltage is checked to make sure it is at least 12 volts to ensure reliable upgrade results. Click OK if the results indicate voltage is OK.

If battery voltage is below 12 voltages as below, click BACK and then run the engine to assure an adequate battery charge state for reliable upgrade results.

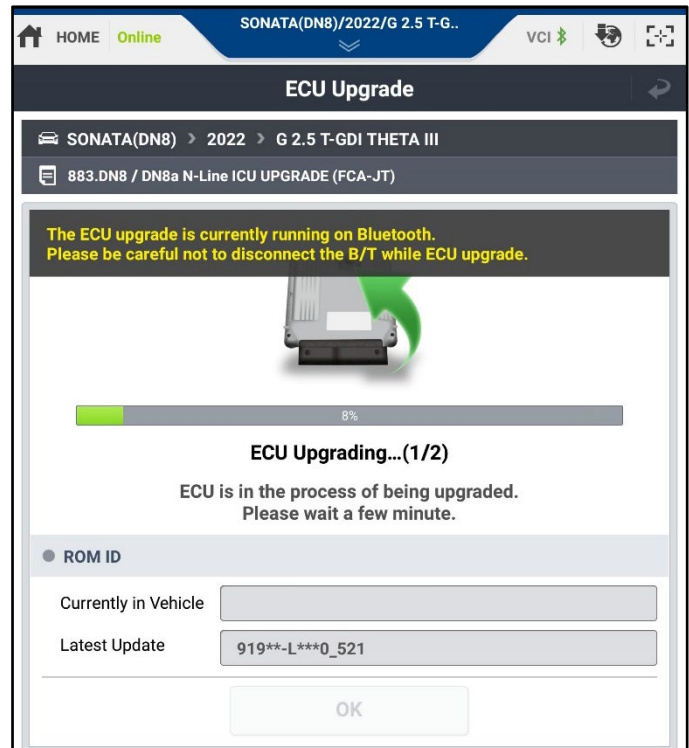
16. Upgrade (1/2) will begin, and the progress of the upgrade will appear on the bar graph.

Upgrade (1/2) will occur until 100% is reached on the bar graph.

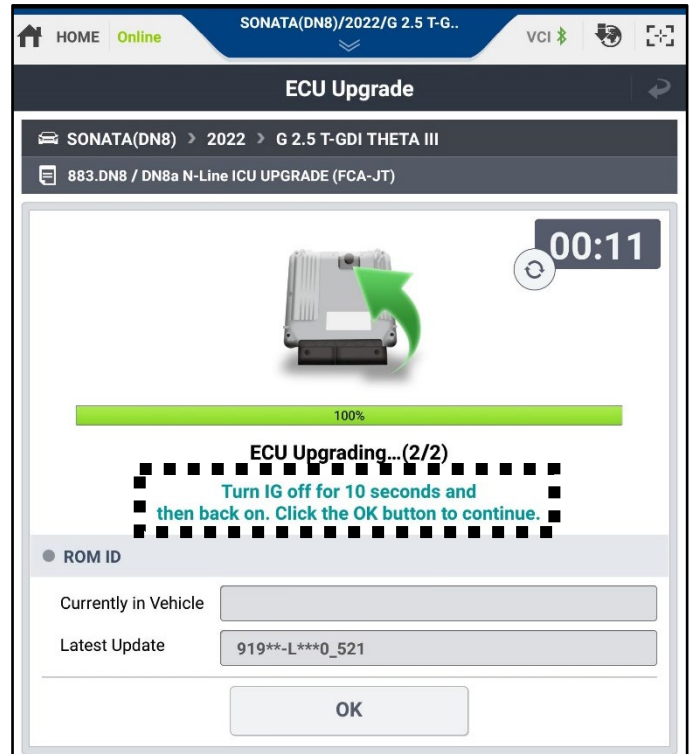
17. Upgrade (2/2) will begin, and the progress of the upgrade will appear in the bar graph.

Upgrade (2/2) will occur until 100% is reached on the bar graph.

When upgrade reaches 100%, follow GDS instructions to “Turn IG off for 10 seconds and then back on. Click the OK button to continue.”

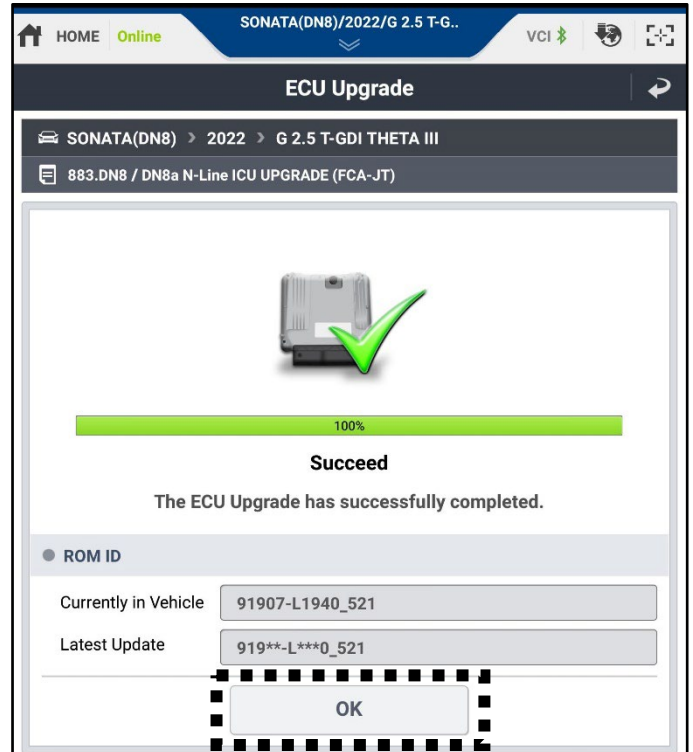
18. Click **OK** on the final screen, which indicates upgrade is complete.

Check the ICU ROM ID and compare it to the ROM ID Information Table to confirm latest ROM ID was updated.

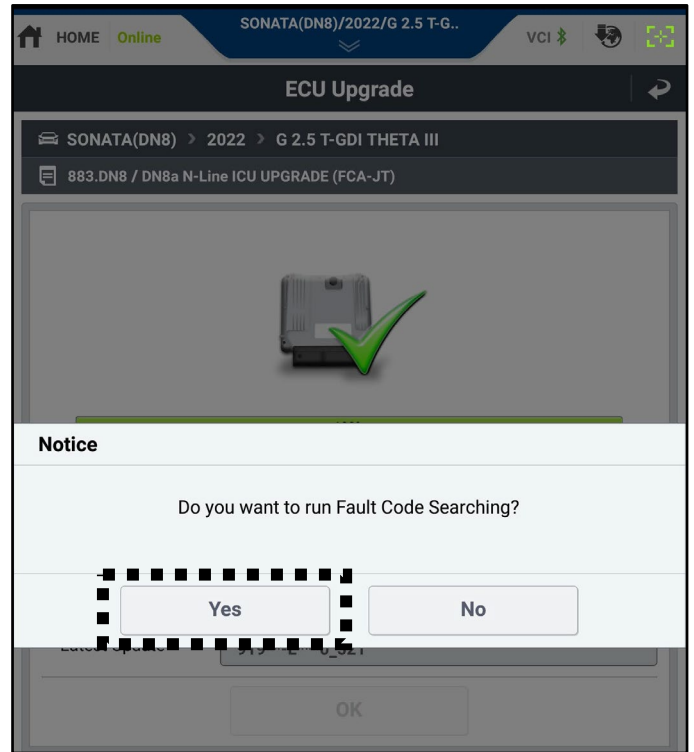
19. Check if any incidental Diagnostic Trouble Codes (DTC) have been created by the upgrade and clear the DTC(s) present.

Start the engine to confirm proper operation of the vehicle.
