Service Bulletin

23-008

Product Update: PGM-FI Idle Stop Software Update

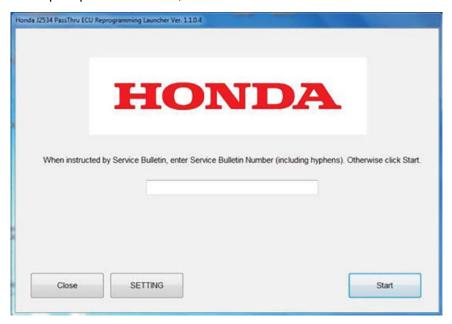
3. When prompted select **Start**, do not enter a service bulletin number.

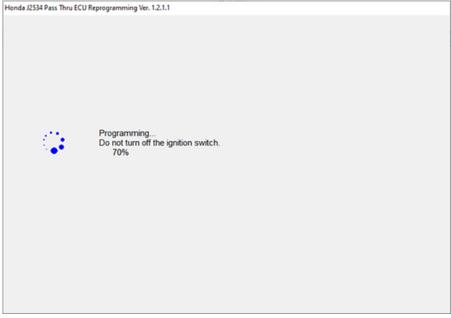
9. Select **ENTER** to begin reprogramming, and follow the screen prompts.

Honda J2534 Pass Thru ECU Reprogramming Ver. 1.2.1.1	
	CM Update Mode
PGM-FI Completed. Turn the ignition switch OFF.	
Honda J2534 Pass Thru ECU Reprogramming Ver. 1.2.1.1	
	CM Update Mode
Turn the ignition switch ON within 60 seconds.	
	58 secs to go
