SERVICE BULLETIN

APPLICABILITY: 2022MY Forester with Gen 2 Telematics
 2022MY WRX with Gen 2 Telematics
 2022-**23**MY BRZ with Gen 2 Telematics

NUMBER: 15-306-22R

SUBJECT: Intermittent Request Failure of Remote STARLINK® Services

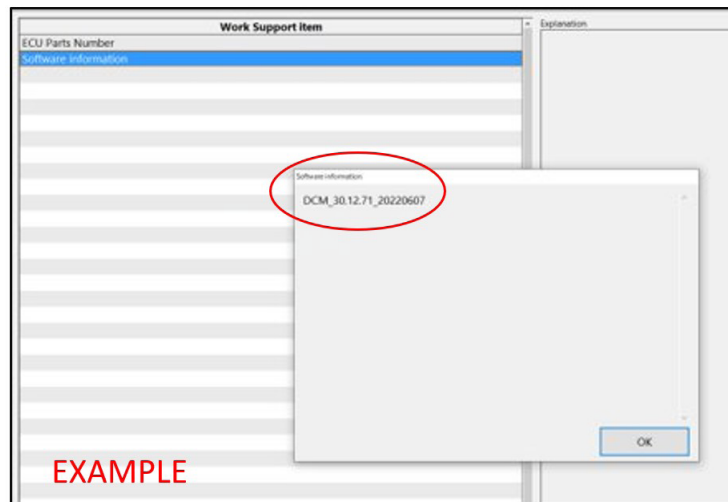
STEP 9: Using the applicable SSM, read the Software Information of the DCM.

STEP 10: Is version “DCM_30.12.71_20220607” found?
