February 3, 2023

Version 1

Product Update: 2023 CR-V Hybrid Active Grill ICM Software Update**AFFECTED VEHICLES**

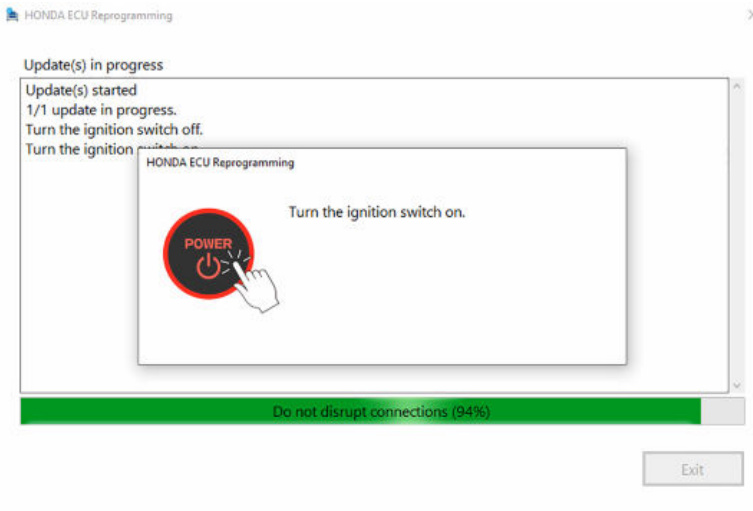
10. Turn the ignition switch ON.
