Service Bulletin

Bulletin No.: 23-NA-008

Subject: DEF Pump Controller Update with DTCs P105A and/or P208A Set.

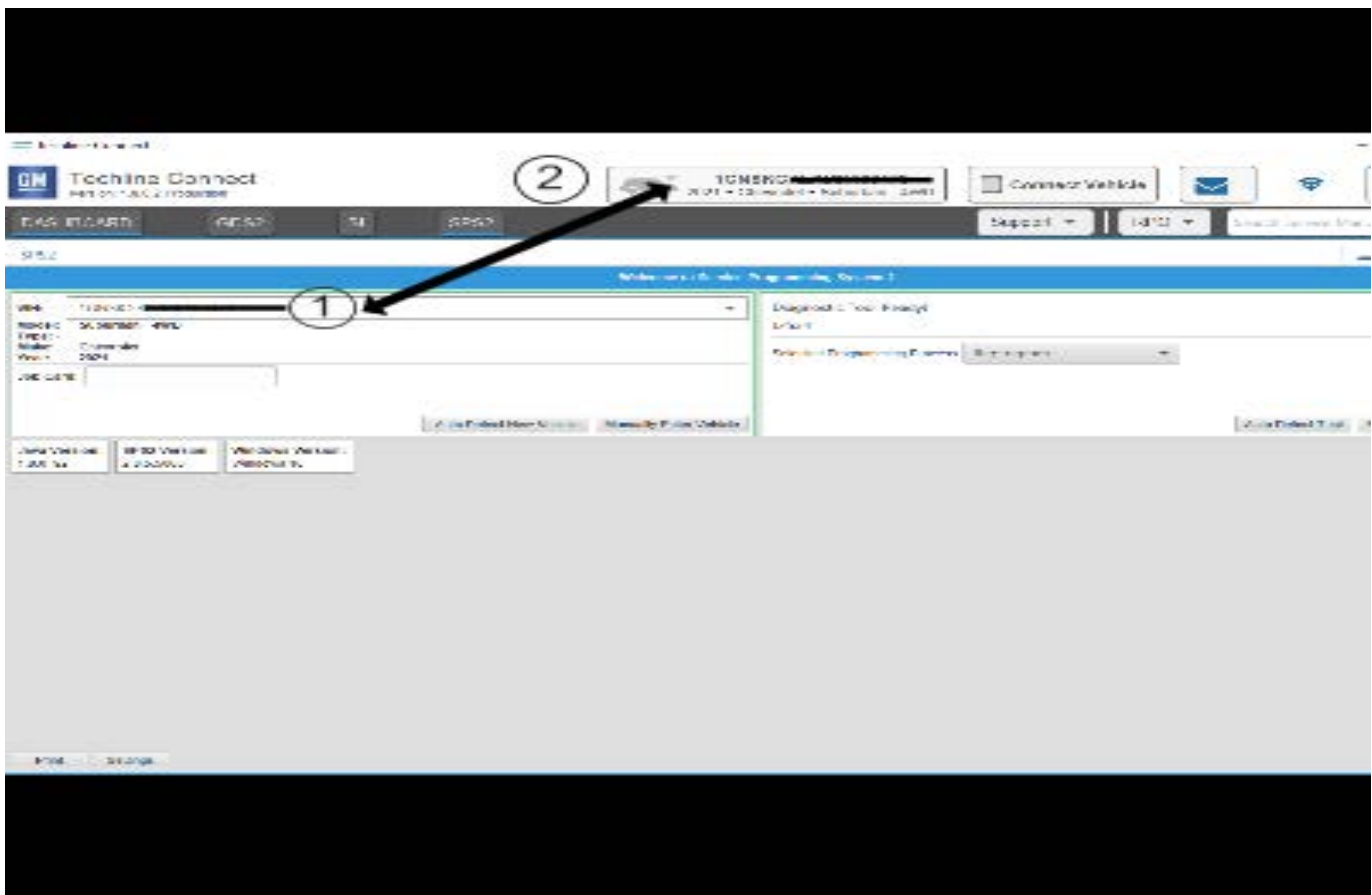
Caution: Be sure the VIN selected in the drop down menu (1) is the same as the vehicle connected (2) before beginning programming.

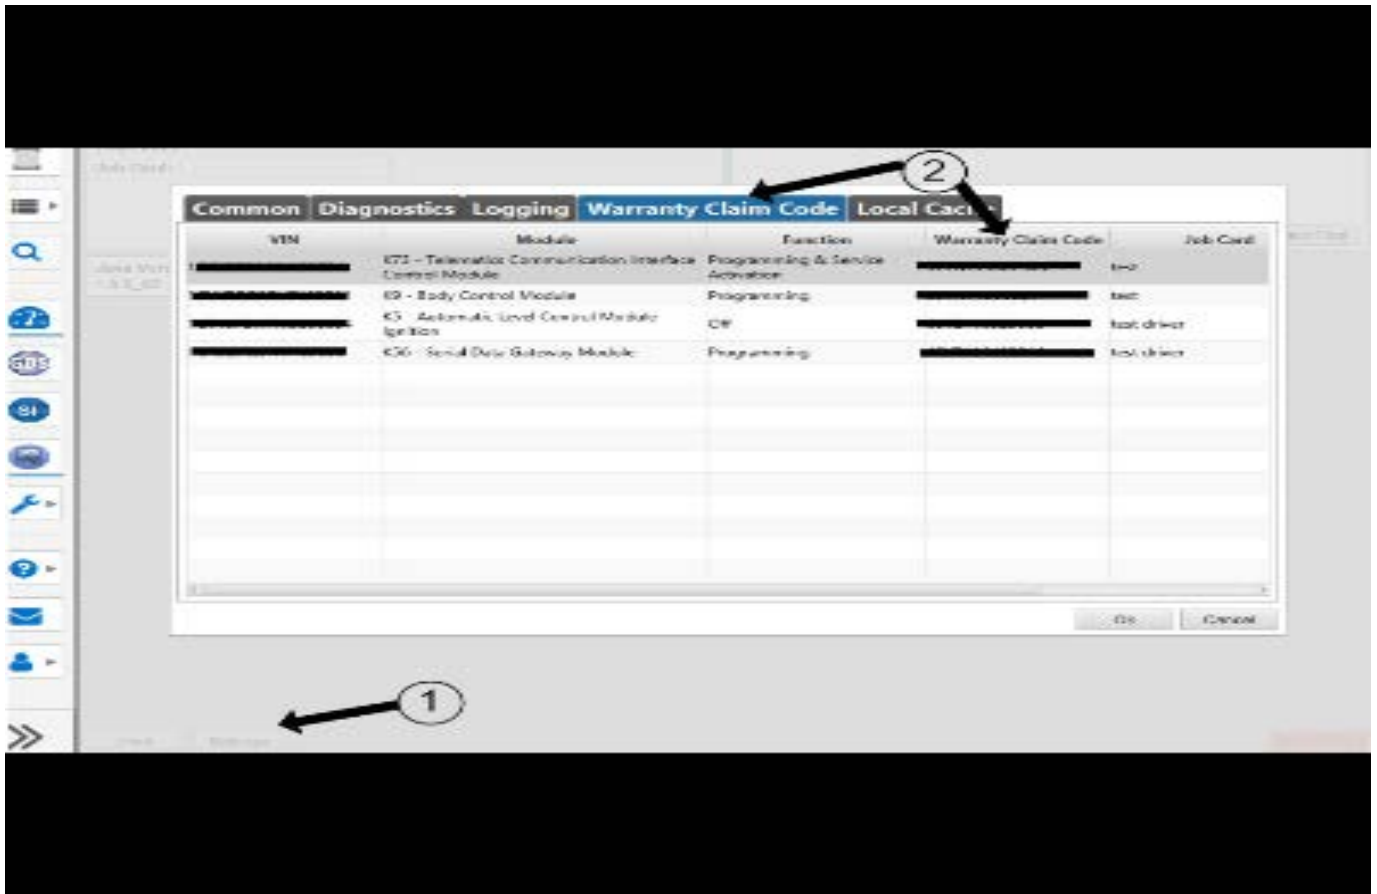
If the Warranty Claim Code was not recorded on the Job Card, the code can be retrieved in the SPS2 system as follows:

1. Open TLC on the computer used to program the vehicle.
2. Select and start SPS2.
3. Select Settings (1).
4. Select the Warranty Claim Code tab (2).

The VIN, Warranty Claim Code and Date/Time will be listed on a roster of recent programming events. If the code is retrievable, dealers should resubmit the transaction making sure to include the code in the SPS Warranty Claim Code field.
