Technical Service Bulletin	GROUP CAMPAIGN	NUMBER 23-01-012G
	DATE FEBRUARY, 2023	MODEL(S) GV70 (JK1)
SUBJECT: ADVANCED DRIVER ASSISTANCE SYSTEM (ADAS) - REMOTE SMART PARKING ASSIST SOFTWARE UPDATE (SERVICE CAMPAIGN T30G)

Description: This bulletin provides information related to the ADAS Parking system software upgrade for certain 2023MY GV70(JK1) vehicles.

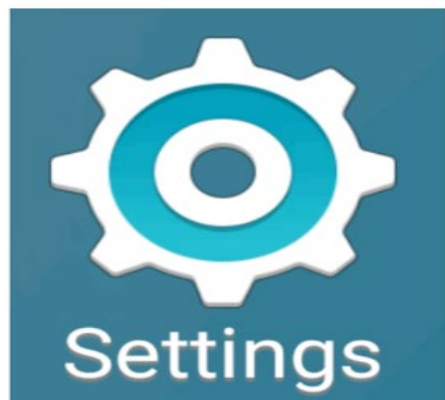
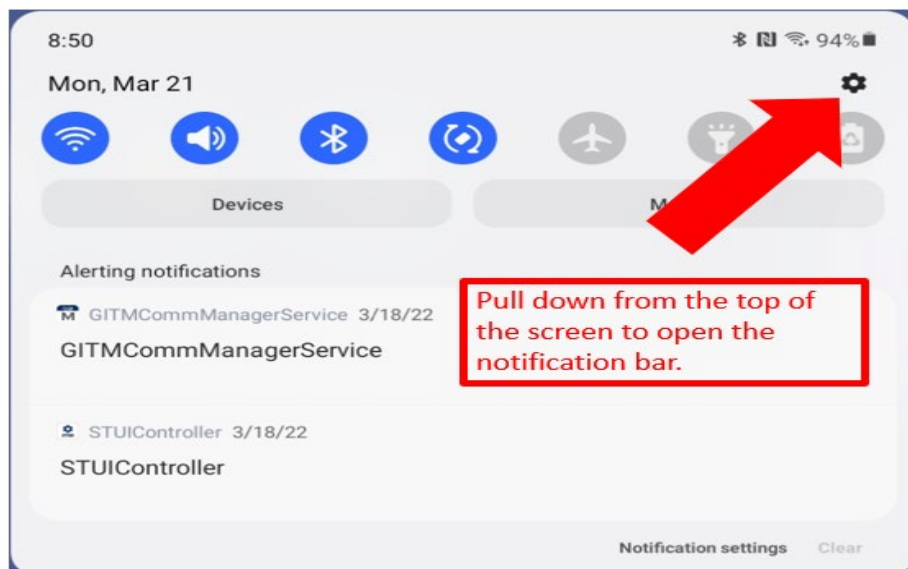
Step 1: Open tablet “Settings” from the apps screen or the drop-down notification bar.

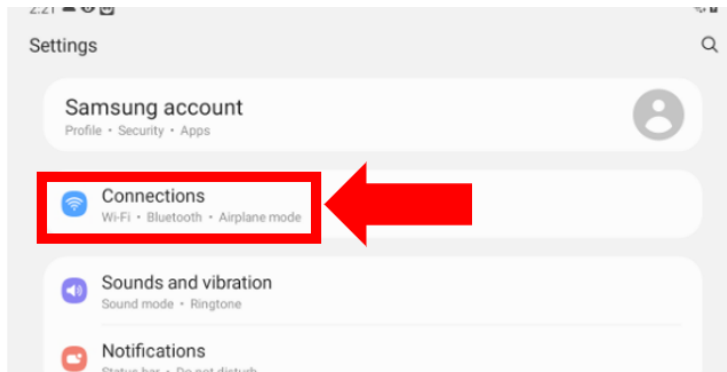
Step 2: Select “Connections” from the Settings menu.

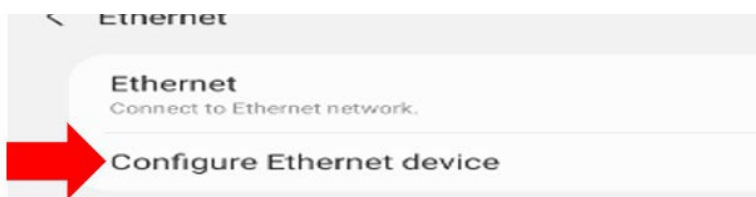
Step 5: Select “Configure Ethernet Device”.

Step 6: Select "Static IP".

A screenshot of a network configuration dialog box. At the top, it says "Select Ethernet device" with "eth0" selected in a dropdown menu. Below that, "Connection type" has two radio buttons: "DHCP" (unselected) and "Static IP" (selected). Under "Static IP", there is a "Proxy" dropdown menu with "None" selected. At the bottom, there are two buttons: "Discard" and "Save".

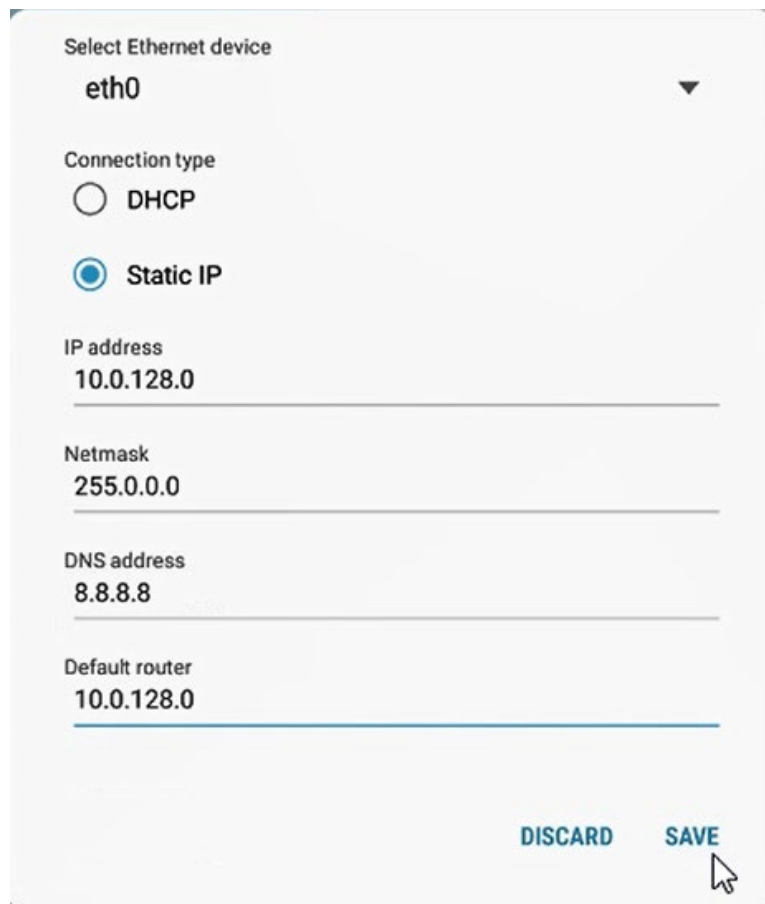
Step 7: Enter the following digits exactly as shown for IP address, Netmask, DNS address, and Default gateway. Save and close.

IP address – 10.0.128.0	Netmask – 255.0.0.0
DNS address – 8.8.8.8	Default gateway – 10.0.128.0

A screenshot of the same network configuration dialog box, but now with the following values entered in the input fields: "IP address" is 10.0.128.0, "Netmask" is 255.0.0.0, "DNS address" is 8.8.8.8, and "Default router" is 10.0.128.0. The "Static IP" radio button remains selected. The "DISCARD" and "SAVE" buttons are at the bottom right, with a mouse cursor pointing at the "SAVE" button.

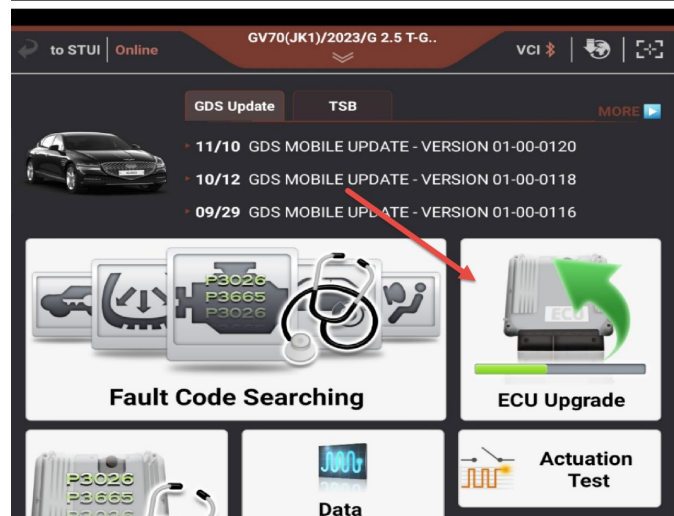
1. Select ECU Upgrade on the initial screen after entering the vehicle information.

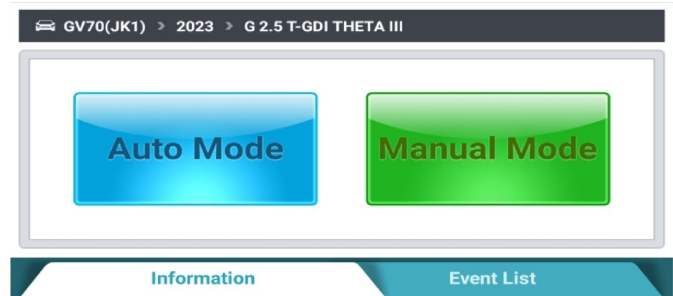
2. Select Auto Mode and then tab the system.

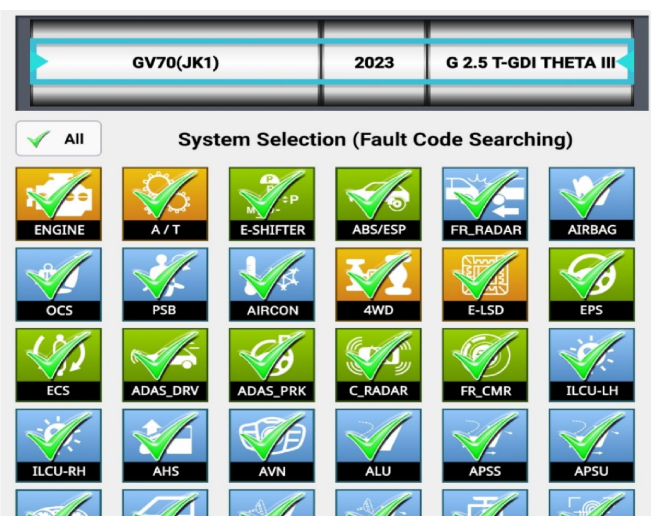
- Check if any incidental Diagnostic Trouble Codes (DTC) have been created by the upgrade and clear the DTC(s) present.

Start the engine to confirm proper operation of the vehicle.

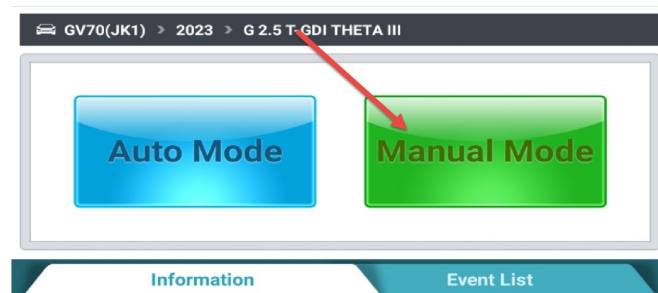
- Within the upgrade screen, select Manual Mode, then select upgrade event.

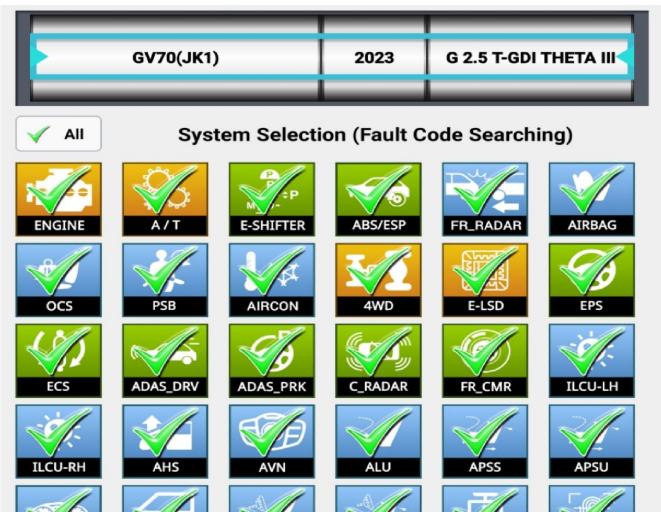
7. Check if any incidental Diagnostic Trouble Codes (DTC) have been created by the upgrade and clear the DTC(s) present.

Start the engine to confirm proper operation of the vehicle.
