# Technical Service Bulletin

GROUP <b>EV SYSTEMS</b>	NUMBER <b>23-EV-002H</b>
DATE <b>MARCH 2023</b>	MODEL(S) <b>Ioniq 5 Electric (NE1)</b>

**SUBJECT:** 4WD/AWD VCU UPDATE FOR ECO MODE IMPROVEMENT

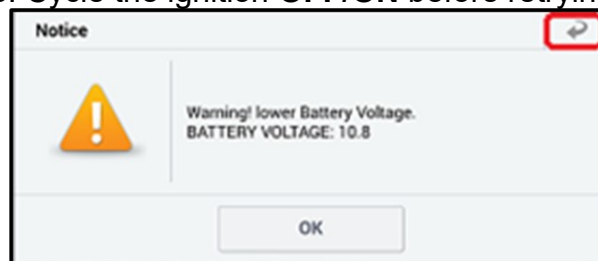
**WARNING**
**GDS Vehicle Battery Voltage:**

- If the voltage is below 12 volts as per the GDS warning, then select **Back** and run the vehicle at least 15 minutes to reach an adequate battery state of charge to prevent an ECU Update failure. Cycle the ignition **OFF/ON** before retrying ECU update again.

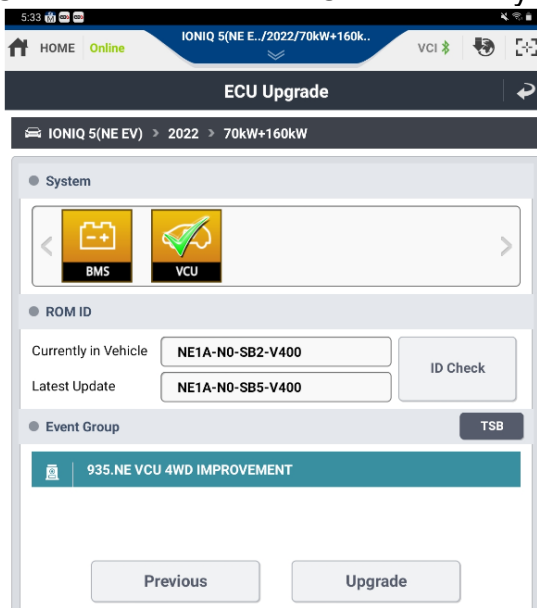
## 1. Perform the VCU Update in Auto Mode.

- Use the Auto Mode ID Check to verify the VCMS ROM ID before updating the software.

- After the ECU Upgrade process shows 100% complete, cycle the ignition key to **OFF** for at least 10 seconds to reset the control unit.
