Technical Service Bulletin

Subject: CHECK ENGINE LIGHT ON WITH DTC P0524 OR P055F	Bulletin No.: 01-004/23
	Last Issued : 02/03/2023

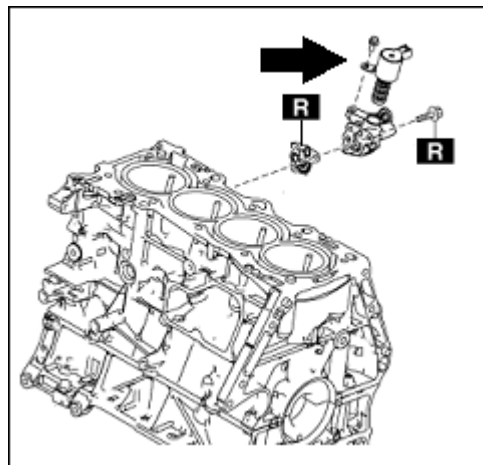
Parts Number	Description	Qty.	Notes
PYFA-14-440C	VALVE,OIL CONTROL	1	CX-5, Mazda6 and Mazda3 (Japan built)
P5PW-14-440	VALVE,OIL CONTROL	1	CX-30 and Mazda3 (Mexico built)
PY8W-14-365	GASKET	1	[R]
PY8W-14-275	BOLT	3	[R]
1WPE-14-302	CARTRIDGE,OIL FILTER	1	---

[R]: Replacement parts
