Service Bulletin

Bulletin No.: 23-NA-025

Subject: Engine Control Module Software Anomalies with MIL Illuminated and DTC P060C Set

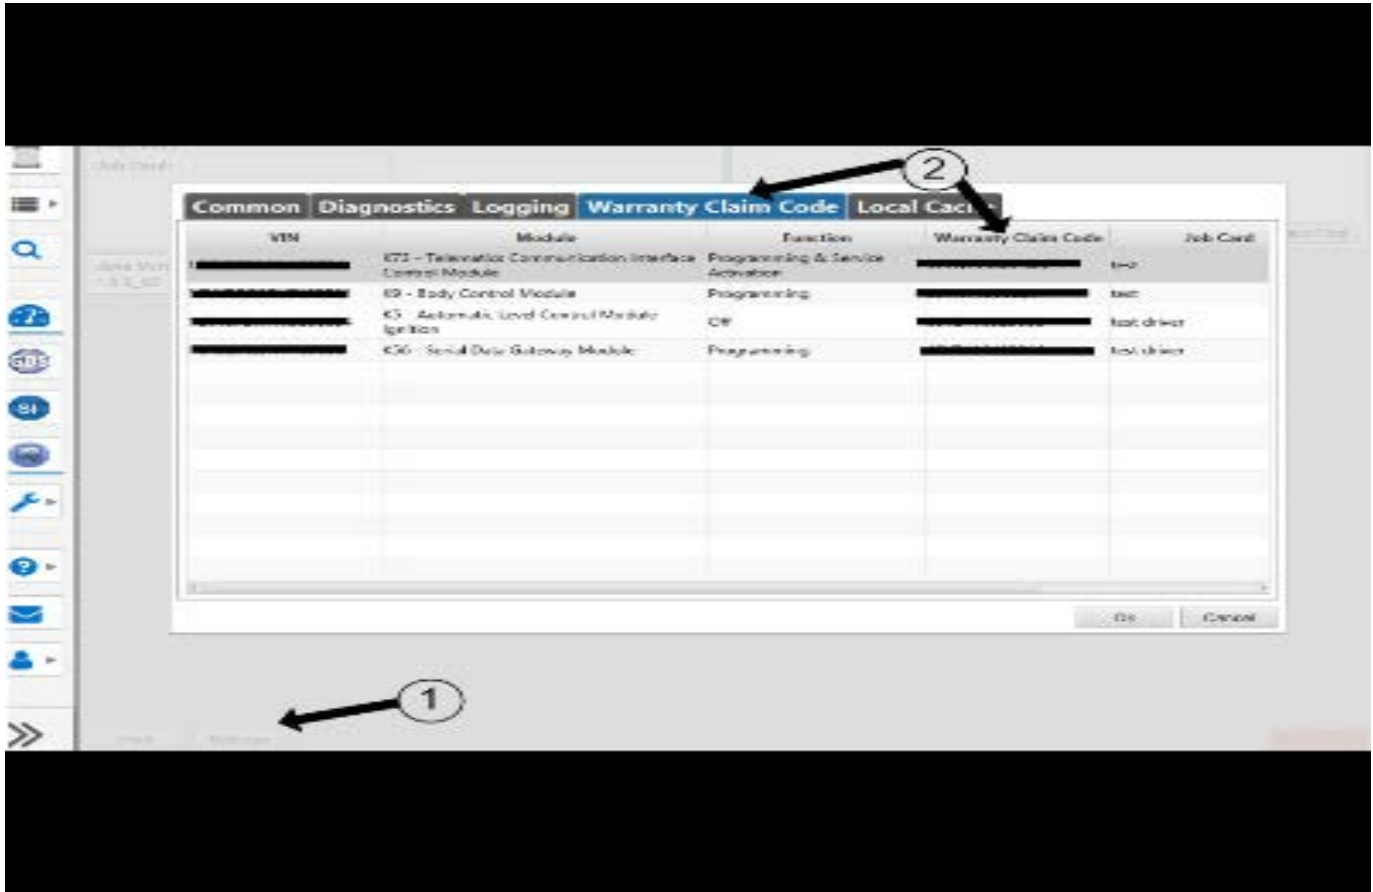
1. Open TLC on the computer used to program the vehicle.
2. Select and start SPS2.
3. Select Settings (1).
4. Select the Warranty Claim Code tab (2).

The VIN, Warranty Claim Code and Date/Time will be listed on a roster of recent programming events. If the code is retrievable, dealers should resubmit the transaction making sure to include the code in the SPS Warranty Claim Code field.
