# Service Bulletin

Bulletin No.: 22-NA-124

**Subject: Bolt EUV with Super Cruise Digital Map Control Module - Outdated Map Data**

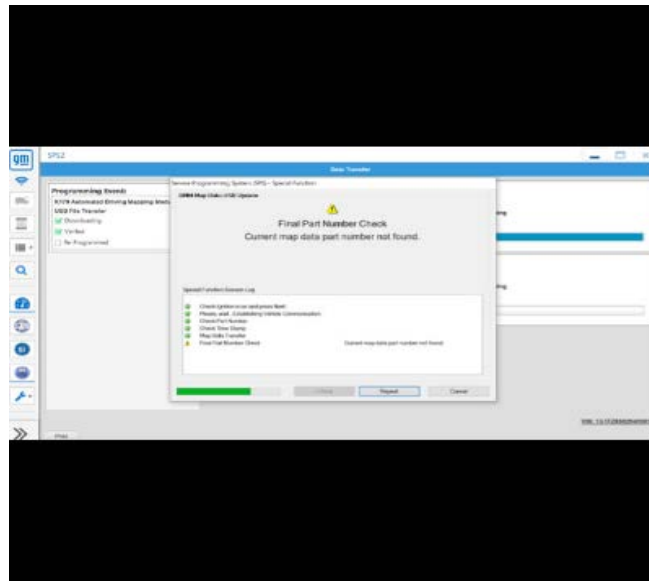
6101178

1. Drive the vehicle for 5 minutes (do not power cycle ignition after drive).
2. Setup Programming outside of garage.
3. Ensure "Share Hotpot" is off.
4. Run the Map Module – Programming - Refer to *K179 Digital Map Control Module: Programming and Setup* in the Service Manual. (After programming clear system wide DTCs using GDS).
5. Run the Map Module – USB - Refer to Digital Map Module Map Update.
6. If USB fails, immediately start over with SPS running (without key cycle). Hit the CANCEL button. DO NOT HIT THE REPEAT BUTTON.

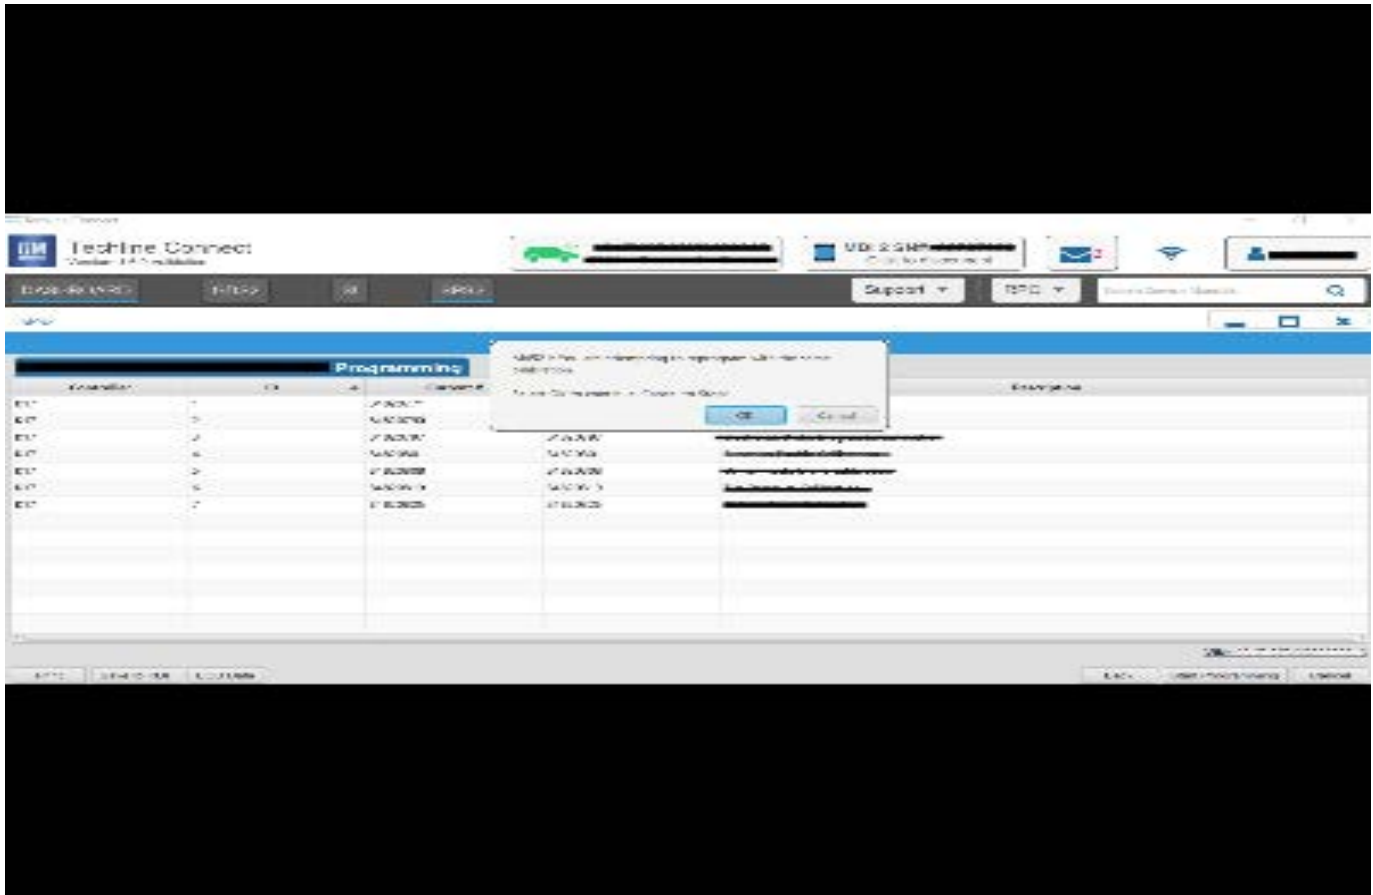
**Important:** Techline Connect screen shown above.

**Important:** If the same calibration/software warning is noted on the TLC or SPS Summary screen, select OK and follow screen instructions. After a successful programming event, the WCC is located in the Service Programming System dialogue box of the SPS
