Service Bulletin

Bulletin No.: 22-NA-045

Subject: Air Conditioning Odor During Restart After Auto-Stop

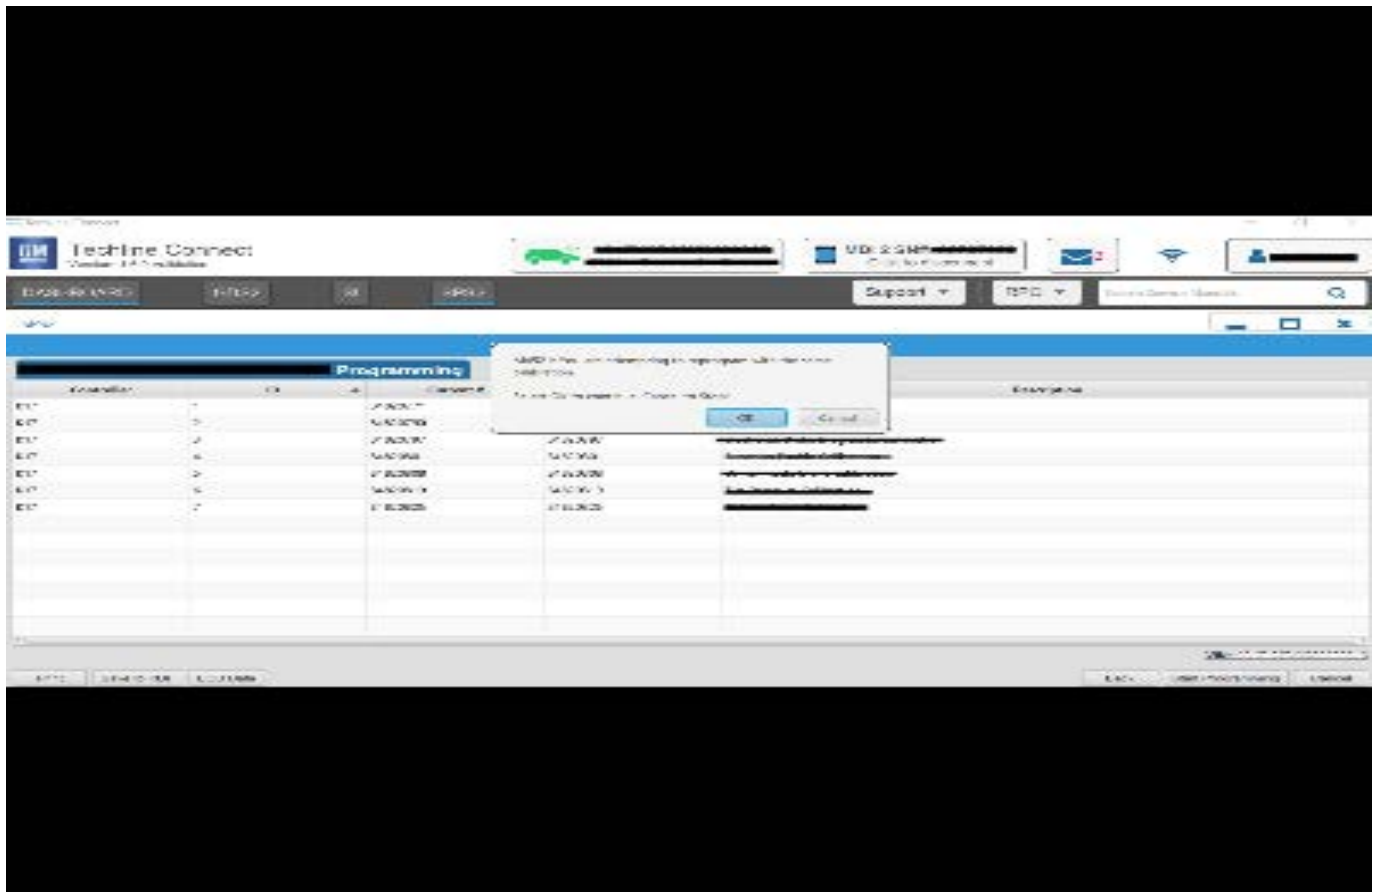
5644477

Important: Techline Connect and TIS2WEB screens shown above.

Important: If the same calibration/software warning is noted on the TLC or SPS Summary screen, select OK and follow screen instructions. After a successful programming event, the WCC is located in the Service

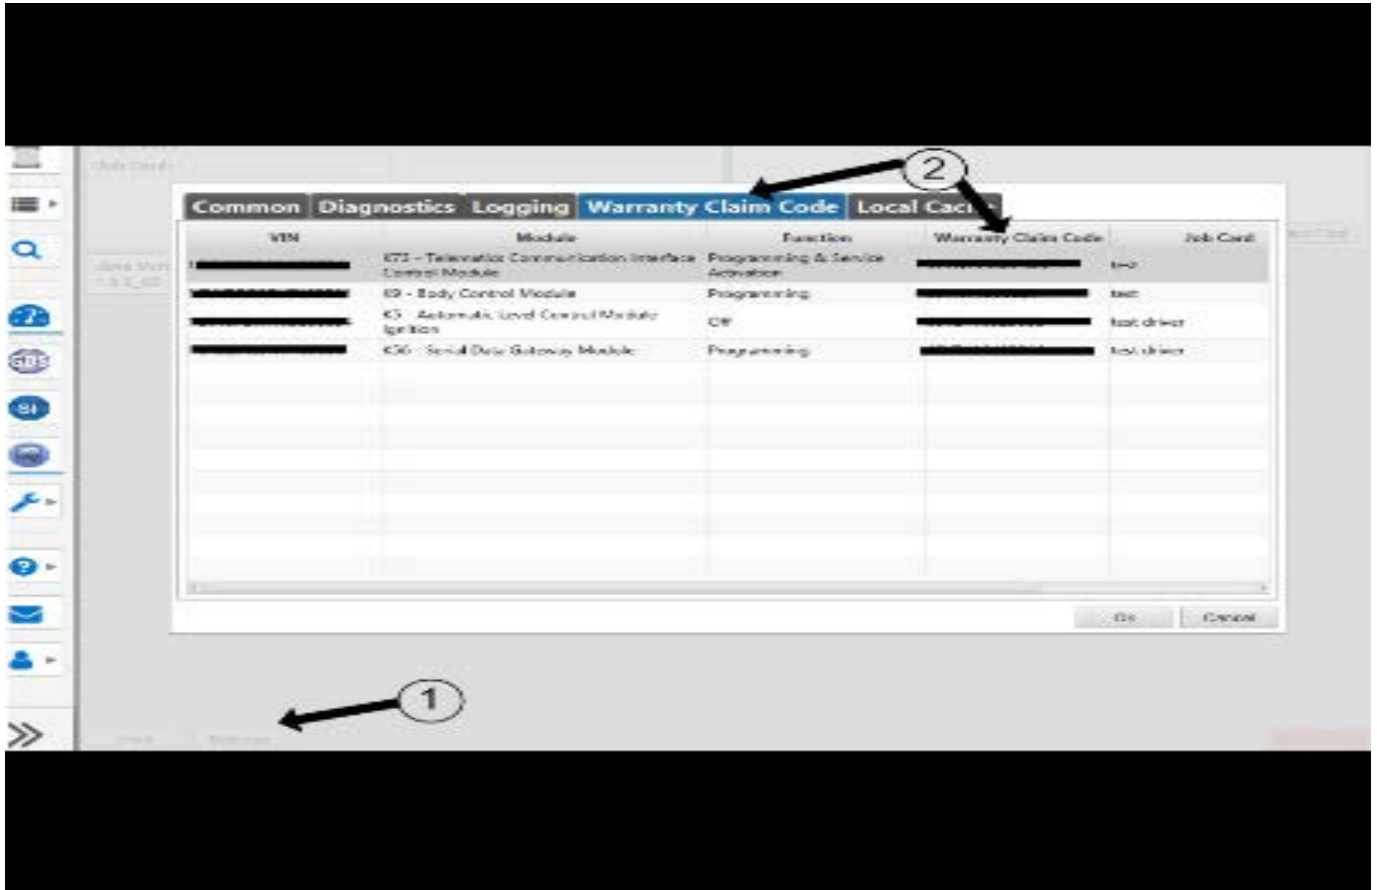
Warranty Claim Code Information Retrieval

If the Warranty Claim Code was not recorded on the Job Card, the code can be retrieved in the SPS2 system as follows:

1. Open TLC on the computer used to program the vehicle.
2. Select and start SPS2.
3. Select Settings (1).
4. Select the Warranty Claim Code tab (2).

The VIN, Warranty Claim Code and Date/Time will be listed on a roster of recent programming events. If the code is retrievable, dealers should resubmit the transaction making sure to include the code in the SPS Warranty Claim Code field.
