GROUP	MODEL
TRA	2022-2023MY K5 (DL3a), Sorento (MQ4a) w/2.5L T-GDI w/DCT
NUMBER	DATE
107	March 2023

TECHNICAL SERVICE BULLETIN

**SUBJECT: SERVICE ACTION: 8-SPEED DUAL CLUTCH
TRANSMISSION (DCT) S/W LOGIC IMPROVEMENT (SA526)**

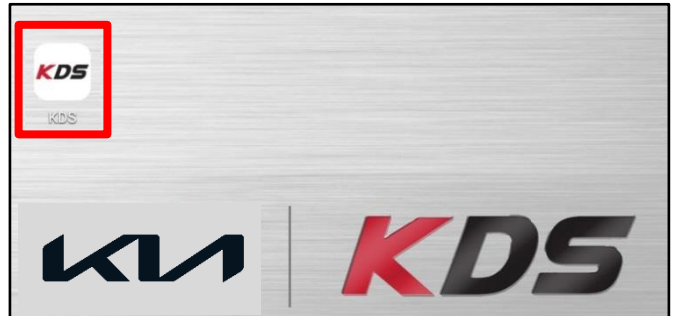
2. With the ignition ON, turn ON the KDS tablet. Select 'KDS' from the home screen.

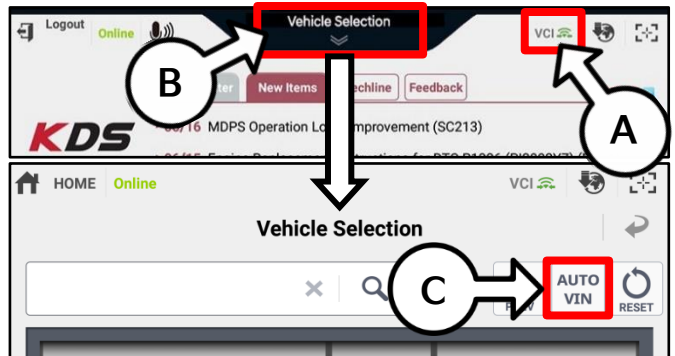
3. Confirm communication with VCI (A) and then configure the vehicle (B) using the 'AUTO VIN' (C) feature.

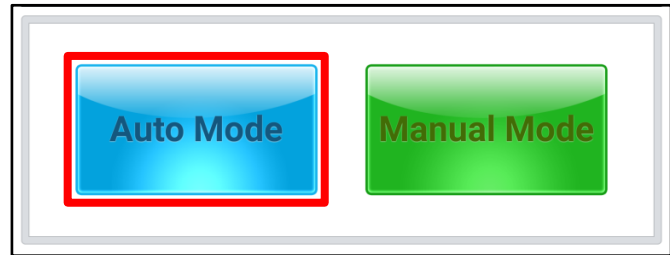
6. Select Auto Mode.
