Subject: N222385500 - Customer Satisfaction Program  
Key Fob Retrofit – With RPO BTV and TC2

Models: 2023 Buick Envision

# Customer Satisfaction Program

N222385500 Key Fob Retrofit – With RPO BTV and TC2

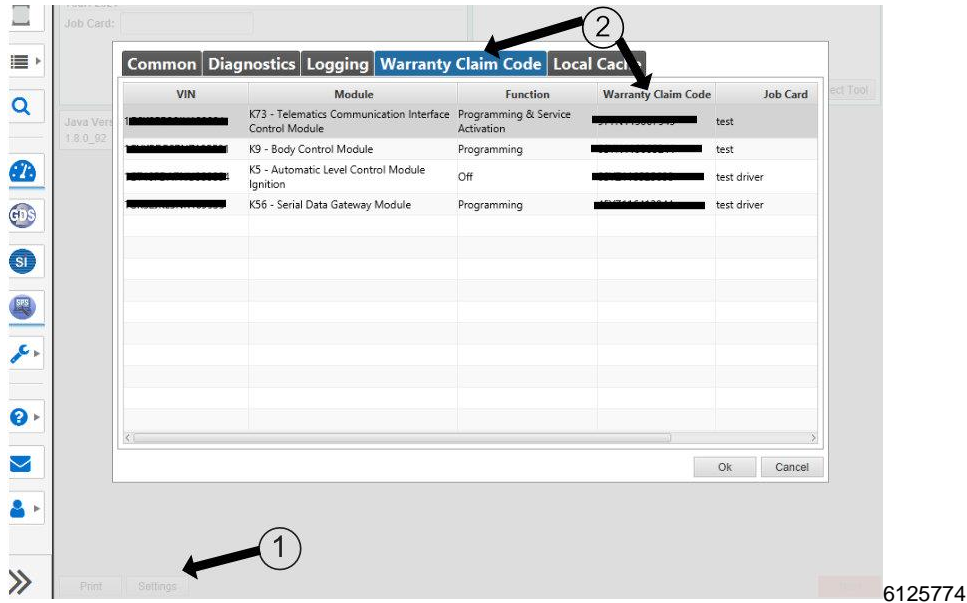
If the Warranty Claim Code was not recorded on the Job Card, the code can be retrieved in the SPS2 system as follows:

1. Open TLC on the computer used to program the vehicle.
2. Select and start SPS2.
3. Select Settings (1).
4. Select the Warranty Claim Code tab (2).

The VIN, Warranty Claim Code and Date/Time will be listed on a roster of recent programming events. If the code is retrievable, dealers should resubmit the transaction making sure to include the code in the SPS Warranty Claim Code field.
