GLOBAL SAFETY FIELD INVESTIGATIONS
DCS6490
URGENT - DISTRIBUTE IMMEDIATELY

Subject: N222385501 - Customer Satisfaction Program
Key Fob Retrofit – Without RPO BTV and TC2

Models: 2023 Buick Envision

N222385501 Key Fob Retrofit – Without RPO BTV and TC2

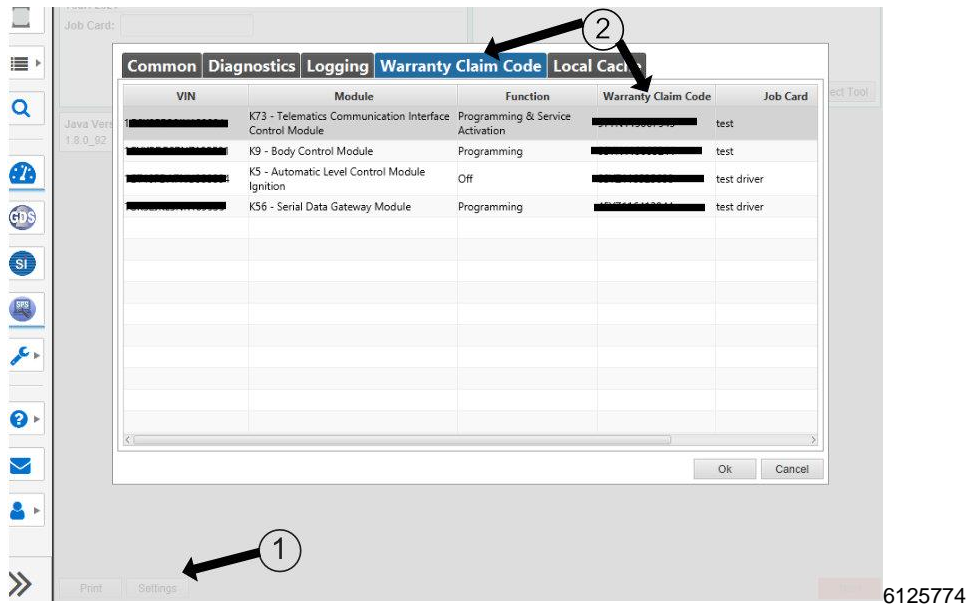
Warranty Claim Code Information Retrieval

If the Warranty Claim Code was not recorded on the Job Card, the code can be retrieved in the SPS2 system as follows:

1. Open TLC on the computer used to program the vehicle.
2. Select and start SPS2.
3. Select Settings (1).
4. Select the Warranty Claim Code tab (2).

The VIN, Warranty Claim Code and Date/Time will be listed on a roster of recent programming events. If the code is retrievable, dealers should resubmit the transaction making sure to include the code in the SPS Warranty Claim Code field.
