Release Date	03/14/2023	Technical Service Bulletin	
24iR UPDATE Software Update – (NVLW) REVISION

Condition/Technical Background

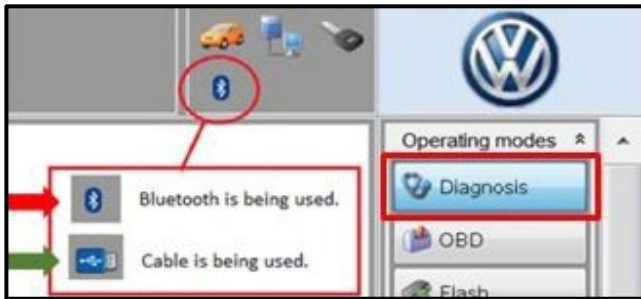
- Confirm that scan tool is communicating with the diagnostic head by USB <Green Arrow>.
 - If the Bluetooth symbol is shown <Red Arrow> then disconnect the diagnostic head from the vehicle and reconnect the USB cable to the diagnostic head and then reattach to the vehicle.
- Upon ODIS startup, verify the “Diagnosis” operating mode is selected <as shown>.
- Once the GFF scan is complete, select “Special functions” <arrow 1>, then “Adapting software” <arrow 2>, then select “Perform test” <arrow 3>.

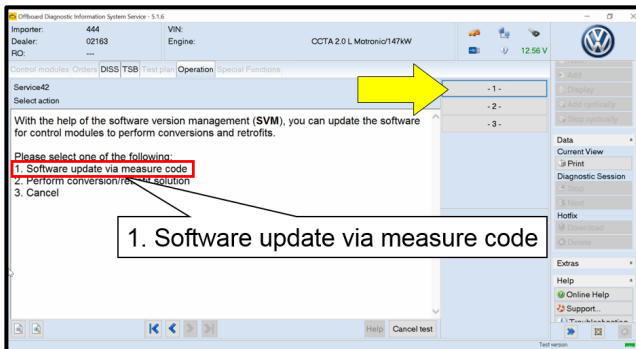
- Enter the corrective action code (SVM code) as listed below.

SVM code

49C5

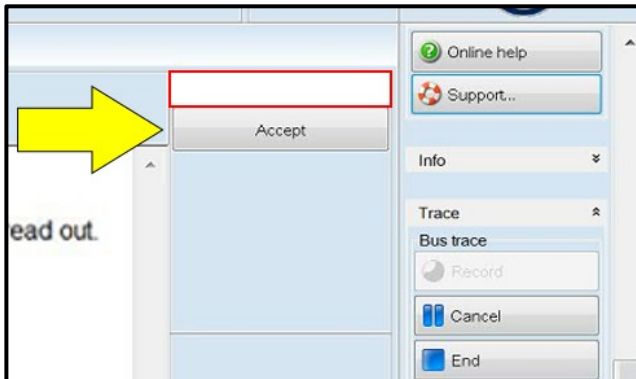
- Select “Accept” <arrow> and follow the on screen prompts.

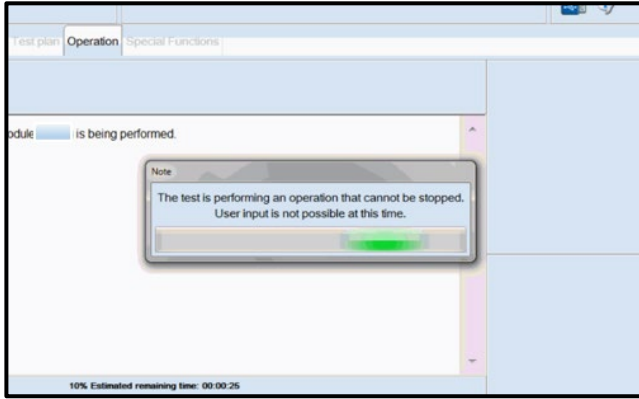
- During the flash, this screen appears when each operation is performed:

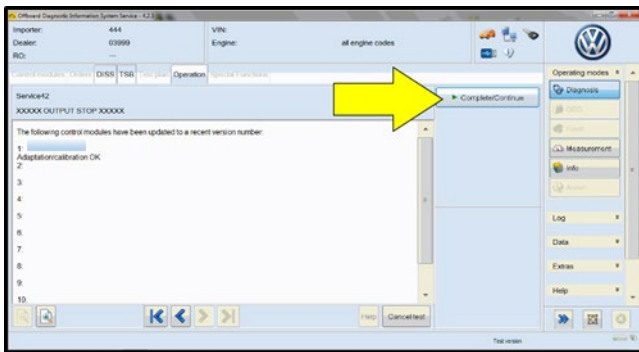
- Select Complete/Continue <arrow> after each operation is completed.

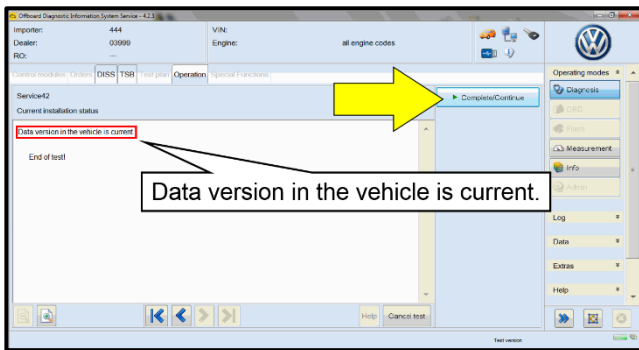
- When the SVM update is complete a confirmation message is displayed <as shown>.
- Select “Complete/Continue” <arrow>.

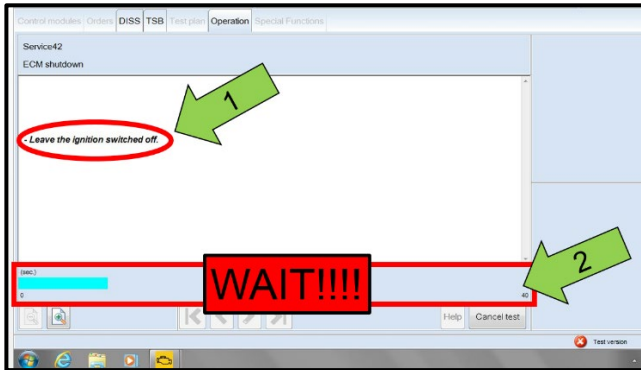
- It is **IMPERATIVE** that **ALL** of the ignition cycle on/off delay requests are fulfilled in their entirety during this flash process <arrow 1>.
- Failing to wait for the ignition on/off timing cycle to complete (progress bar and countdown timer <arrow 2>) before cycling the ignition on/off **MAY** damage a control module.
- Damage to control modules as a result of failing to wait the specified time displayed by the progress bar and countdown timer <arrow 2> are **NOT** covered under this action.

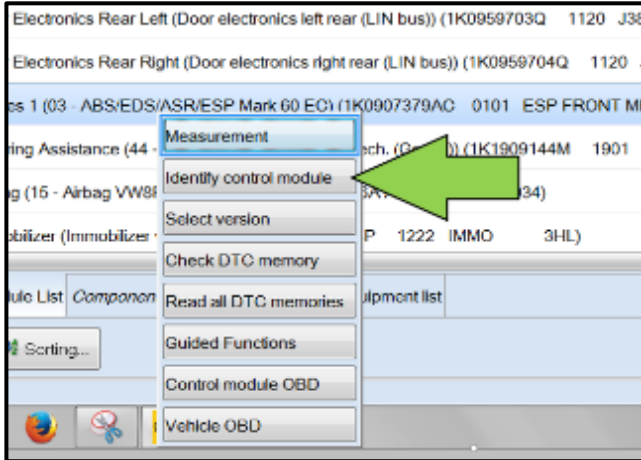
- After the software update is completed and before sending the GFF Log Online:
 - Select the “Control Module” tab.
 - Scroll down and right click on the modules that were updated.
 - Select “Identify Control Module” <arrow>.

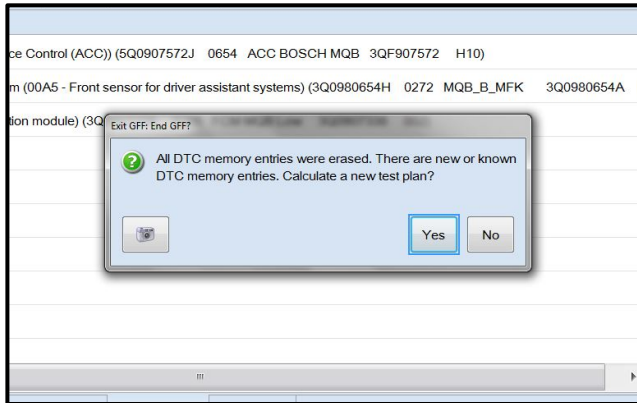
- Exit GFF and send diagnostic protocol online when prompted.
