GLOBAL SAFETY FIELD INVESTIGATIONS
DCS6511
URGENT - DISTRIBUTE IMMEDIATELY

Subject: REVISION: N232399010-01 - Service Update
TCM Loss of Communication
Revised Labor Time and Population Expansion

Models: 2023 Cadillac CT4
2023 Cadillac CT5
2023 Cadillac Escalade
2023 Cadillac Escalade ESV
2023 Chevrolet Silverado 1500 New
2023 Chevrolet Suburban
2023 Chevrolet Tahoe
2023 GMC Sierra 1500 New
2023 GMC Yukon
2023 GMC Yukon XL

N232399010 TCM Loss of Communication

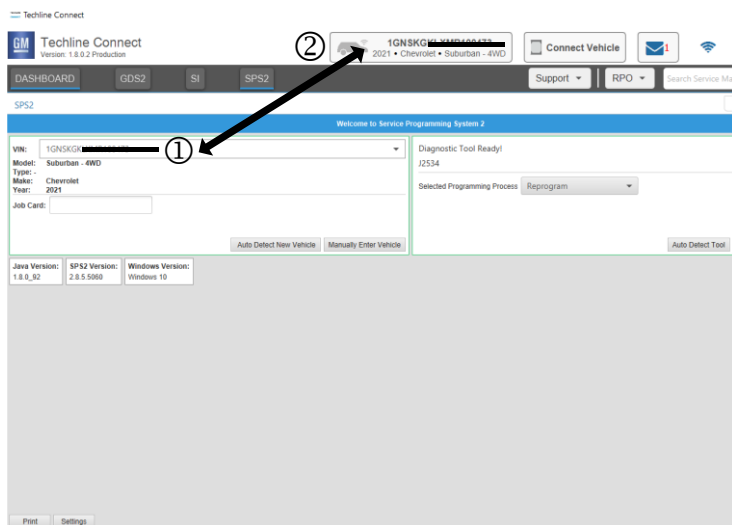
5743643

Caution: Be sure the VIN selected in the drop down menu (1) is the same as the vehicle connected (2) before beginning programming.

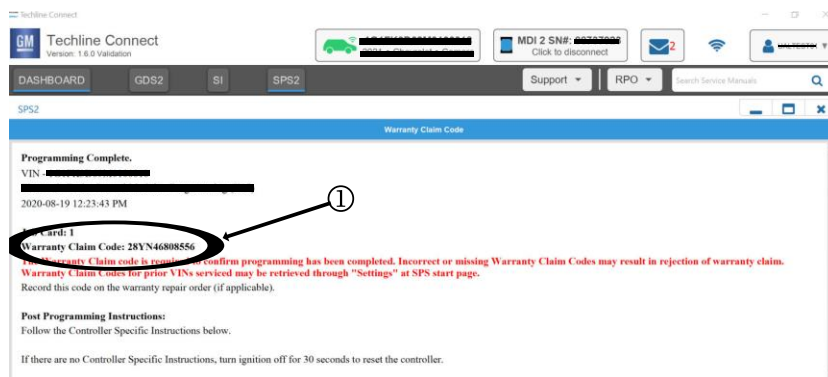
Note: The screenshot above is an example of module programming and may not be indicative of the specific module that is being programmed. Module selection and VIN information have been blacked out.

Important: To avoid warranty transaction rejections, you **MUST** record the warranty claim code provided on the Warranty Claim Code (WCC) screen shown above on the job card. Refer to callout 1 above for the location of the WCC on the screen.

Important: If the same calibration/software warning is noted on the TLC Summary screen, select OK and follow screen instructions. After a successful programming event, the WCC is located in the Service Programming System dialogue box of the SPS Summary screen. No further action is required. Refer to the Warranty section of the bulletin.
