Subject: TomTom Android Black Box Update

Models Affected: Specific Model Year 2020-2022 Freightliner Cascadia Vehicles, manufactured January 16, 2019, through November 2, 2021.

Daimler Truck North America LLC (DTNA), on behalf of its Freightliner Trucks Division, is initiating Field Service Campaign SF662 to modify the vehicles mentioned above.

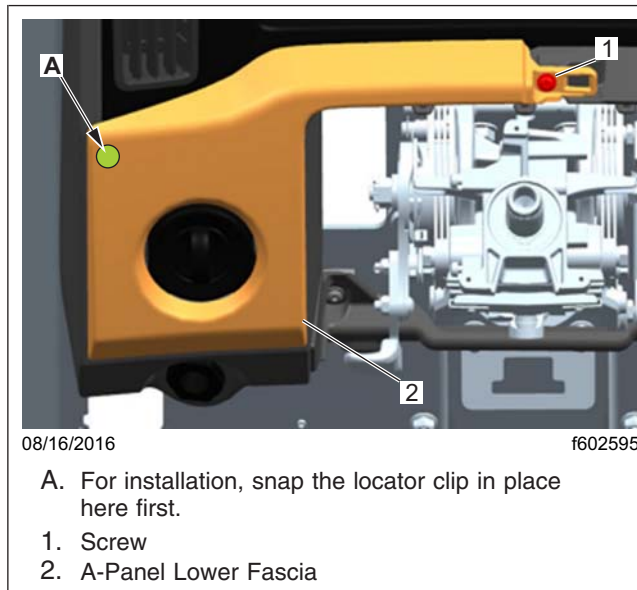
Fig. 4, Lower A-Panel Fascia Removal

5.4 Remove the lower A-panel fascia. See [Fig. 4](#).

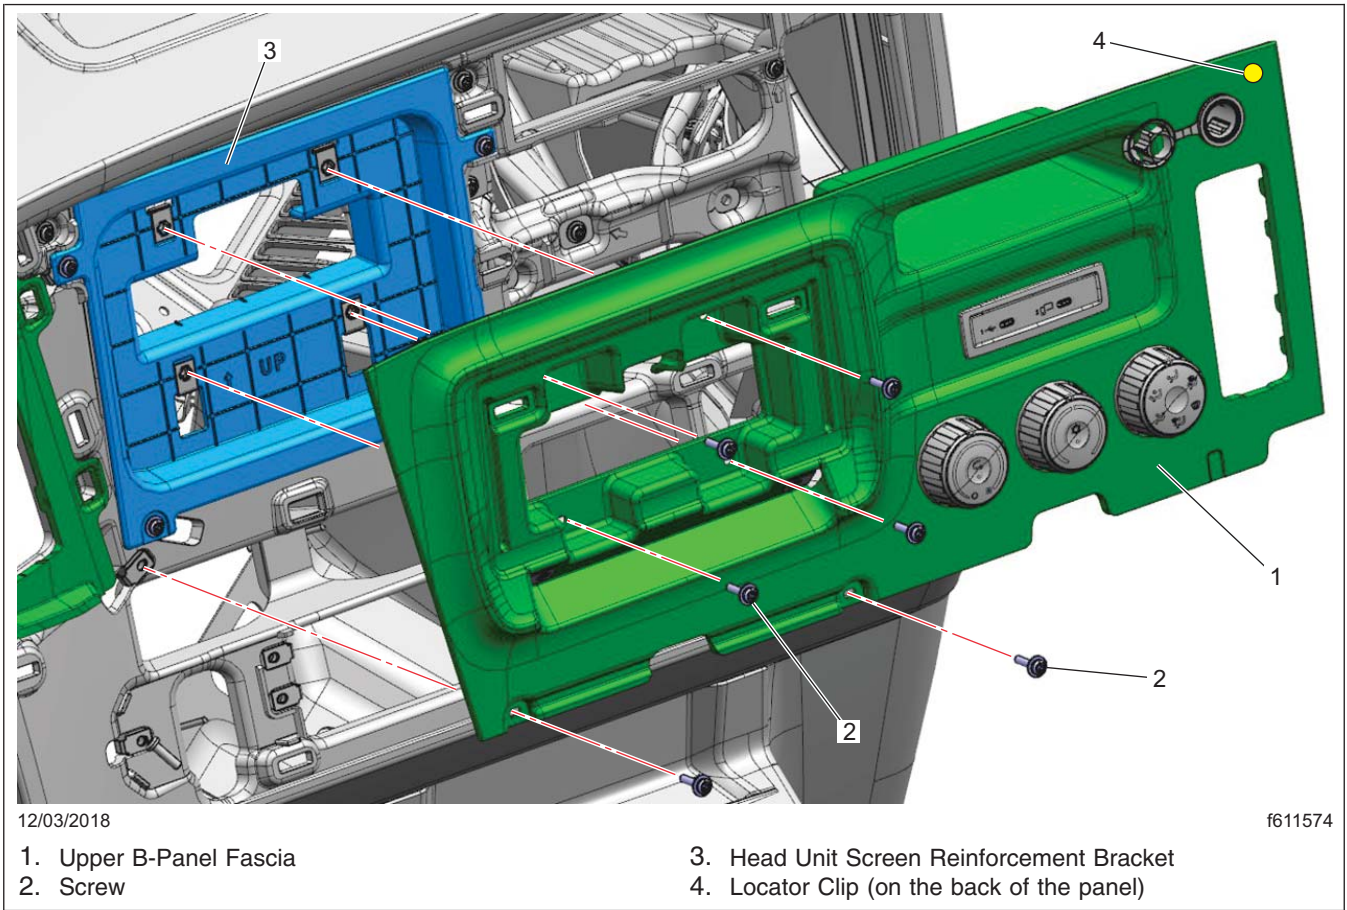
Fig. 5, Upper B-Panel Fascia Removal

5.5 Remove the upper B-panel fascia, and disconnect the wiring as needed. See [Fig. 5](#).

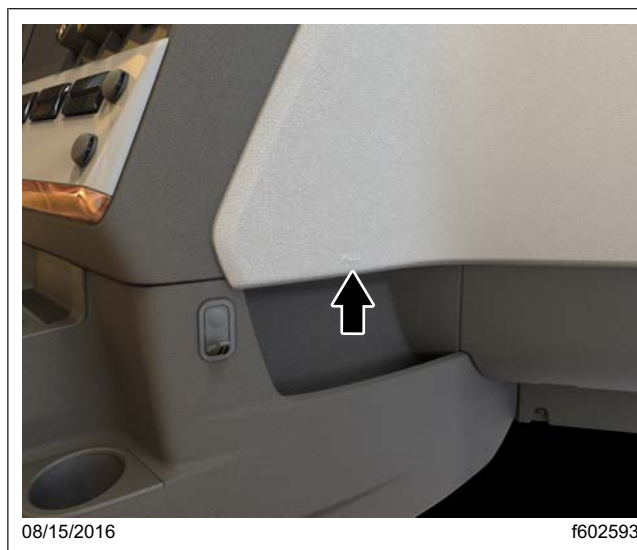
Fig. 8, Electrical Bay Cover Location

- 5.8 Remove the electrical bay cover. See [Fig. 8](#).

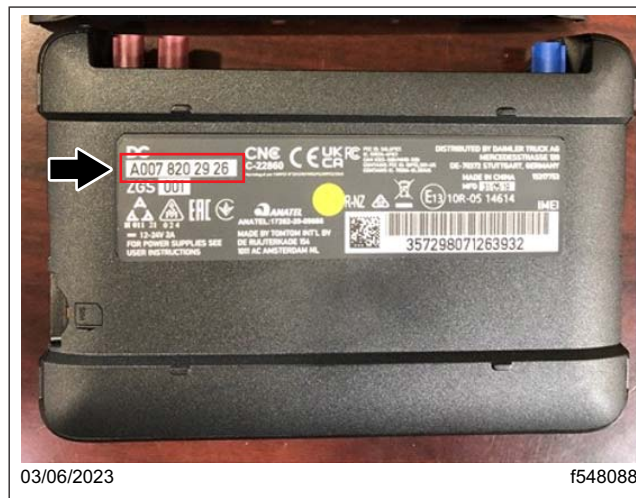
Fig. 9, TomTom Part Number Identification

7. Remove the TomTom from the bracket, and check the part number on the label on the bottom side. See [Fig. 9](#).

Is the part number **A 008 820 15 26**?

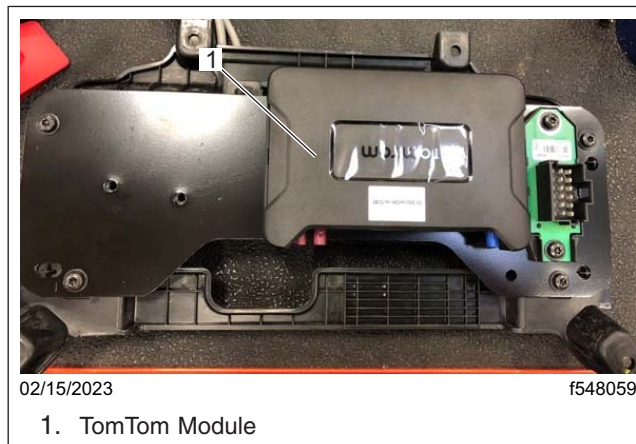
Fig. 11, TomTom Module Installation

- 8.2 Snap the TomTom module into the bracket as shown in [Fig. 11](#).

6. Check if a TomTom module is already installed on the back side of the instrument cluster screen reinforcement. See [Fig. 11](#).

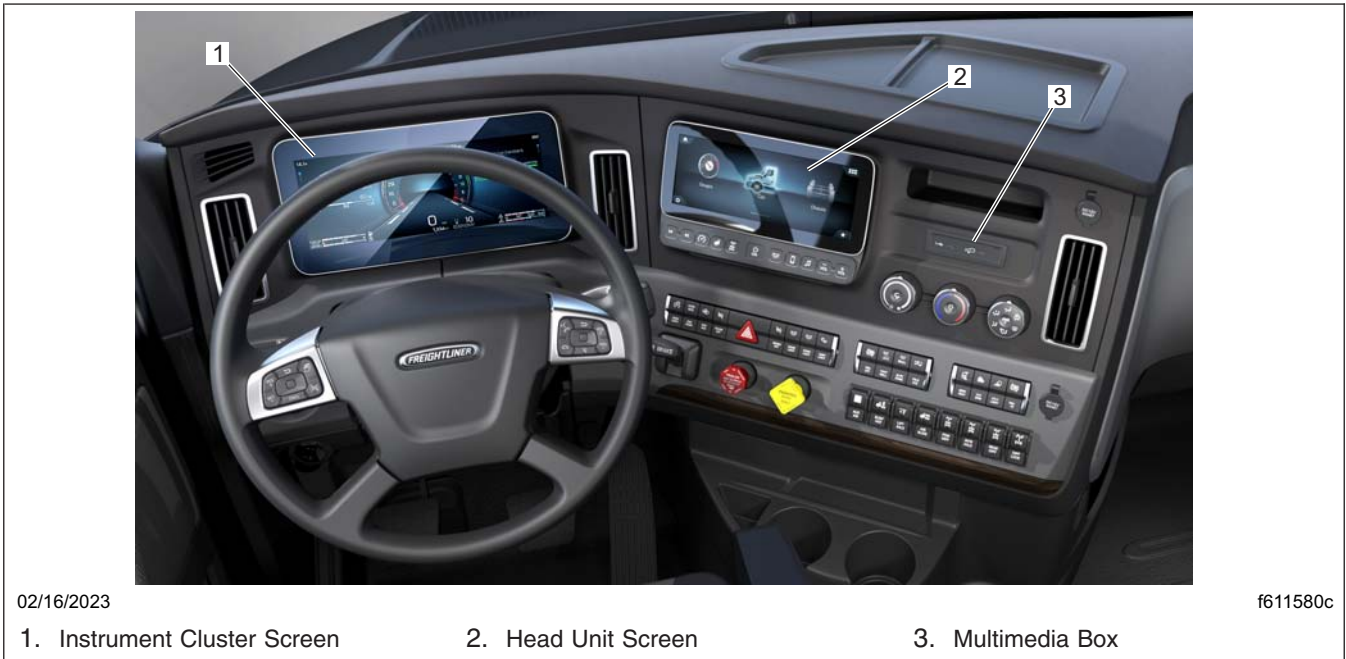
Fig. 12, Multimedia Box Location

9. Route the USB cable from the TomTom module location to the multimedia box (MMB). See **Fig. 12** and **Fig. 13**. Ensure the cable ends are routed correctly, as shown in **Fig. 14**.

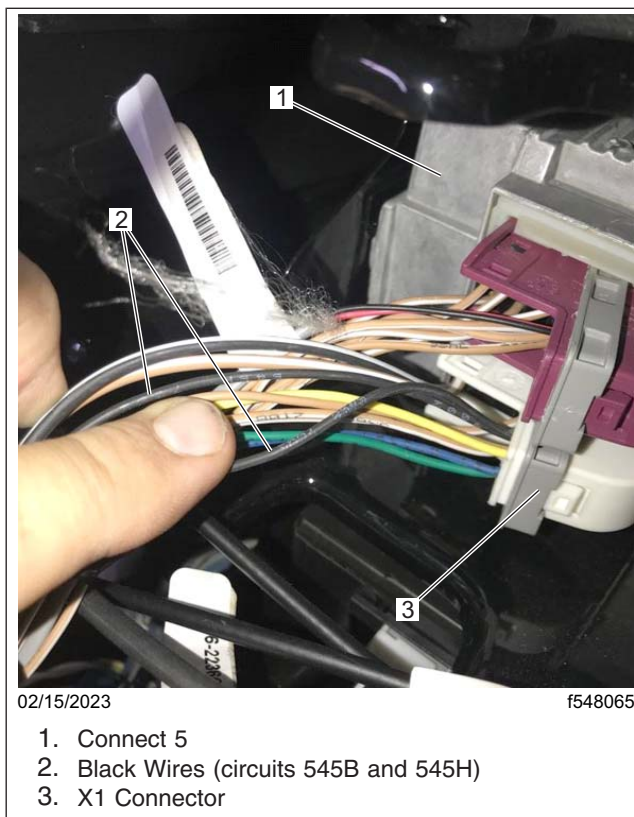
- 13.5 Secure the green 433 circuit to the harness bundle leading to the VPDM with zip ties as needed.
- 13.6 In the harness leading to the Connect 5 X1 connector (white latching connector), locate the circuits 545B and 545H as both have black wires. See [Fig. 20](#).

**Fig. 20, Locating Existing Circuits 545B and 545H
Connecting to Connect 5**

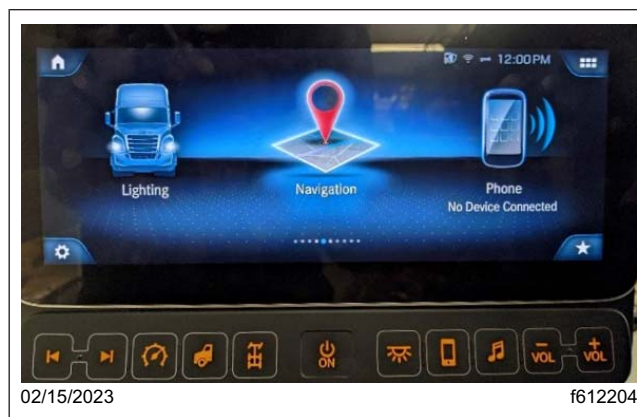
Fig. 28, Navigation Icon

- 22.2 Select the navigation icon shown in **Fig. 28** to start the route navigation. A caution is displayed as shown in **Fig. 29**; select 'OK.'

- 22.3 If the screens shown in **Fig. 28**, **Fig. 29**, and **Fig. 30** are displayed, then the TomTom installation is successful.
23. Clean a spot on the base label (Form WAR259) and attach a campaign completion sticker for SF662 (Form WAR261), indicating this work has been completed.

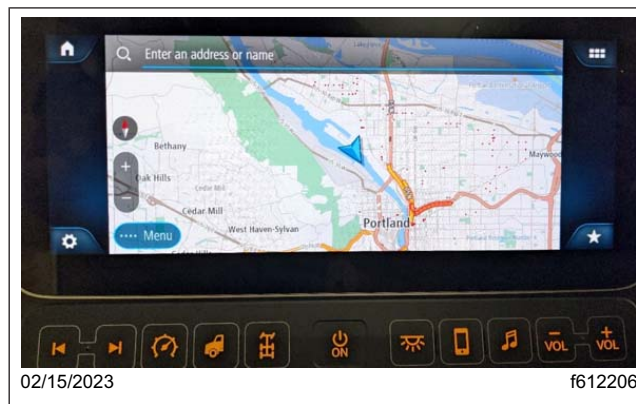
Fig. 30, Navigation Map

Figure 30 shows the navigation map indicating that the navigation system is functioning.
